# Aviation Investigation Final Report

| <b>Location:</b> | Englewood, Colorado | <b>Accident Number:</b> | CEN21FA215 |
| <b>Date &amp; Time:</b> | May 12, 2021, 10:23 Local | <b>Registration:</b> | N280KL (A1); N416DJ (A2) |
| <b>Aircraft:</b> | Swearingen SA226TC (A1); CIRRUS DESIGN CORP SR22 (A2) | <b>Aircraft Damage:</b> | Substantial (A1); Substantial (A2) |

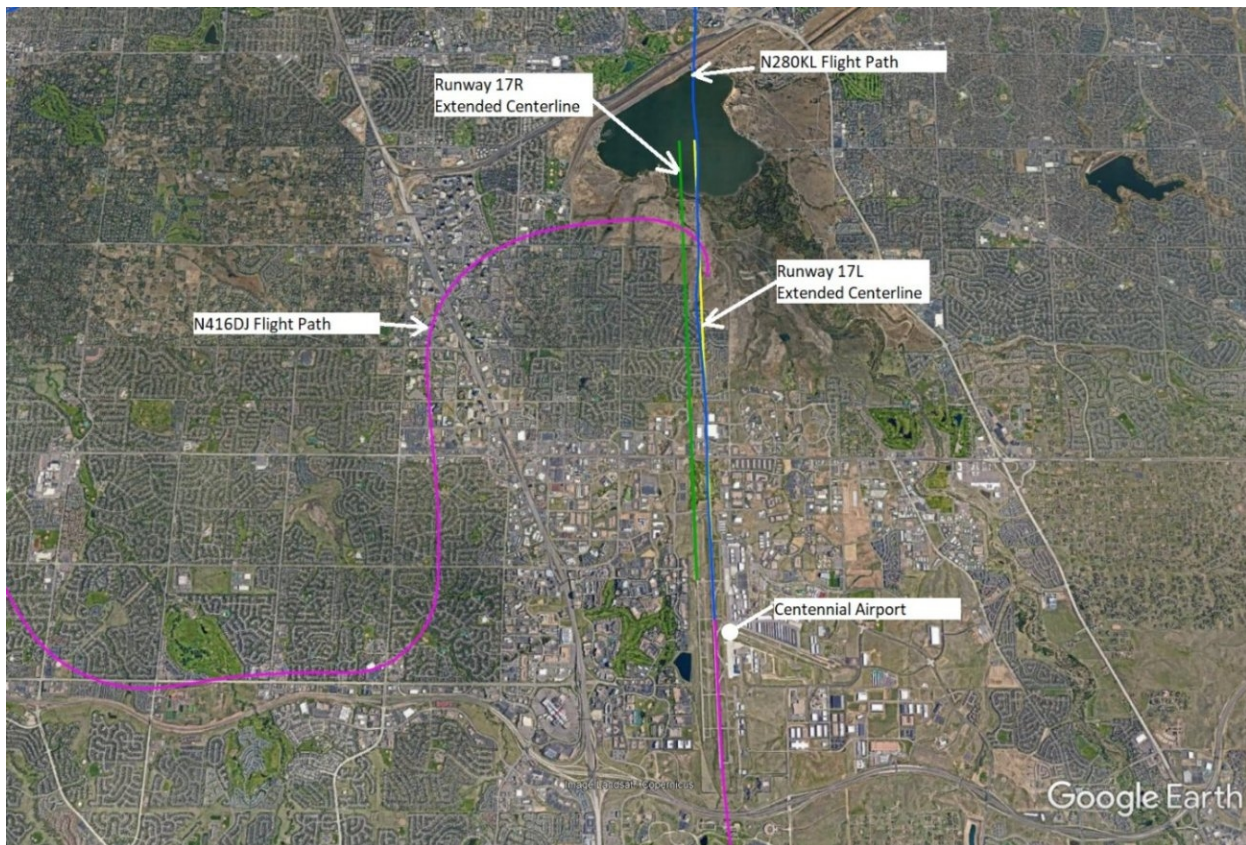
Figure 1 – Plot of ADS-B and RDM flight path information

Data from an on-board recording device showed that the Cirrus' airspeed on the base leg of the approach was more than 50 kts above the manufacturer's recommended speed of 90 to 95 kts. As the Cirrus made the right turn from the base leg to the final approach, its flight path carried it through the extended centerline for the assigned runway (right), and into the extended centerline for the left runway where the collision occurred. At the time of the collision, the Cirrus had completed about ½ of the 90° turn from base to final and its trajectory would have taken it even further left of the final approach course for the left runway.

Based on the available information, the pilot of the Cirrus utilized a much higher than recommended approach speed which increased the airplane's radius of turn. The pilot then misjudged the airplane's flight path, which resulted in the airplane flying through the assigned final approach course and into the path of the parallel runway. The controller did not issue a traffic advisory to the pilot of Swearingen regarding the location of the Cirrus. The two airplanes were on different tower frequencies and had the controller issued an advisory, the pilot of the Swearingen may have been able to identify the conflict and maneuver his airplane to avoid the collision.

The Swearingen continued its approach and remained aligned with runway 17L. The Cirrus continued the right-hand traffic pattern through the base leg, and then began to turn toward the final approach course for the runway. The Cirrus continued through the extended centerline for runway 17R, and then continued to the extended centerline for runway 17L where it collided with the Swearingen. The airplanes collided at 1023:52 when they were about 3.2 nm from APA. The Swearingen was aligned with runway 17L while the Cirrus had not completed the turn from base to final and was heading about 146° when the collision occurred.

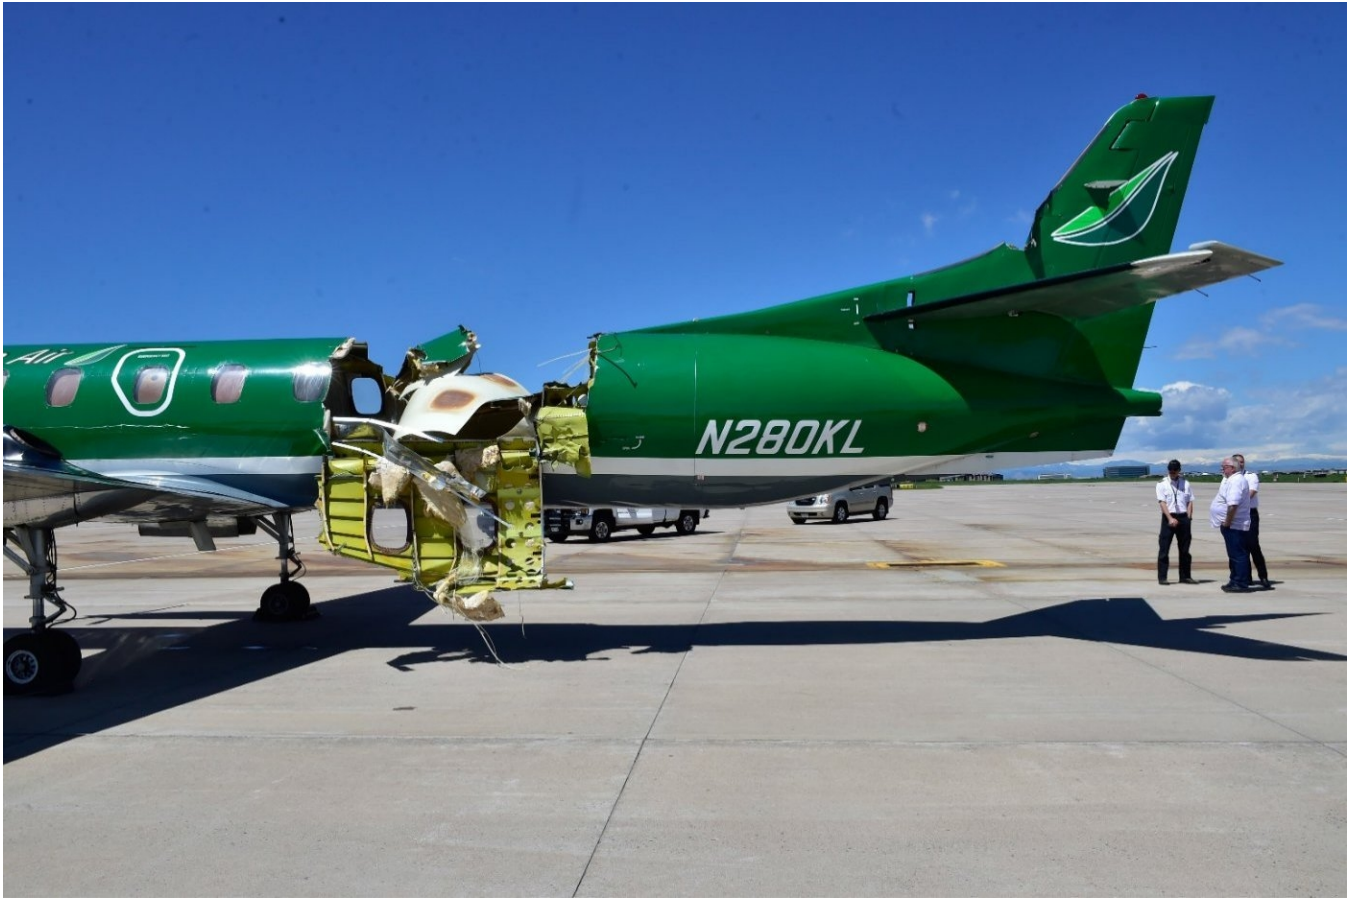
After the impact, the pilot of the Swearingen declared an emergency, continued to APA, and landed successfully on runway 17L. The pilot of the Cirrus reported that the airplane was not controllable after the impact, and he deployed the Cirrus Airframe Parachute System (CAPS). The Cirrus came to rest about 3 nm north of APA. Both airplanes sustained substantial damage (see figures 2 & 3)

Figure 2 – Photograph of the Swearingen after the accident.

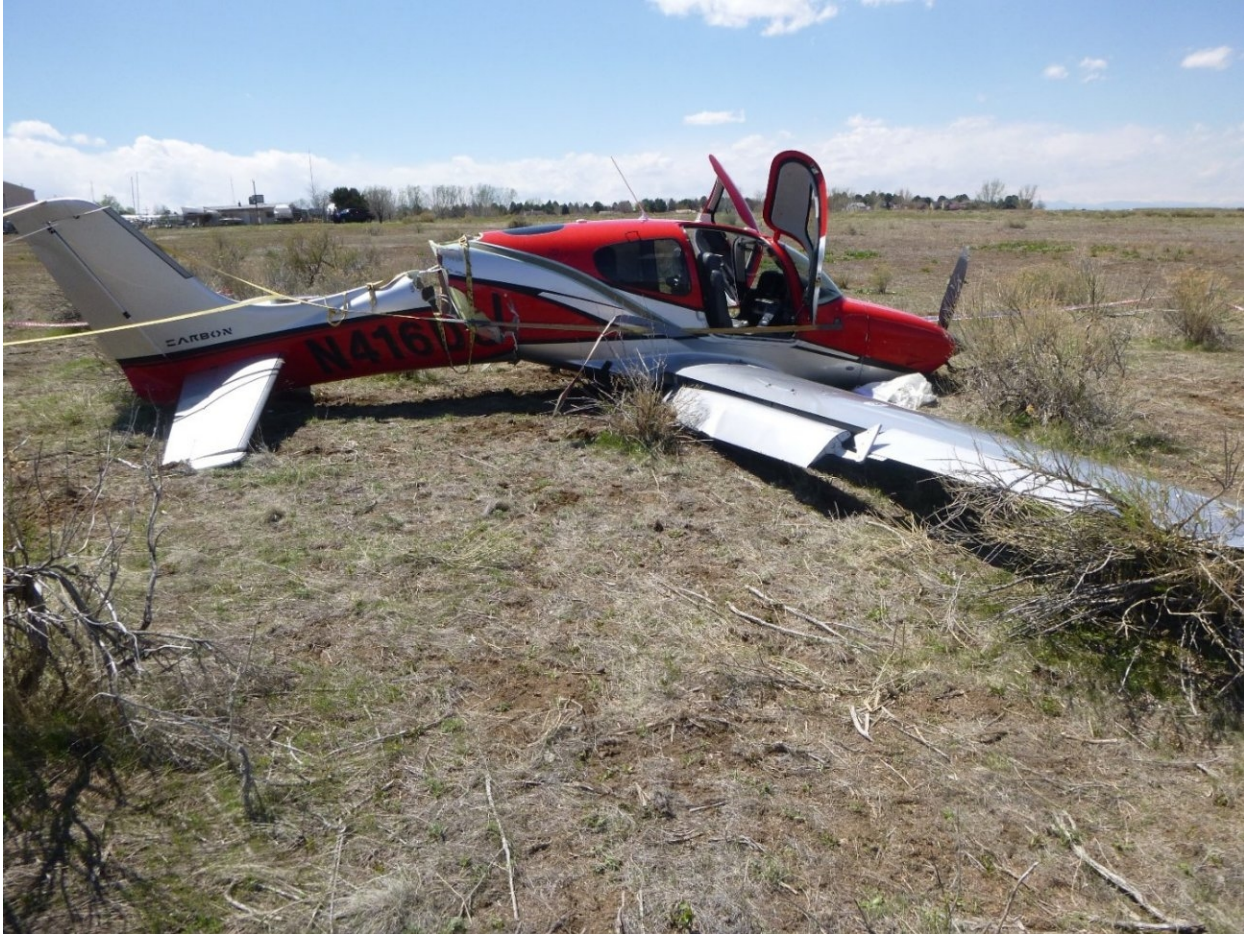
Figure 3 – Photograph of the Cirrus at the accident scene.
