# Aviation Investigation Final Report

| <b>Location:</b> | Helena, Montana | <b>Accident Number:</b> | WPR21LA313 |
| <b>Date &amp; Time:</b> | August 11, 2021, 09:00 Local | <b>Registration:</b> | N783MB |
| <b>Aircraft:</b> | Cessna 425 | <b>Aircraft Damage:</b> | Substantial |

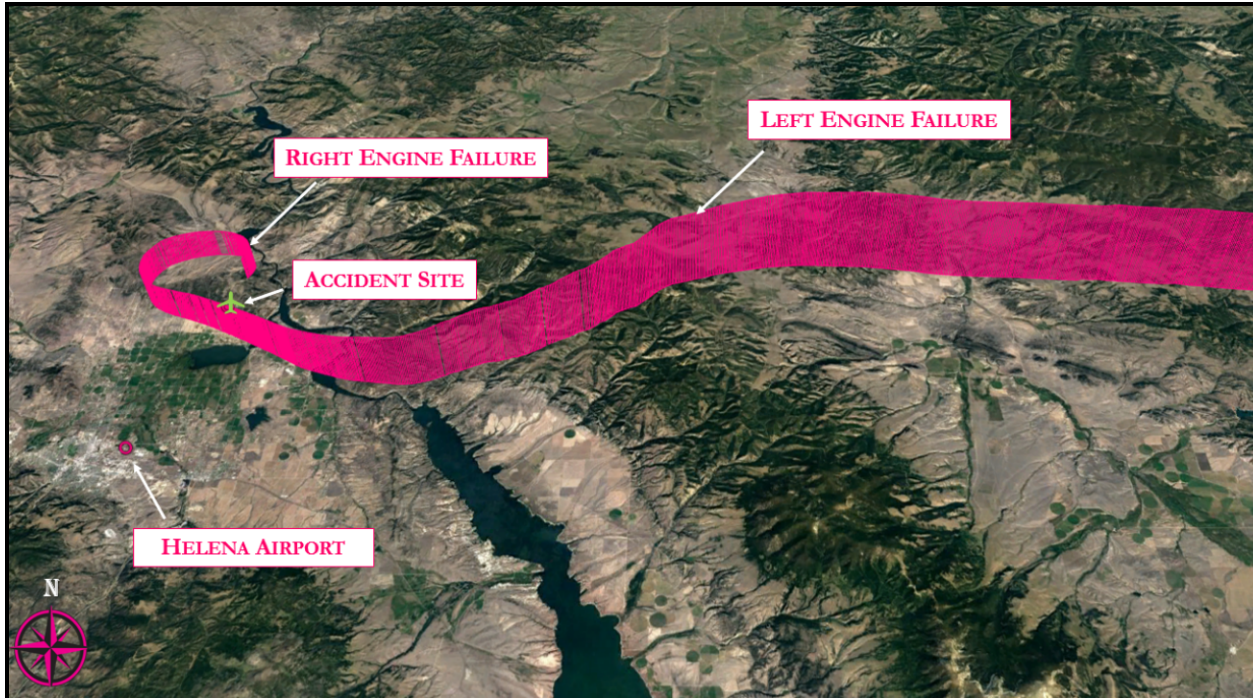
Figure 1: Flight Track Plot

At 0852:59 the pilot reported to the air traffic controller that he had an hour and a half of fuel on board and about 3 minutes later the airplane made a right turn to the north. At 0857:15, with the airplane about 7,900 ft msl, the pilot reported that the right engine experienced a loss of power (see Figure 1 below). At 0859:02, the pilot reported the airplane was going to collide with trees. The airplane came to rest with the right wing and empennage severed from the fuselage. There was fuel onboard the airplane at the time of impact, the quantity is unknown due to the fuel tanks being breached. The pilot estimated there was about 400 pounds in each tank at the time of the occurrence.
