Aviation Investigation Final Report

Location:	Santee, California	Accident Number:	WPR22FA004
Date & Time:	October 11, 2021, 12:14 Local	Registration:	N7022G
Aircraft:	Cessna 340A	Aircraft Damage:	Destroyed
Defining Event:	Loss of control in flight	Injuries:	2 Fatal, 2 Serious
Flight Conducted Under:	Part 91: General aviation - Personal

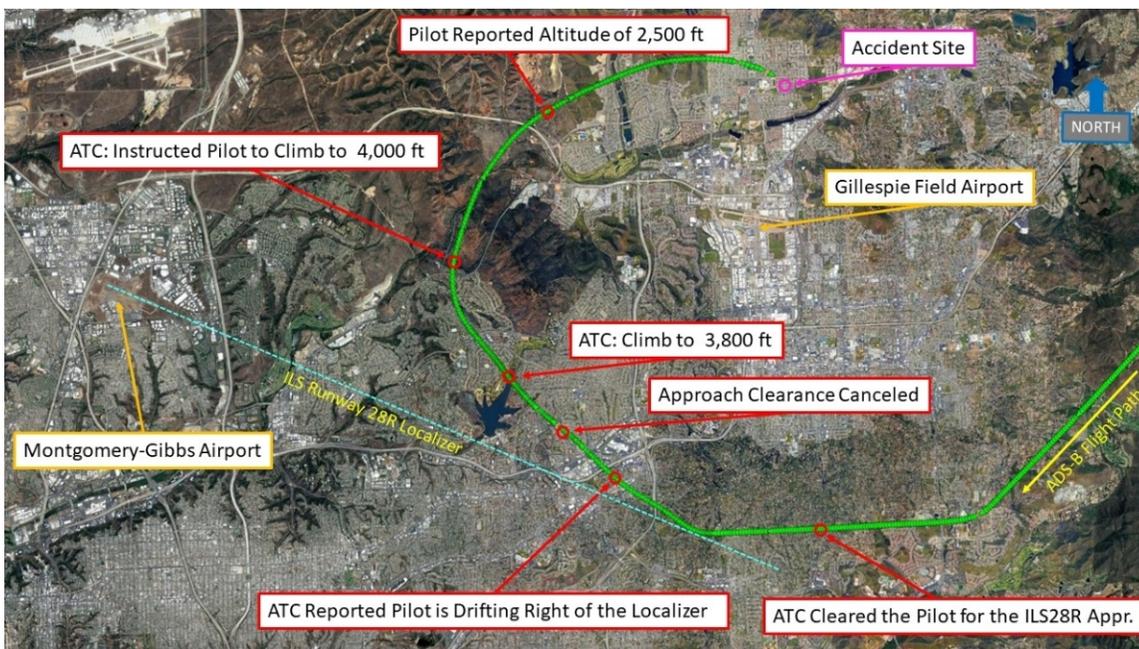
ADS-B data showed that the airplane had begun to climb at 1213:39, from 2,550 ft msl. The airplane continued a climb ascent while turning from a northeasterly-easterly heading and reached a maximum altitude of 3,500 ft msl, where it remained for about 4 seconds before it began a descending right turn. The airplane remained in the right descending turn until the last recorded target at 900 ft msl, located about 1,333 ft northwest of the accident site.

Figure 1: ADS-B data with ATC communication points noted.

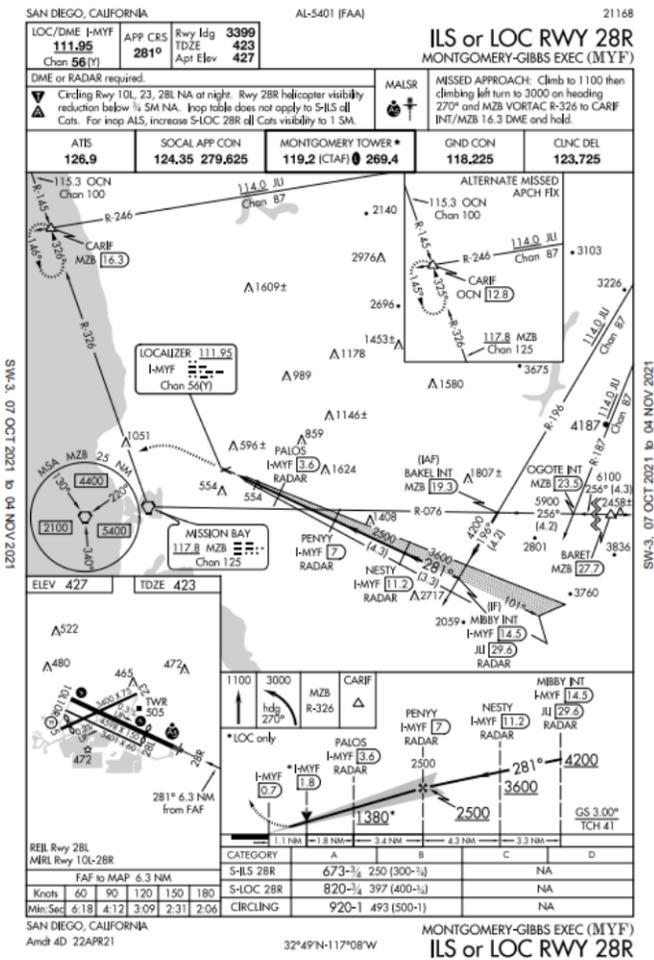
Figure 2: ILS / Localizer approach plate for Runway 28R at Montgomery - Gibbs Executive Airport.

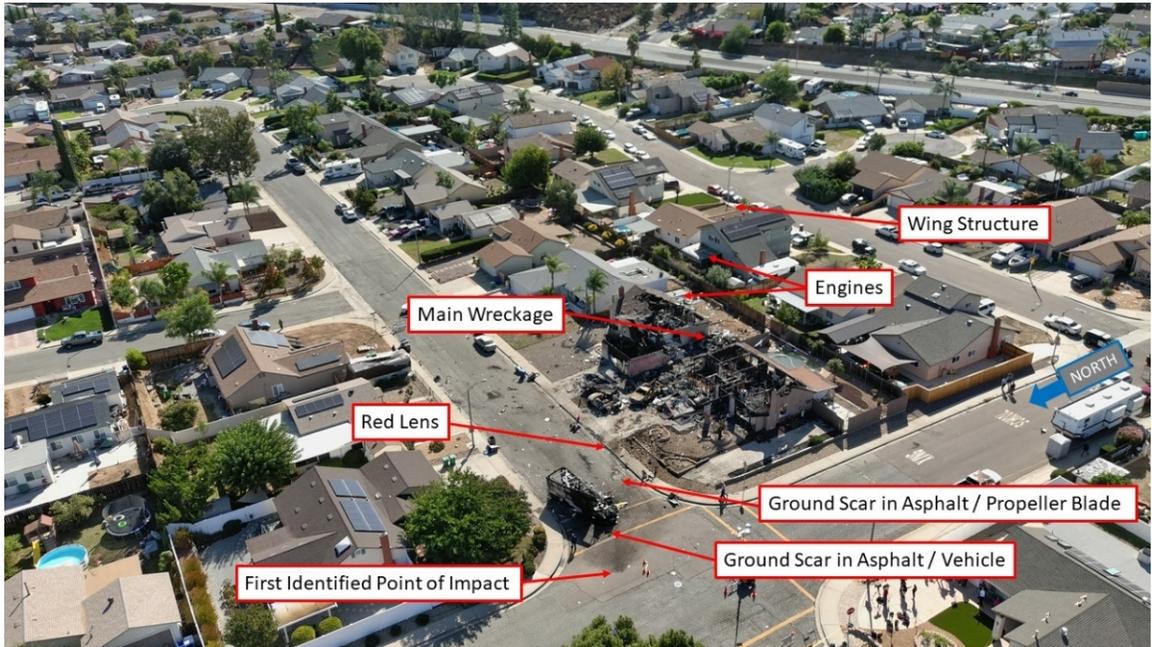
Examination of the accident site revealed that the airplane impacted a residential street on a heading of about 113° magnetic. The debris path, which consisted of various airplane, vehicle, and residential structure debris, was about 475 ft long and 400 ft wide, oriented on a heading of about 132°. Numerous residential structures exhibited impact related damage and or fire damage.

Figure 3: Annotations of wreckage locations. Aerial photo provided by San Diego County Sheriff.

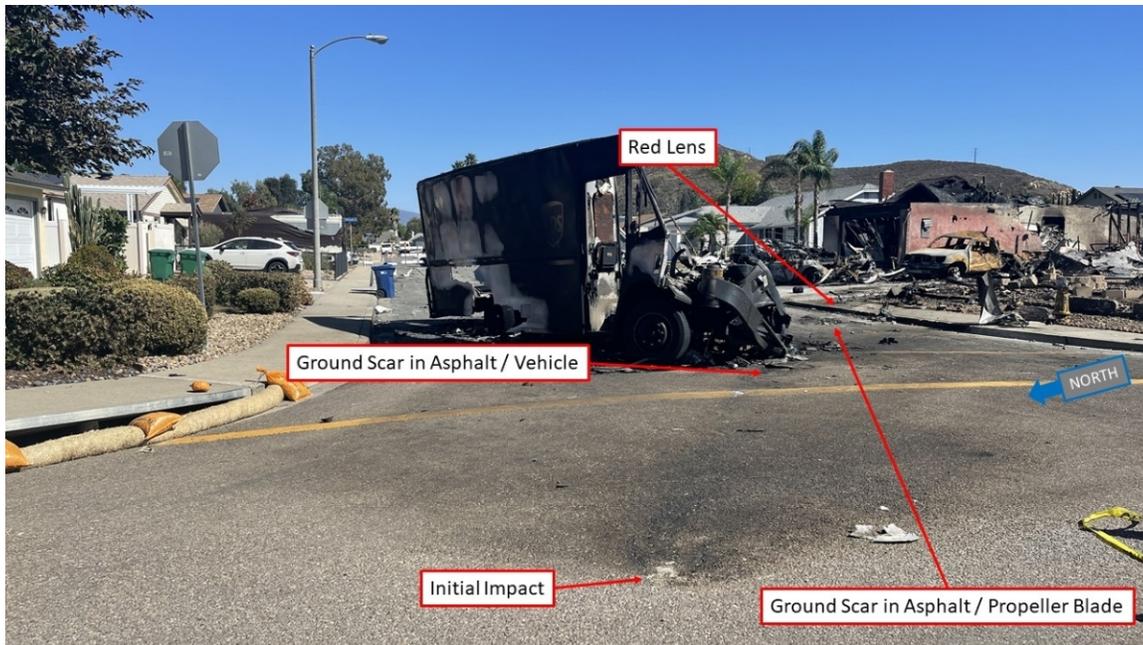
The first identified point of contact (FIPC) was a gouge in the asphalt road about 10 inches long and 5 inches wide. Scrape marks extended from about 18 ft from the FIPC to a second gouge in the asphalt, which was about 2 ft wide and 3 ft long, along with a damaged vehicle. Adjacent to the second scrape mark and vehicle was an additional gouge in the asphalt, about 2 ft long and 4 inches wide. Additional scrape marks extended 28 ft to a large impact crater within the asphalt, which was about 4 ft wide, 3 ft long, and about 6 inches deep, and contained a portion of propeller blade. Additional scratch marks extended another 12 ft to portions of red lens consistent with the left wing navigation lens.

Figure 4: Initial impact area.
