**PRELIMINARY REPORT ON ACCIDENT INVOLVING HAWKER 800XP
AIRCRAFT OPERATED BY FLINTS AERO SERVICES LTD. WITH NATIONALITY
AND REGISTRATION MARKS 5N-AMM WHICH OCCURRED AT IBADAN
AIRPORT, OYO STATE ON 3RD NOVEMBER, 2023**

Registered owner and operator:	Flints Aero Services Ltd
Aircraft type and model:	Hawker 800XP
Manufacturer:	Raytheon Aircraft Company, USA
Date of manufacture:	1999
Nationality and registration marks:	5N-AMM
Serial number:	258286
Location:	220 m short of the threshold, Runway 22, Ibadan Airport, Oyo state
Date and time:	3rd November 2023 at about 20:18 h

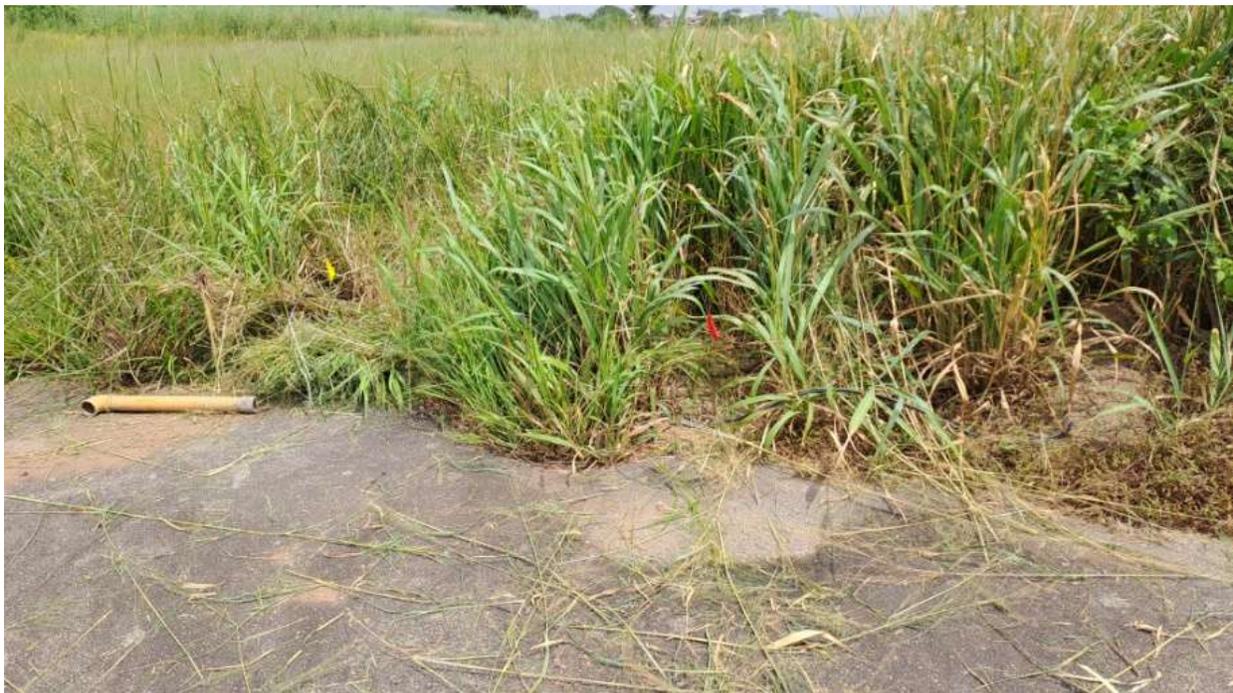
The aircraft veered right of centreline, travelling about 156 m before exiting the runway via the right runway shoulder into the grass verge. Tyre tracks indicate that number 1 tyre was deflated at some point along the aircraft's path on the runway. There was no evidence of braking action. The aircraft came to a stop a distance of about 184 m from the threshold, runway 22.

Figure 1: A view of the aircraft tracks from the paved area

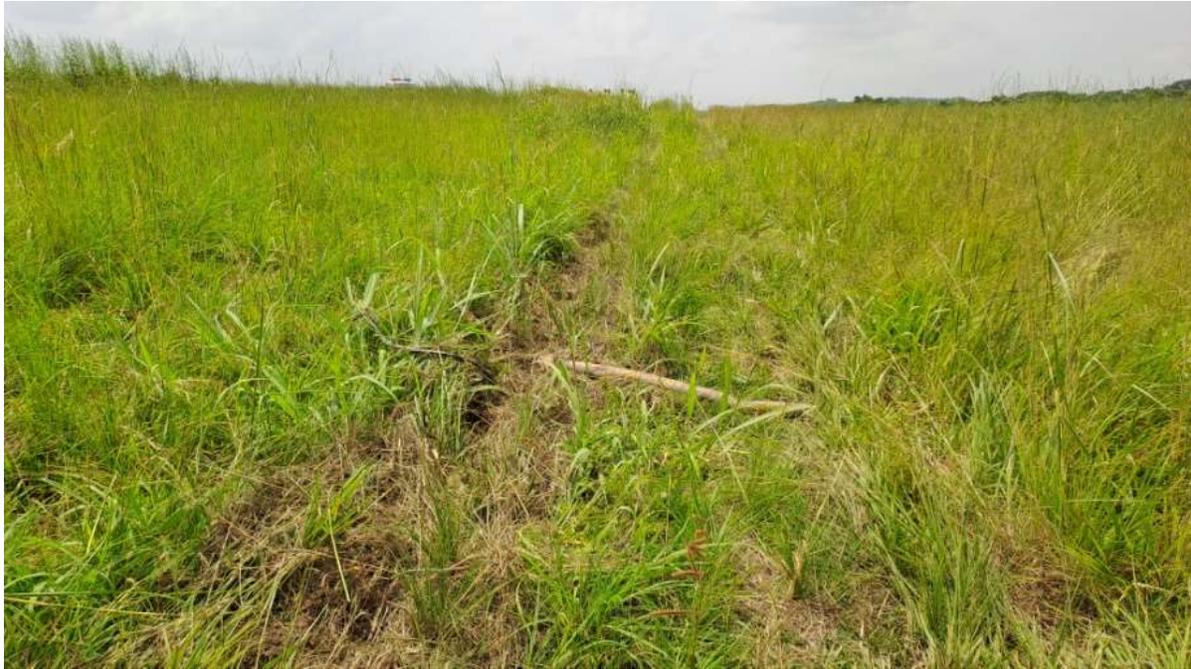
The aircraft touched down in the grass verge on the extended centreline of runway 22, about 220 m from the threshold. It travelled in a relatively straight direction through the grass verge impacting several rows of approach lights until it emerged unto the

Figure 2: A view of the aircraft tracks from the grass verge. Runway 22 is just beyond the horizon

1. The Nigerian Airspace Management Agency (NAMA) should ensure that it strictly observes the airport operational hours as published in the relevant Aeronautical Information Publication (AIP) and not permit extensions beyond the airport limitations.
2. The Nigerian Civil Aviation Authority (NCAA) should ensure that Flints Aero Services Limited operates within the limits of the approval given to it, in accordance with Section 18.2.4.3 of the Nigerian Civil Aviation Regulations 2015.
3. Flints Aero Services Limited should ensure that its flight crew have sufficient experience in night-time flight operations.
4. Federal Airports Authority of Nigeria (FAAN) should ensure that the overgrown grass verge on either side of runway 04/22 is immediately cleared.

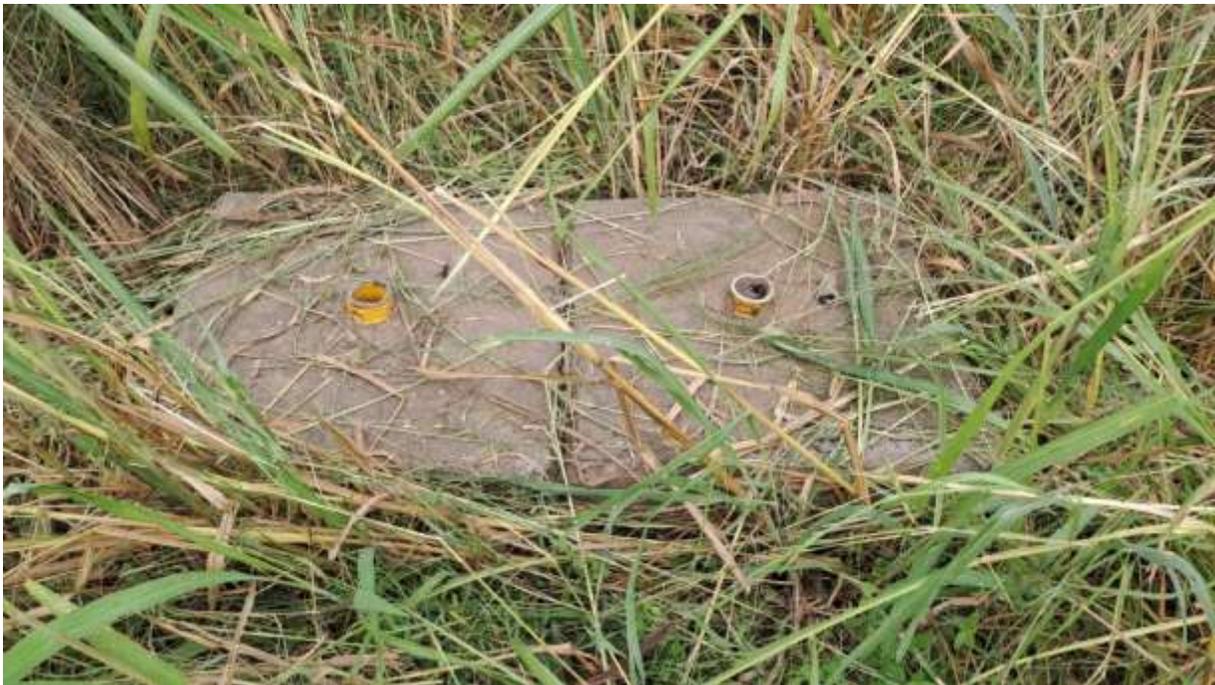
Several runway approach light fittings were destroyed on impact with the aircraft along its trajectory through the grass verge short of the runway 22 threshold.

Figure 3: Some of the decapitated runway approach light fittings

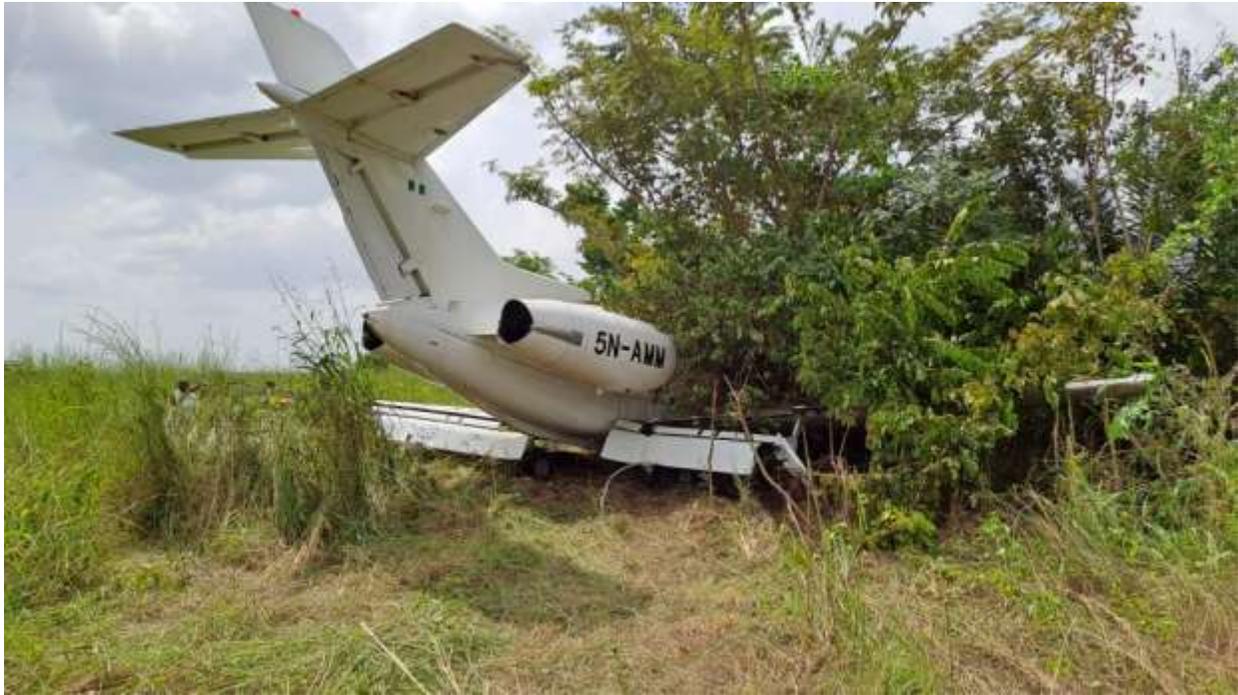
14. There was no evidence of braking action from the tyre tracks on the runway.
15. The aircraft traveled into the grass verge a distance of about 220 m and was stopped by vegetation about 184 m from runway 22 threshold, and about 28 m beyond the right runway shoulder.

Figure 4: The aircraft where it stopped

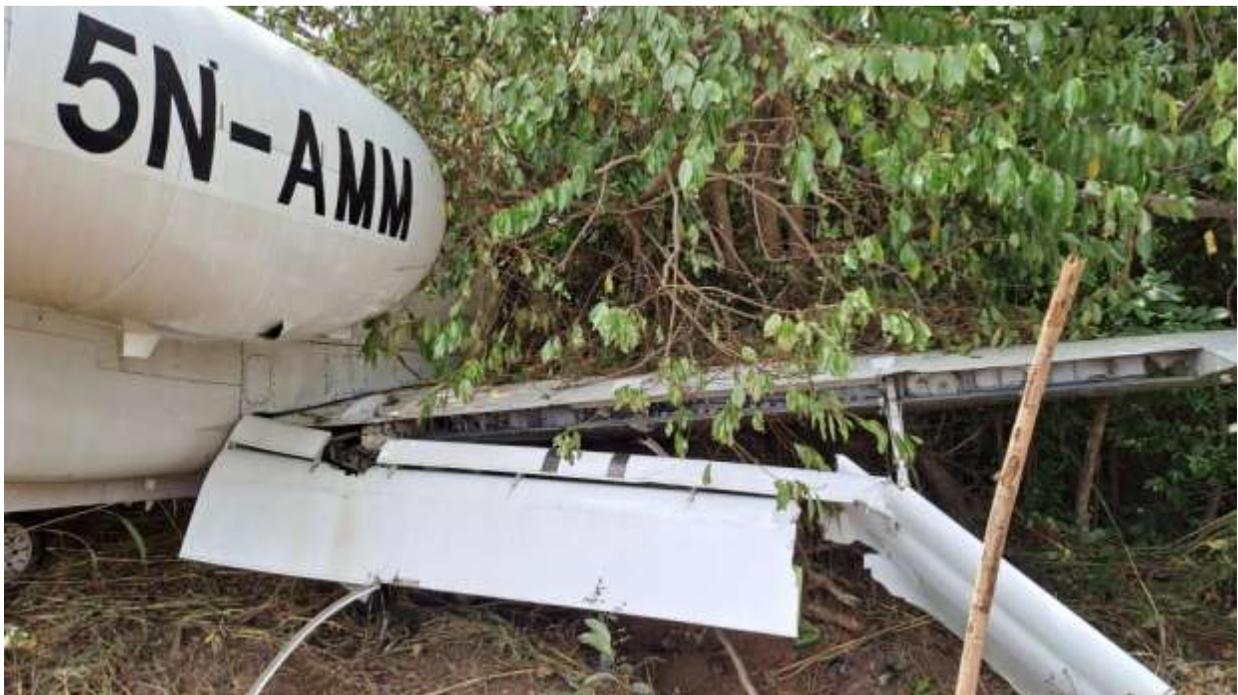
16. Post-incident inspection of the aircraft confirmed substantial damage to the fuselage, the landing gear and flaps.
17. The CVR and FDR were recovered in good condition and recordings were intact after the occurrence.

Figure 5: Damage to the right wing flaps

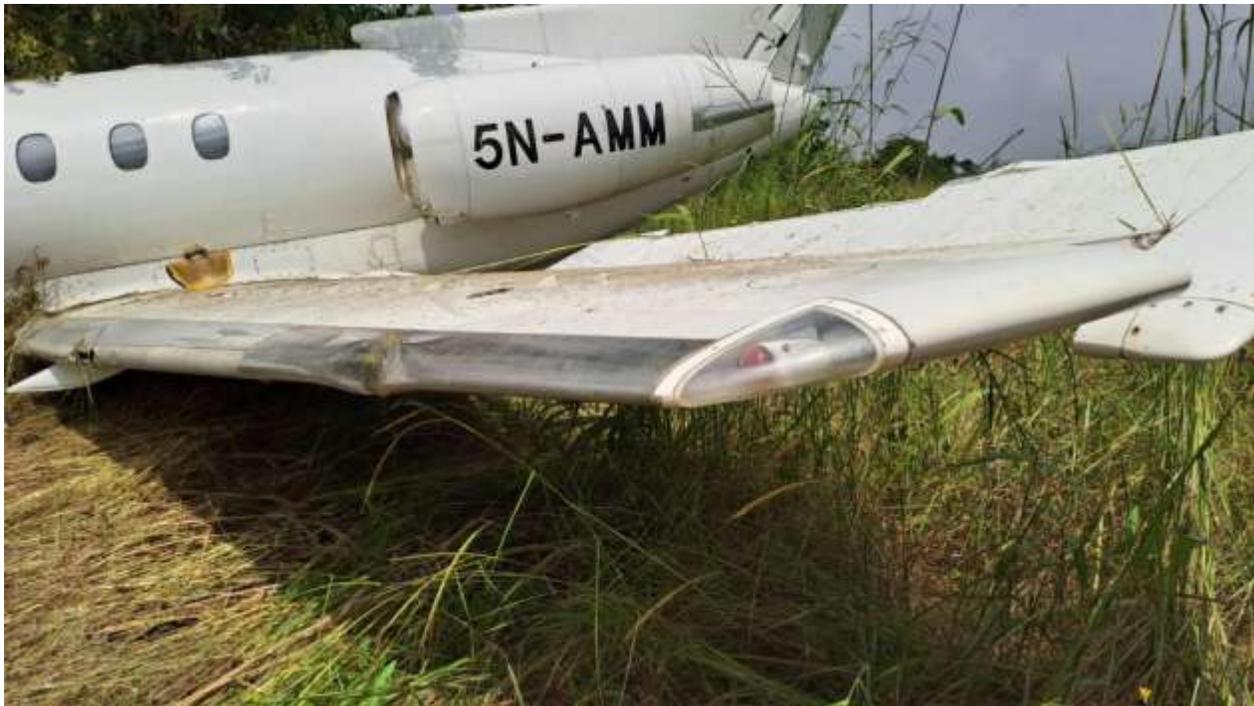
Figure 6: Damage to the left wing leading edge and a fragment of the approach lighting fixture

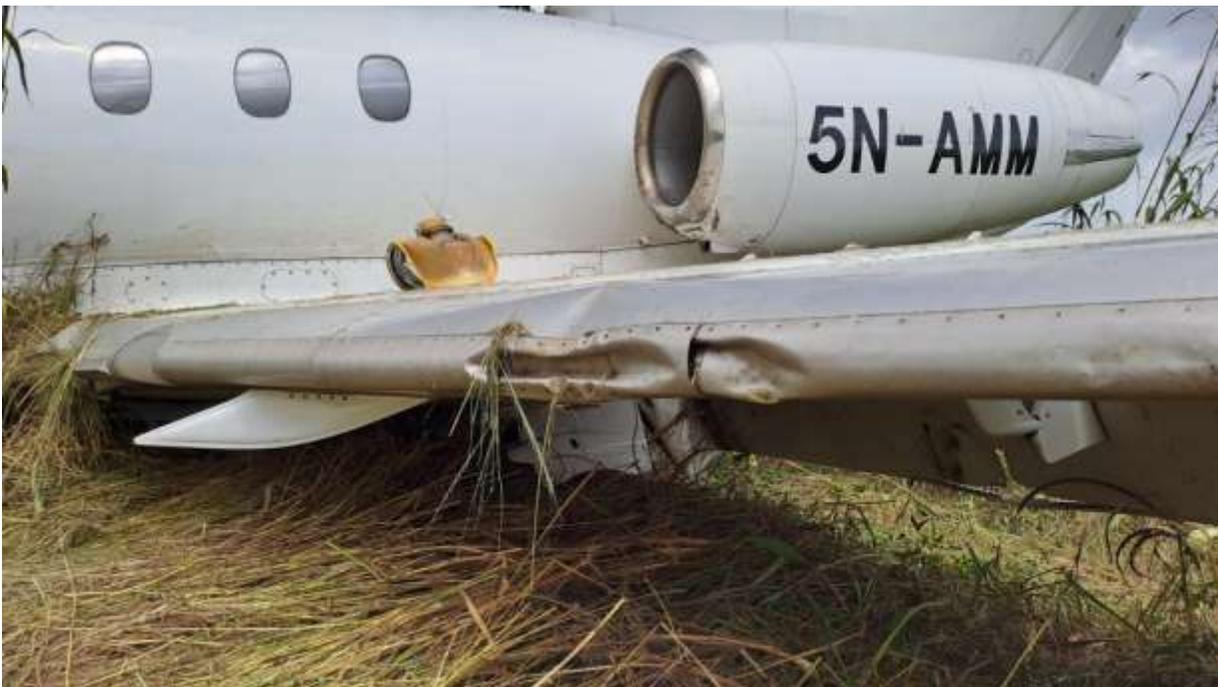
Figure 7: Close-up of damage to the left wing leading edge
