# Aviation Investigation Final Report

<b>Location:</b>	Watsonville, California	<b>Accident Number:</b>	WPR22FA309
<b>Date &amp; Time:</b>	August 18, 2022, 14:55 Local	<b>Registration:</b>	N49931 (A2); N740WJ (A3)
<b>Aircraft:</b>	Cessna 152 (A2); Cessna 340A (A3)	<b>Aircraft Damage:</b>	Substantial (A2); Destroyed (A3)
<b>Defining Event:</b>	Midair collision	<b>Injuries:</b>	1 Fatal (A2); 2 Fatal (A3)
<b>Flight Conducted Under:</b>	Part 91: General aviation - Personal (A2); Part 91: General aviation - Personal (A3)

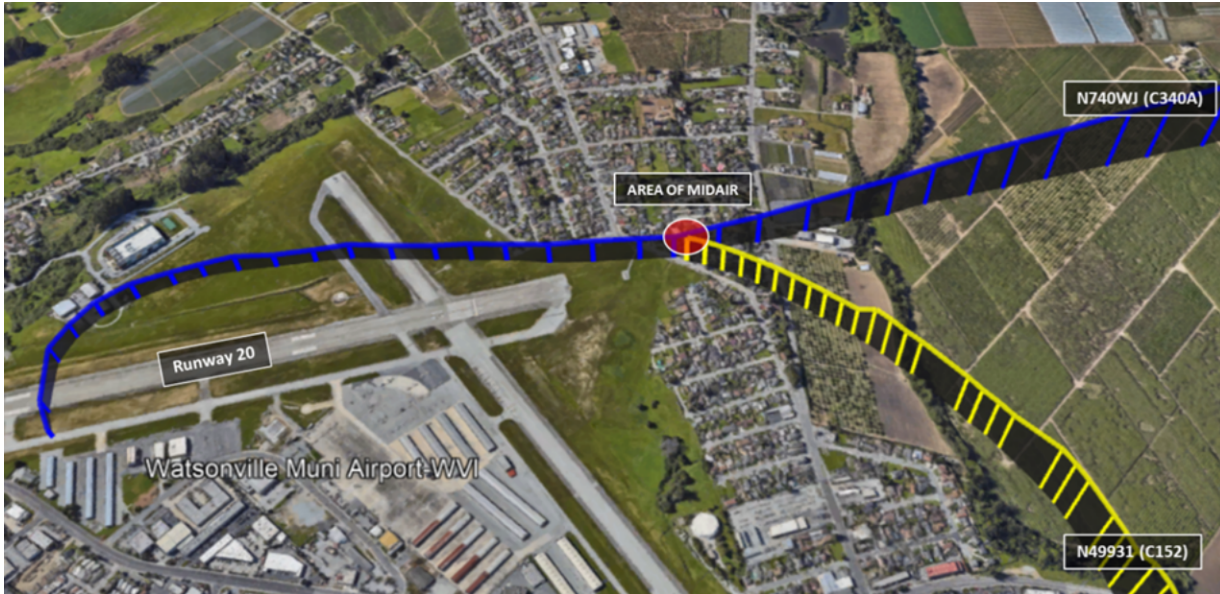
Figure 1. View of the two airplanes' ADS-B flight track data.

Recorded automatic dependent surveillance-broadcast (ADS-B) data provided by the Federal Aviation Administration (FAA) revealed that the Cessna 340 departed Turlock Airport (O15), Turlock, California, and proceeded west toward runway 20 at WVI. The Cessna 340 maintained about 180 knots ground speed until the collision. The data showed that the airplanes' flight paths intersected about 1455:13, at an altitude about 225 to 300 ft msl, or about 150 ft agl, as seen in Figure 1.

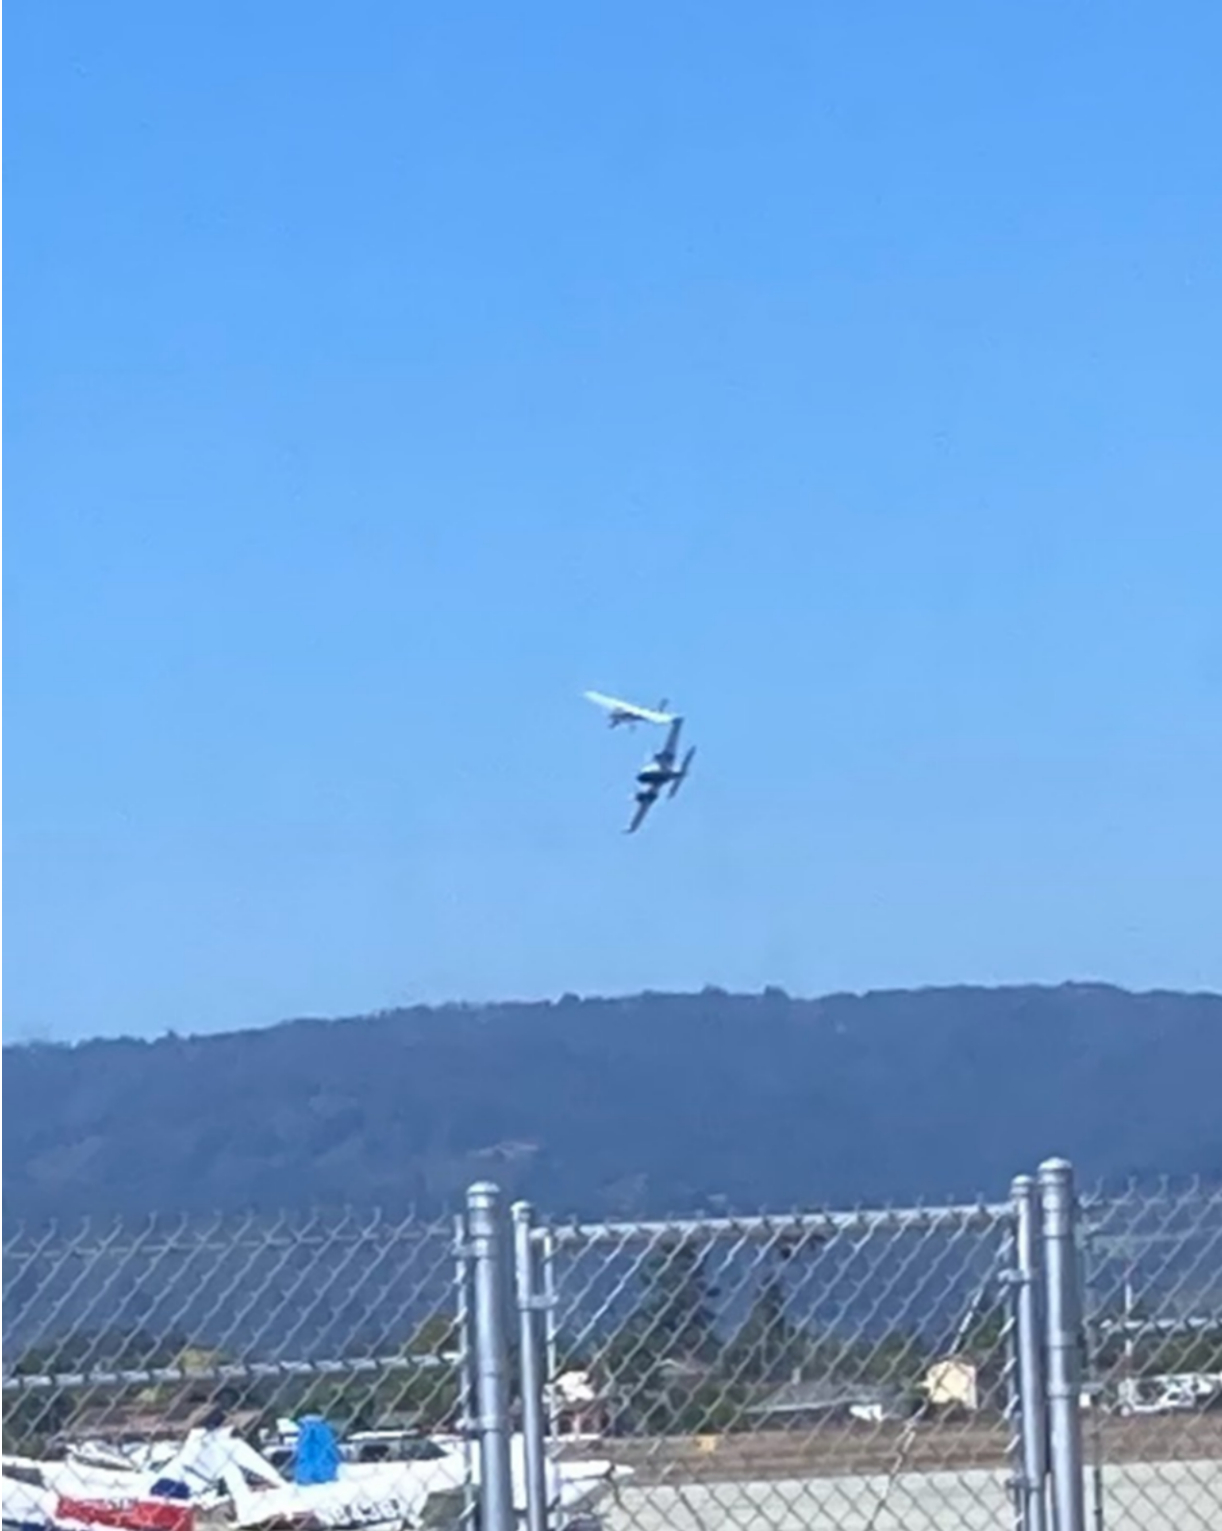
Figure 2. Image captured before the collision.

A witness on the ground at WVI captured an image of the two airplanes before the collision, as seen in Figure 2.
