**REPUBLIC OF KENYA**

**AIRCRAFT ACCIDENT INVESTIGATION**

DRAFT FINAL REPORT ON AIRCRAFT ACCIDENT TO  
CESSNA 208B REGISTRATION 5Y-JKN AT MARSABIT HILL  
ON 20 MARCH 2021

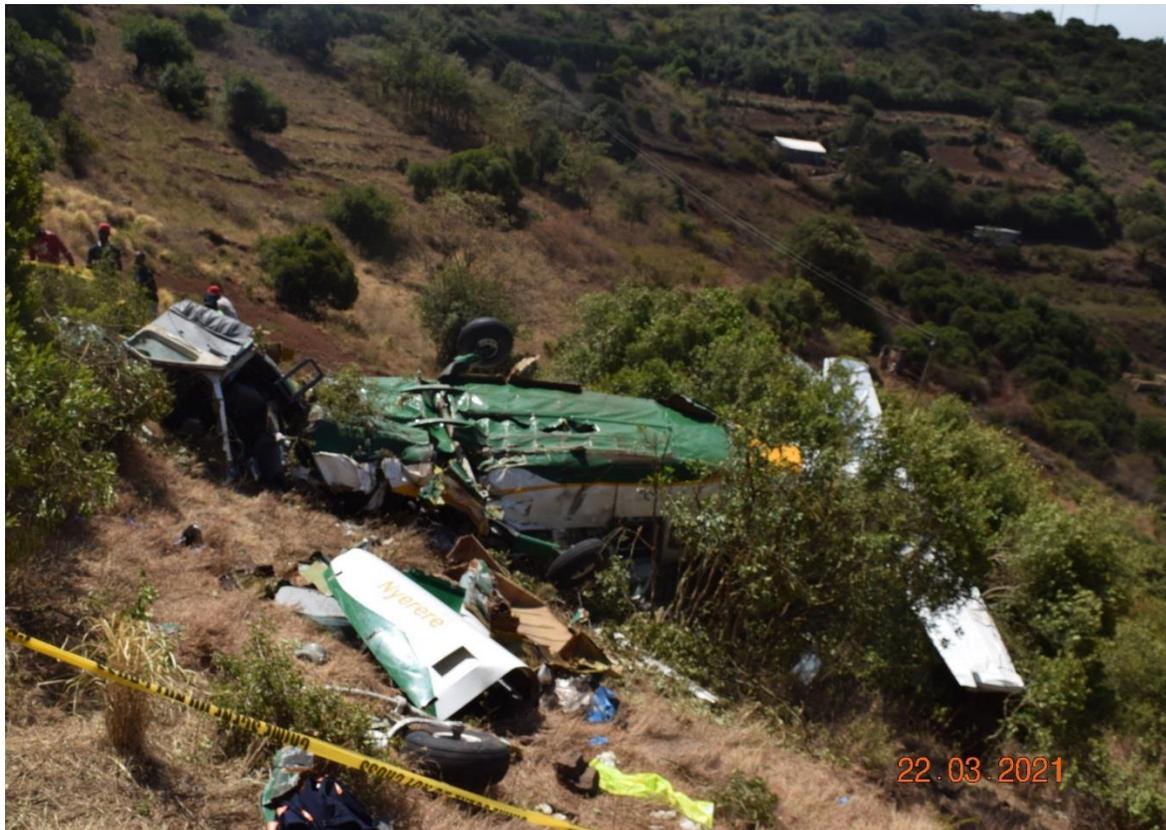
**Figure 1:** Photograph of the accident aircraft at the accident site

main landing gears leaving parts of the fuselage and iron box with its content kept in the lower baggage compartment on the spot. It then ballooned and missed a house before it flipped upside down and impacted the ground and came to rest facing opposite direction. It left a trail of aircraft parts along its path before it came to rest. The nose-wheel and its assembly separated and fell off and was found next to the house 110m from its first point of impact. There was no fire after impact but all the occupants received fatal injuries. Information obtained by eyewitness indicated that the accident occurred in poor visibility due to heavy presence of thick fog.

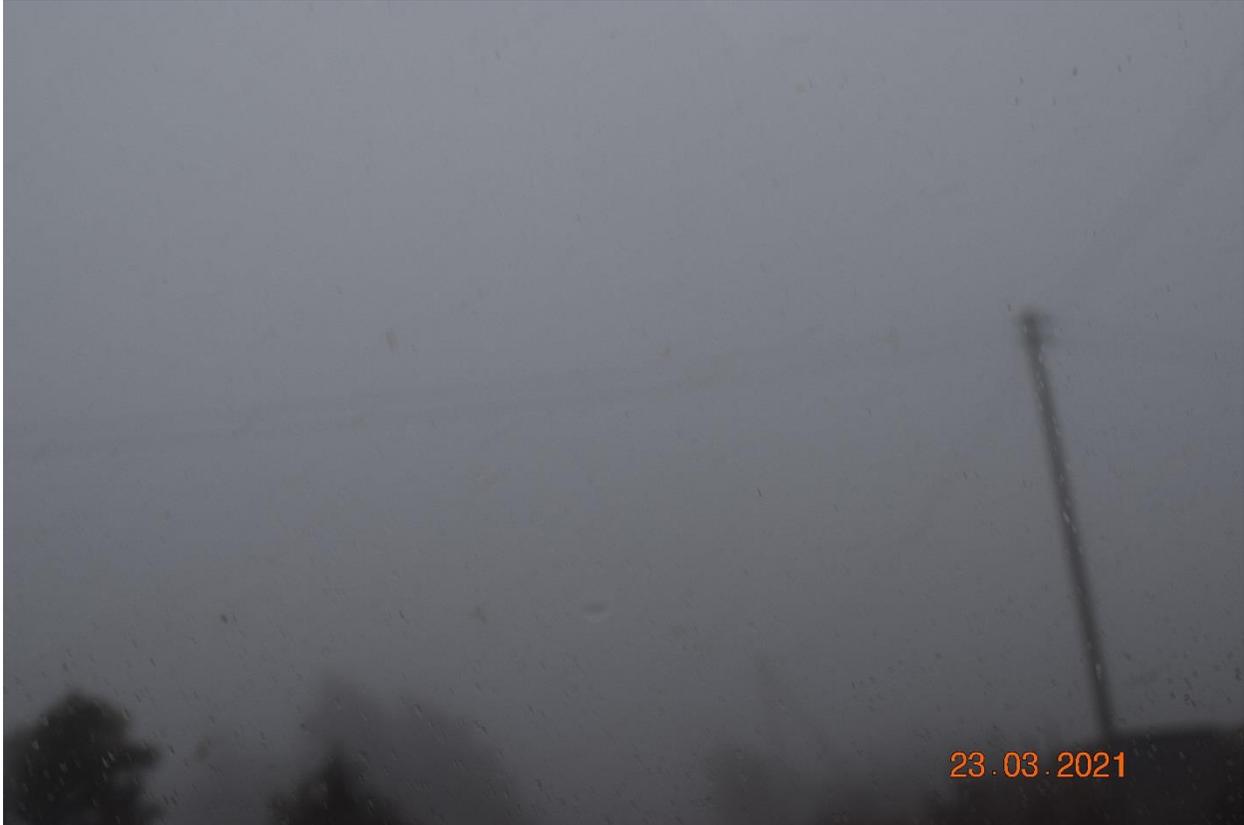
**Figure 5:** Photograph showing fog around Marsabit around 10.00am near the location of the accident.

The actual weather on that day was clear up to 0840 LT hills visible with visibility of more than 7 km, light winds and zero cloud cover. After 0840LT there was fast generating thick fog encompassing the entire family of hills reducing the visibility to less than 200 meters. During this period of thick fog, now and again gaps of improved, forward visibility occurred but they were closing almost as soon as they formed. This was evident from the photographs taken on 23 March at around the same time (See figure 5). With this type of weather it is very difficult for VFR flight to be conducted to Marsbit airstrip considering the type weather formation.

Due to the terrain and natural weather formation around Marsabit hills, AAID recommends crew sensitization and enhanced Local Marsabit weather communication to inbound traffic.

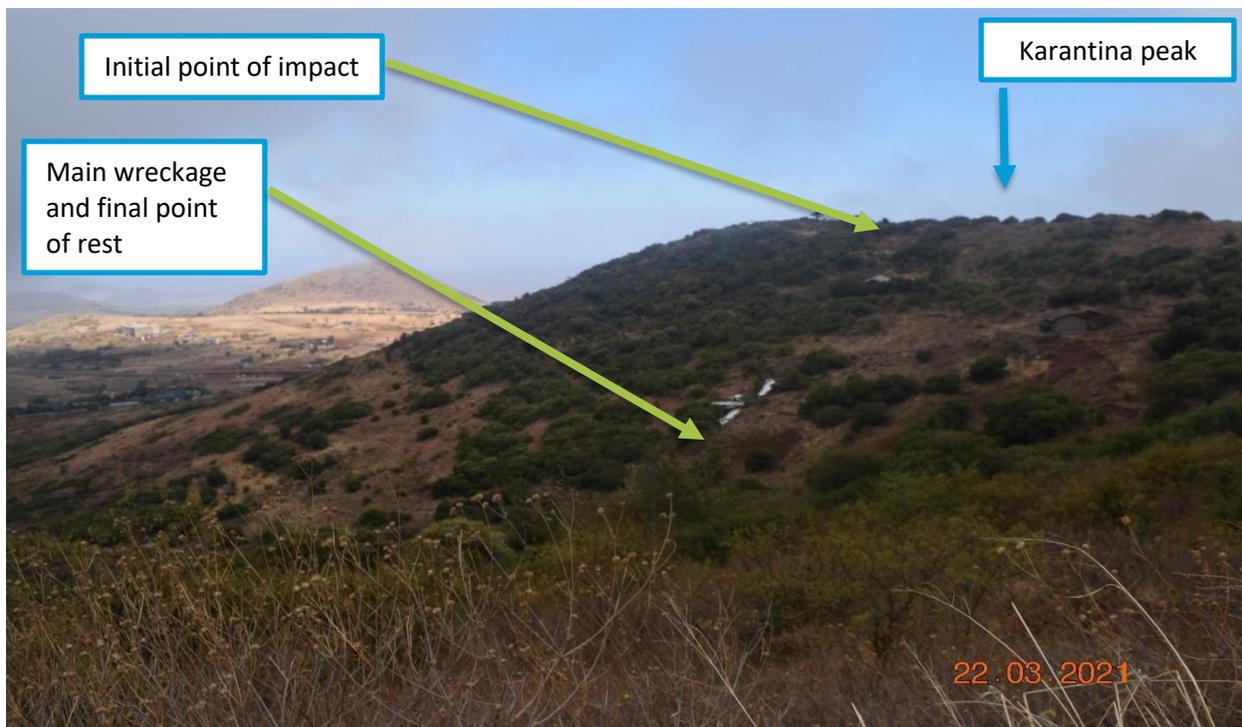
**Figure 6:** Photograph showing the general wreckage distribution after impact

The aircraft impacted the hill top with its nose wheel and landing gear after which the nose wheel collapsed and separated. The fuselage also contacted the ground and some parts peeled-off. An iron box containing aircraft oil lubricants, mechanic rags, locking wire and water was found at the first point of impact. A bag containing personal effects for the first officer was also found at the first point of impact. The right wing broke off and separated from the main fuselage but remained near the main wreckage (7m) away. The propeller and its assembly separated and was not accounted for except a single piece of the propeller blade was collected along the path. The nose wheel landing gear was found next to a house along the wreckage flight path.

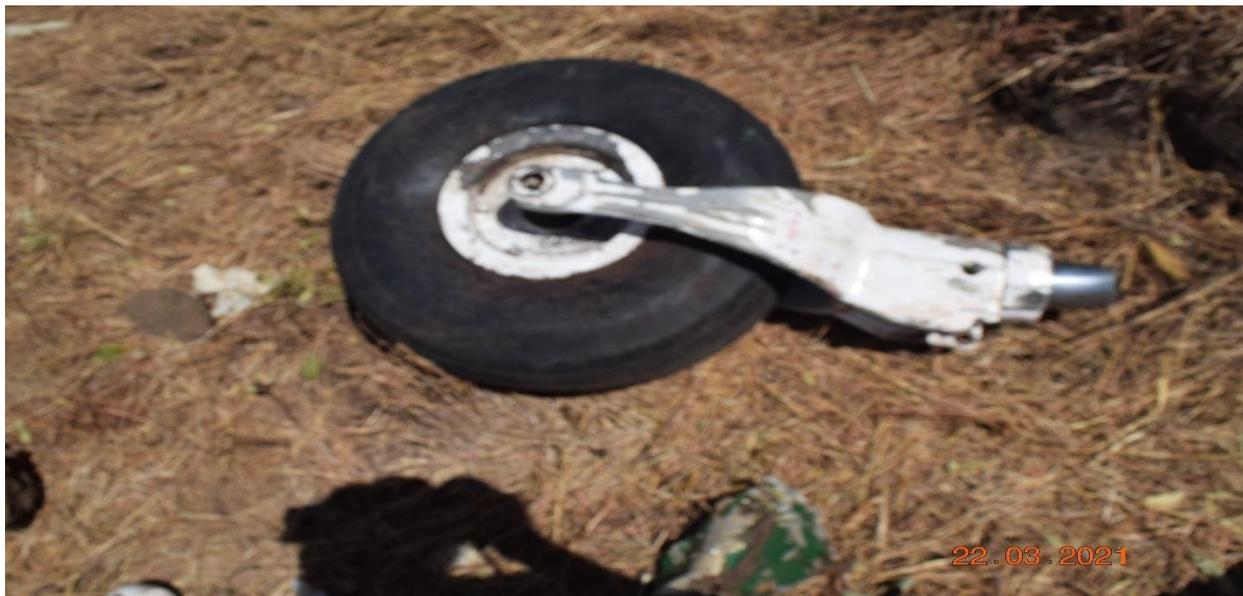
**Figure 7:** Photograph showing the aircraft nose-wheel that separated after impact

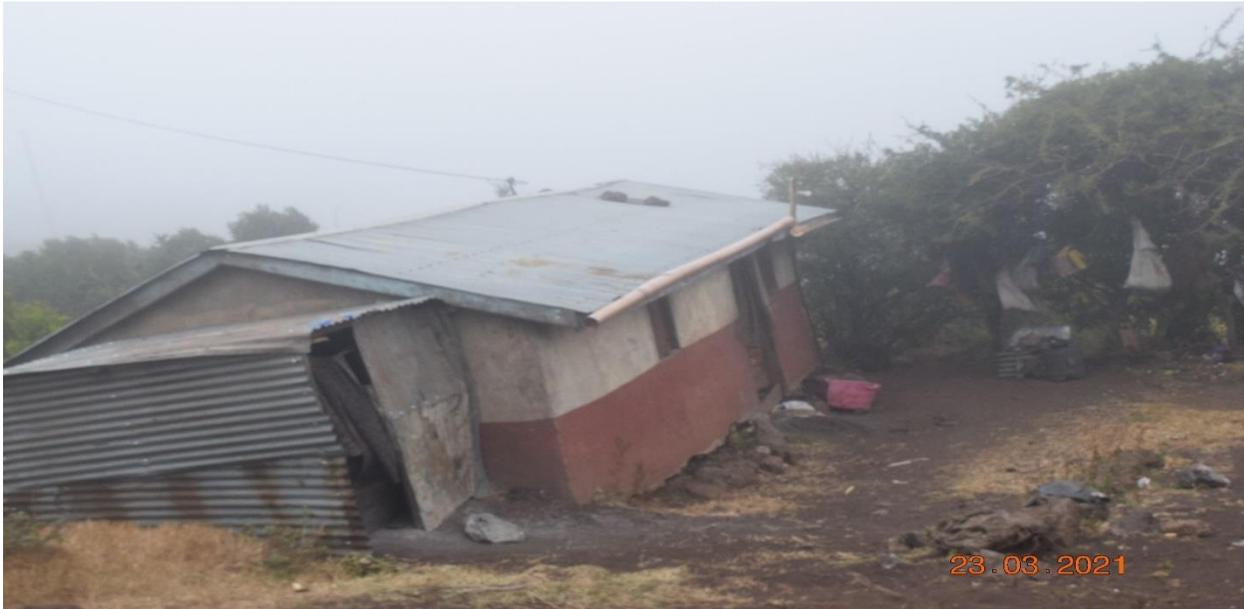
**Figure 8:** Photograph showing family house within the vicinity of the accident.

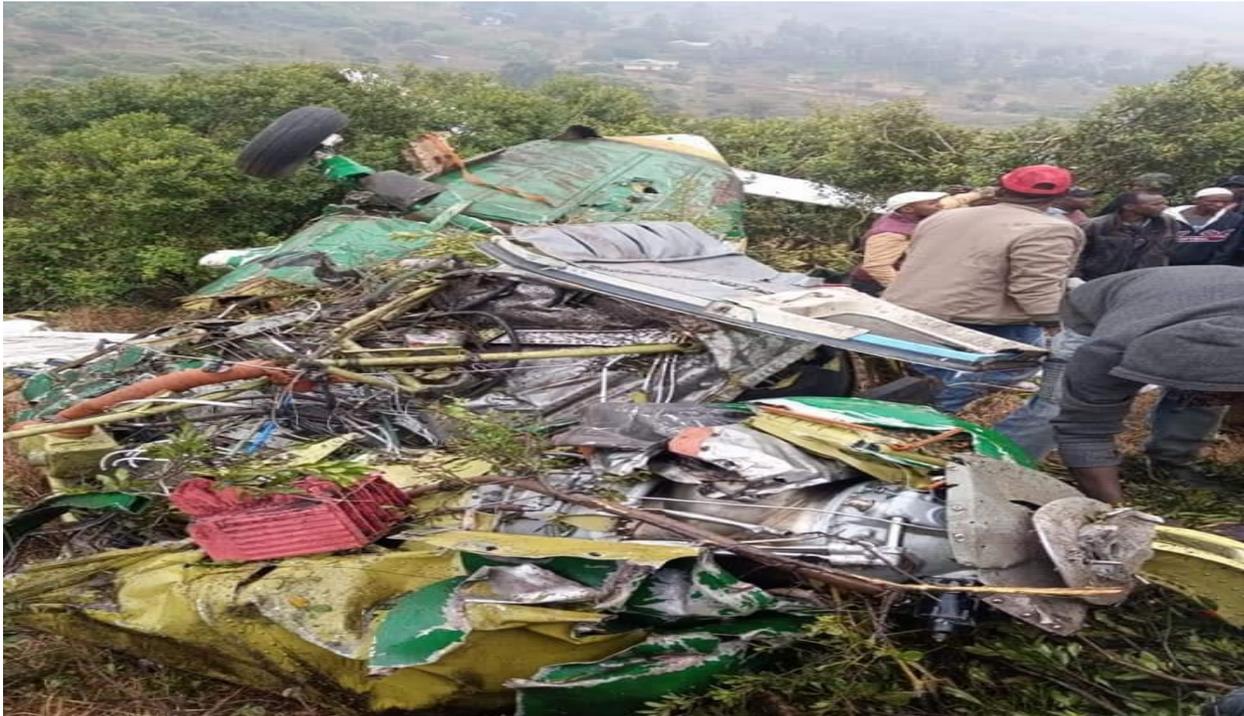
**Figure 9:** Photograph showing the wreckage of the accident aircraft

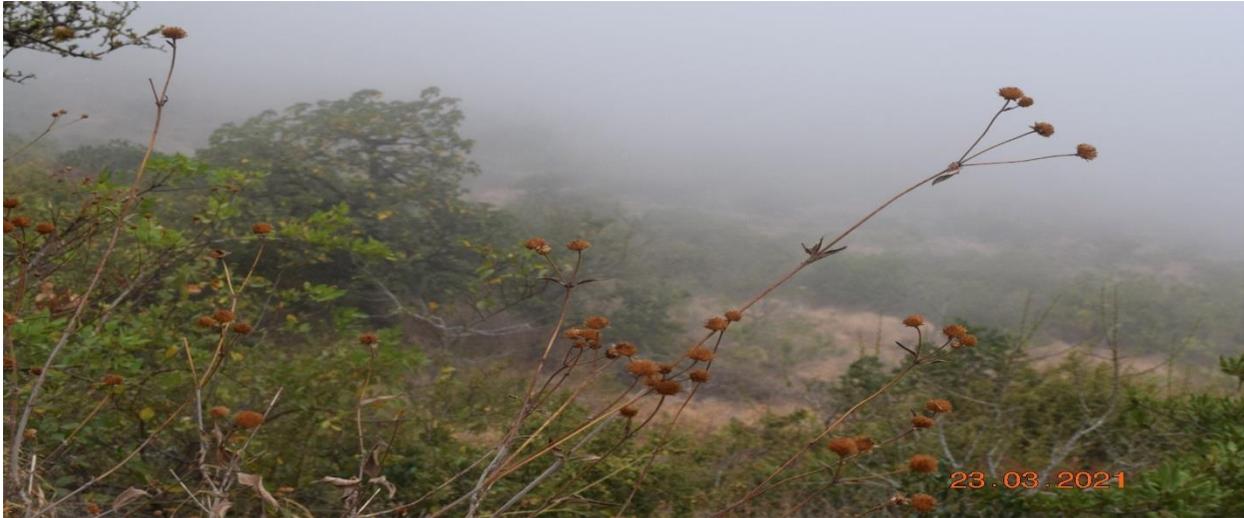
**Figure 10:** Photograph showing the level of fog after it starts to clear

3.1.3. There was poor forward visibility due to heavy presence of fog during approach to Marsabit airstrip.
