## **FINAL INVESTIGATION REPORT**

### **ACCIDENT OF PAKISTAN INTERNATIONAL AIRLINES FLIGHT PIA 8303 AIRBUS A320-214 AIRCRAFT REGISTRATION NUMBER AP-BLD CRASHED NEAR JINNAH INTERNATIONAL AIRPORT KARACHI ON 22<sup>ND</sup> MAY, 2020**

Dated: 20<sup>th</sup> April, 2023

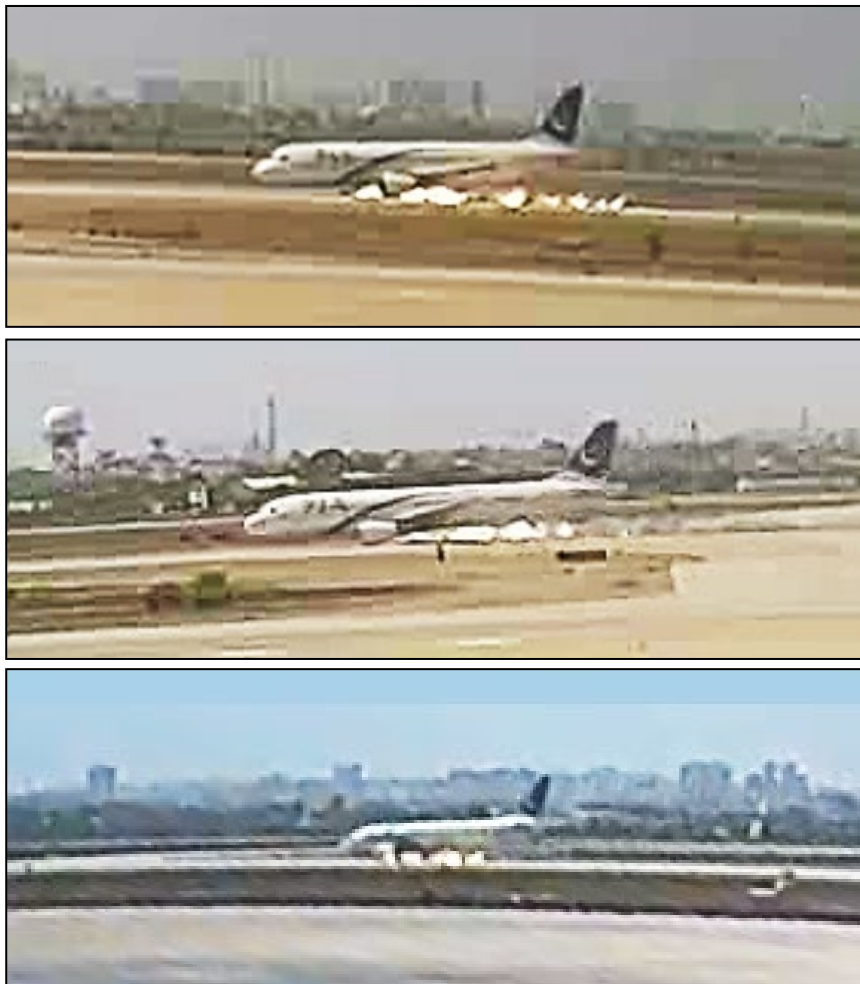
1.1.7.4. Both Engines touched the R/W at four different locations and left scratch marks of varying length and width. The R/W surface being concrete pavement remained intact; however, the surface got severely abraded due to scrubbing of both Engines at high speed. The Engines drag occurred almost symmetrical about R/W centre line. Engine No. 2 remained in contact with the R/W significantly longer than Engine No. 1. The total length of scratch marks including all segments was 2,194 ft for Engine No. 2 and 583 ft for Engine No. 1 (Refer section 1.16.17 – “Runway Inspection Report”).

Figure 10 – Screenshots of Security / CCTV Cameras Footages Confirming Contact of both Engines' Nacelles

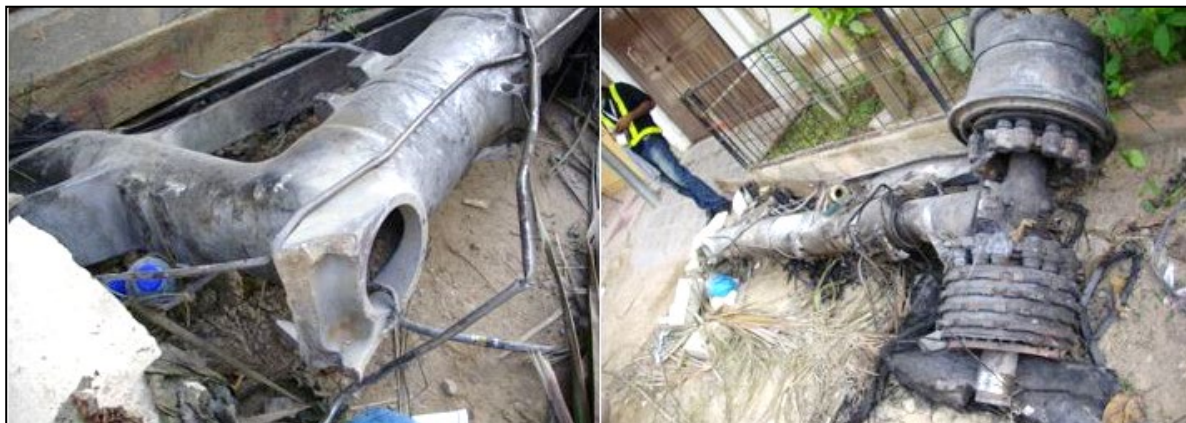
Figure 30 – L/H MLG with Missing Wheel and Tyres

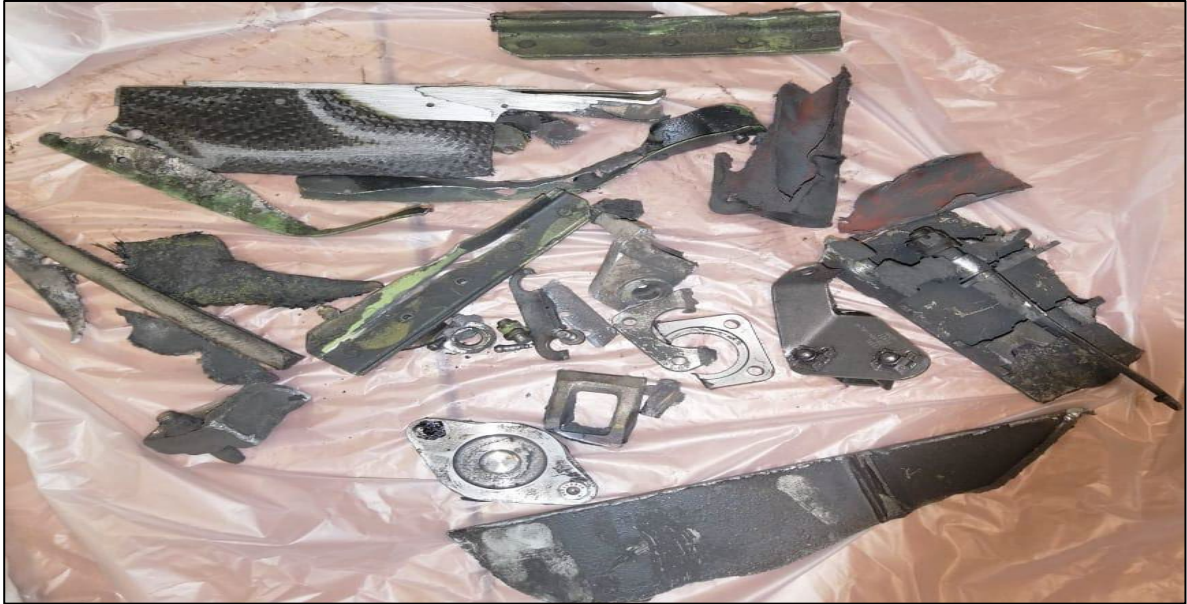
Figure 39 – Parts Found on the R/W

(a) After R/W contact with Landing Gears retracted, four scratch marks were identified on R/W 25L (Refer section 1.16.17 – “Runway Inspection Report”) and few aircraft parts were found on the R/W surface.

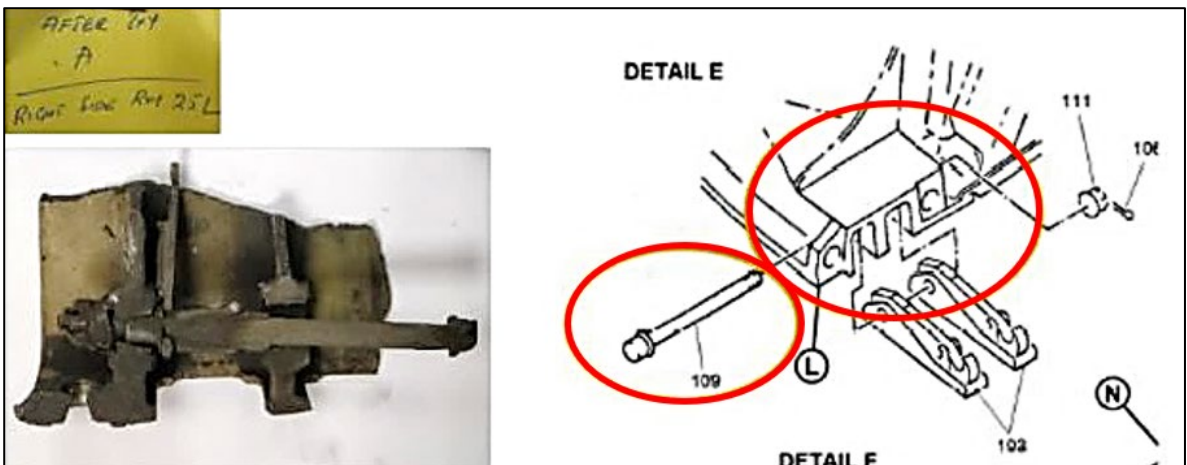
Figure 41 – TR Latch Box

(ii) A TR latch box was found after the Taxiway A on the North (“right”) side of R/W 25L, most likely coming from Engine No. 2. The box was damaged, and scratches were observed. A piece of the box was missing.

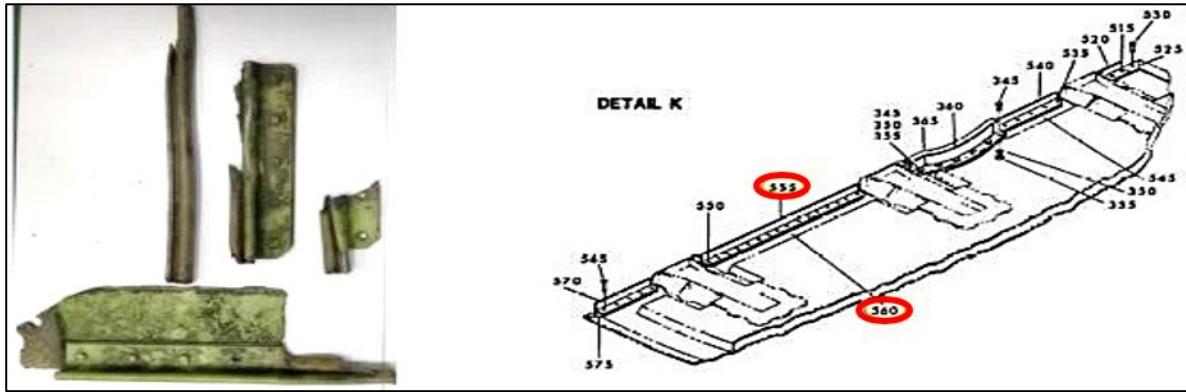
Figure 42 – Seal and Retainer of Fan Cowl Door

(iii) Piece of seal and retainer of one fan cowl door was found as below: -

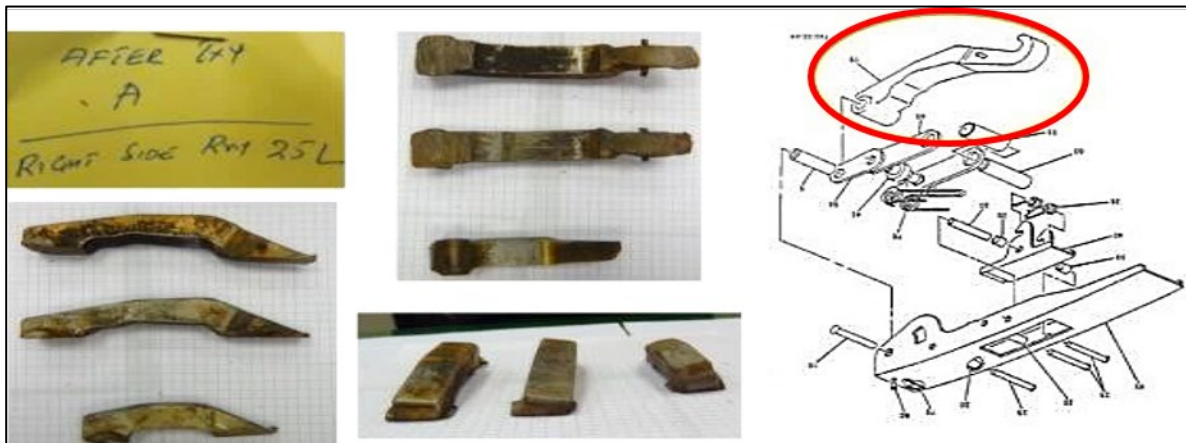
Figure 43 – 03 Hooks of Nacelle Latches

(iv) Several pieces of nacelle hooks were found. The smallest one was most likely one hook from the fan cowl latch. The two others were most likely from the TR cowl latches. All the nacelle parts are fitted at the lowest side of the nacelle at 6 O'clock position.

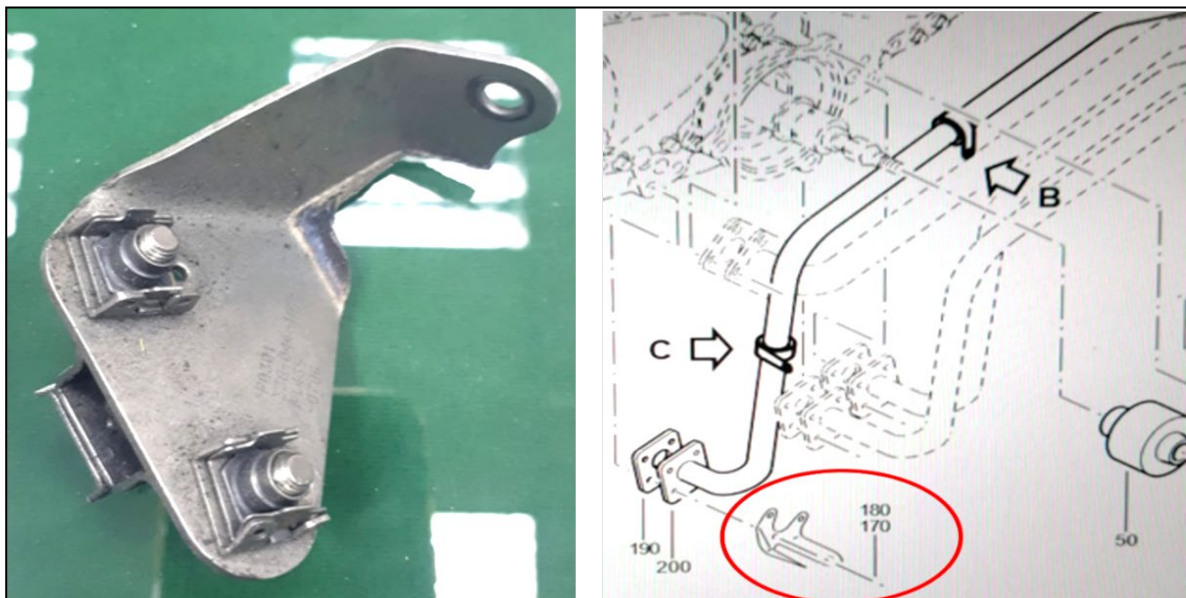
(v) Bracket Part Number (P/N) 338-046-101-0 located at 6 O'clock position on the Engine.

Figure 44 – Damaged Bracket Found on the R/W

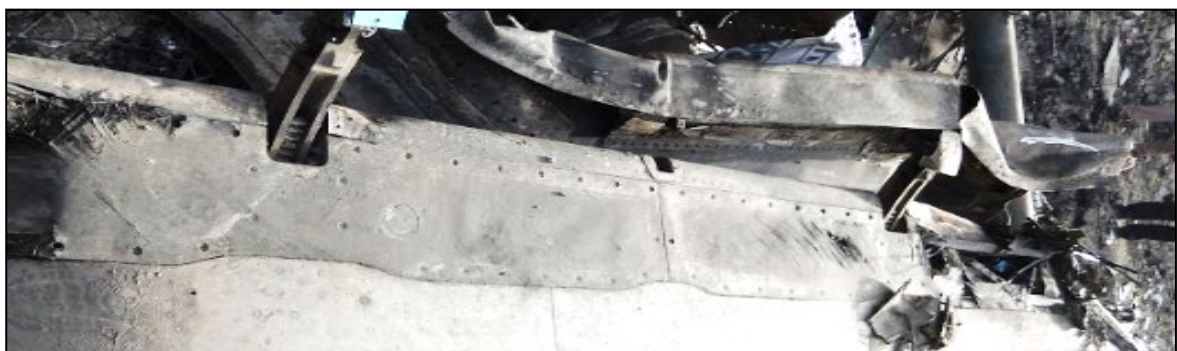
Figure 49 – SLAT Tracks in Position 1

(ii) Several SLAT Tracks were identified on the L/H and R/H wings. For the SLAT tracks found in a condition that allowed reliable extension indication, the dimension Y measured between the roller and the mechanical stop was between 16 cm and 20 cm, consistent with the Position 1.

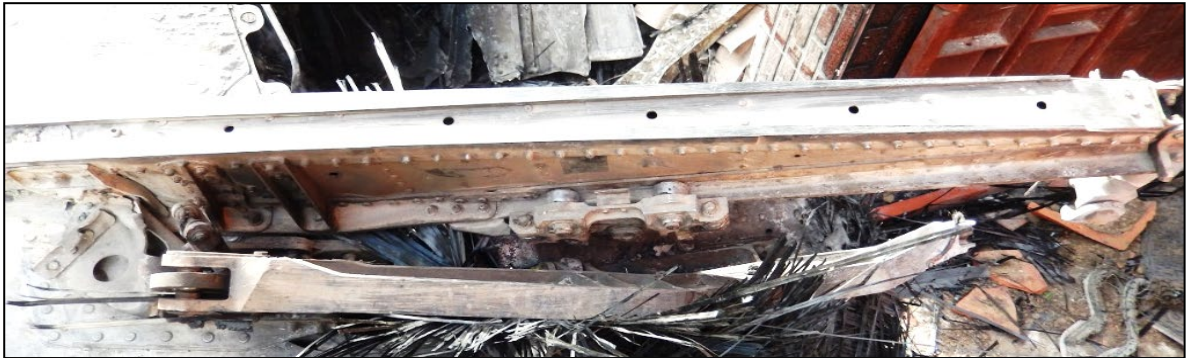
Figure 51 – L/H FLAP Track 4 Fully Retracted

(ii) A part of the L/H wing with FLAP Track 4 carriage was against its mechanical stop ( $X = 0$  mm), consistent with a FLAP retracted position.

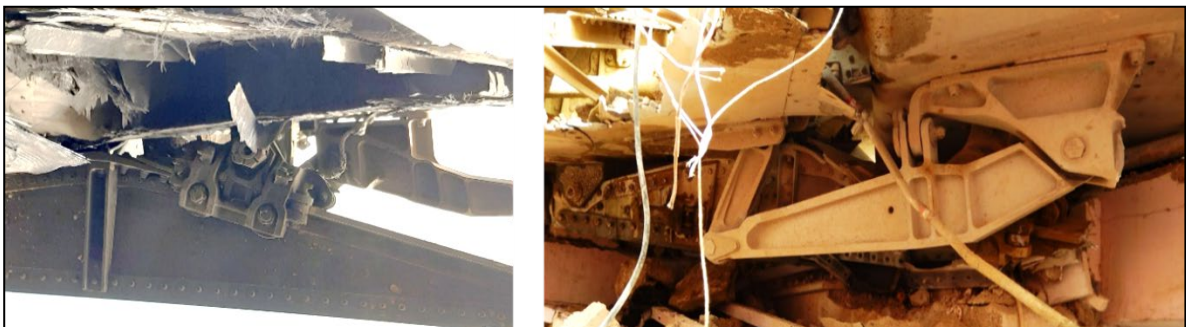
Figure 52 – L/H FLAP Track 2 and 3 Fully Retracted

(iii) FLAP Track 2 was severely damaged and Track 3 was not accessible and therefore measurement was not possible. However, the position of the actuator lever corresponded to a fully retracted position, corresponding to the position of the carriage against its stop.

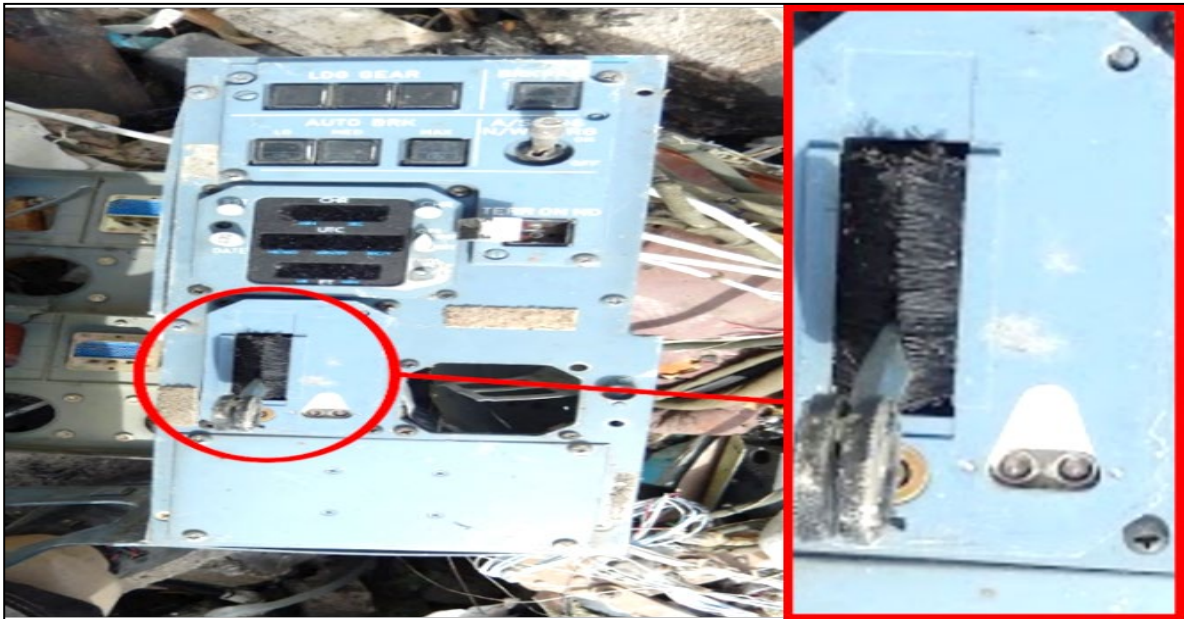
Figure 53 – Landing Gears Control Lever in Down Position

(a) **Landing Gears Control Lever** – The Landing Gears and Braking Mode Control Panel was found on the top of a building. The Landing Gears Control Lever was in DOWN position.

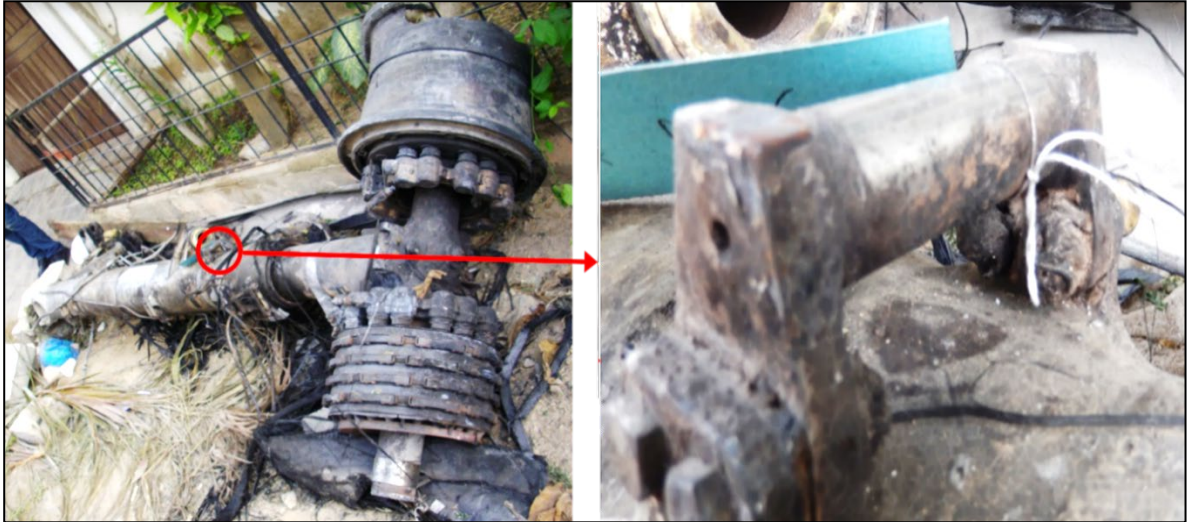
Figure 55 – L/H MLG and Uplock Roller

(ii) L/H MLG was located at very beginning of accident site on the East side of the street. The retraction actuator was not attached to MLG and was found in a retracted position, corresponding to MLG in a DOWN position. The Uplock roller was in good condition.

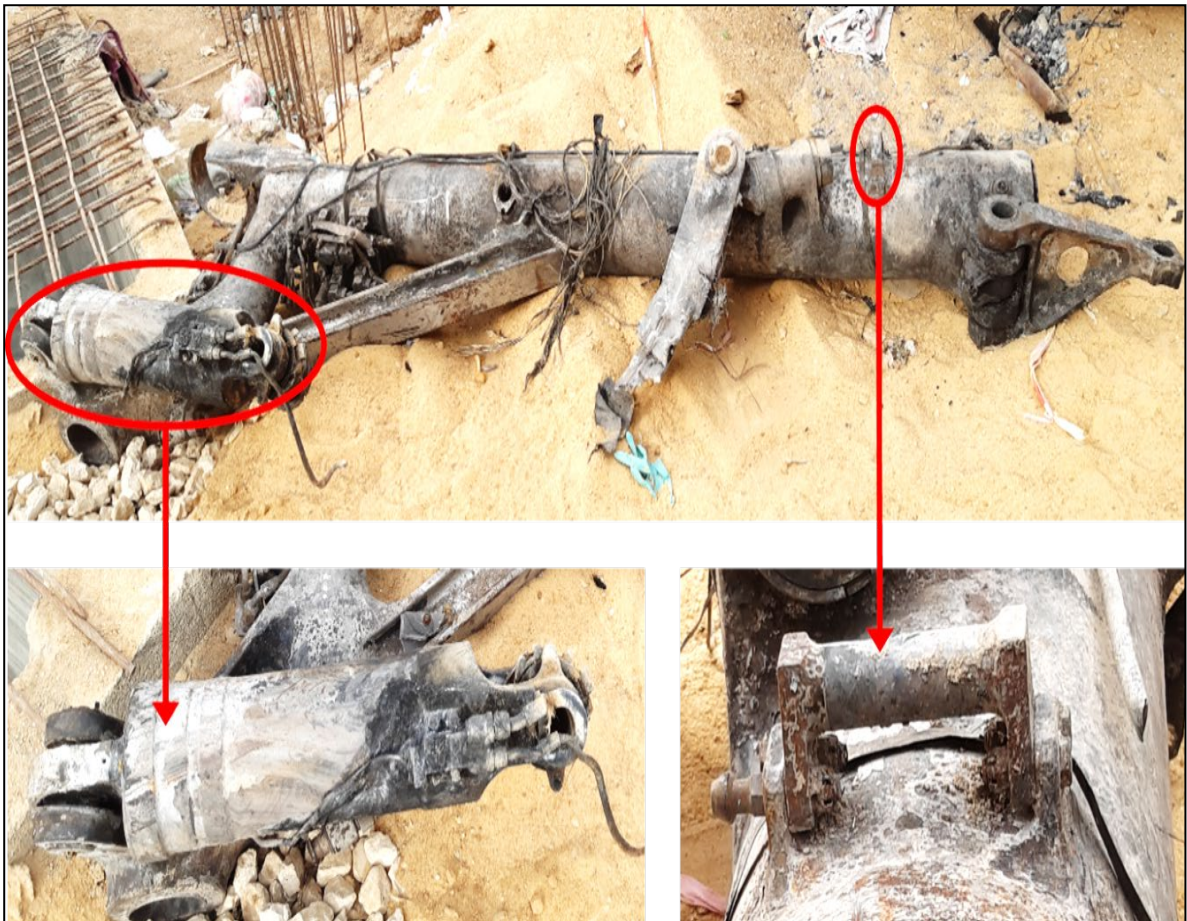
Figure 56 – R/H MLG with the Retraction Actuator and Uplock Roller

(iii) R/H MLG retraction actuator was found in a retracted position, corresponding to MLG in a DOWN position. The Uplock roller was in good condition.

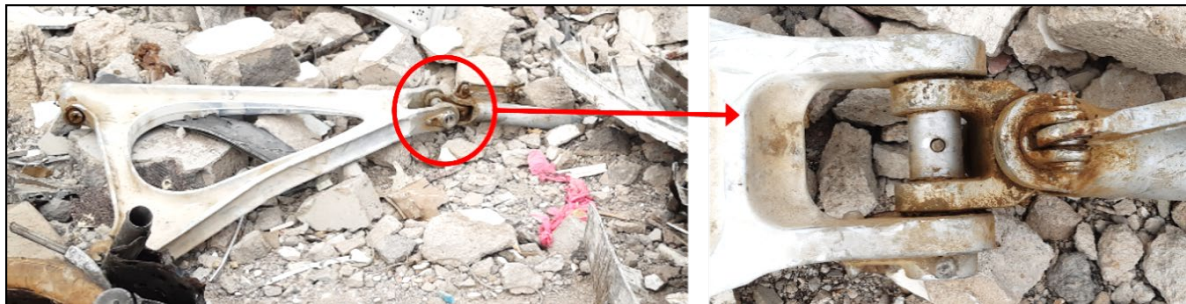
(ii) The drag strut assembly of NLG was located on the top of a building. It was detached from NLG. The uplock roller was missing.

Figure 58 – NLG Drag Strut Assembly with Missing Uplock Roller

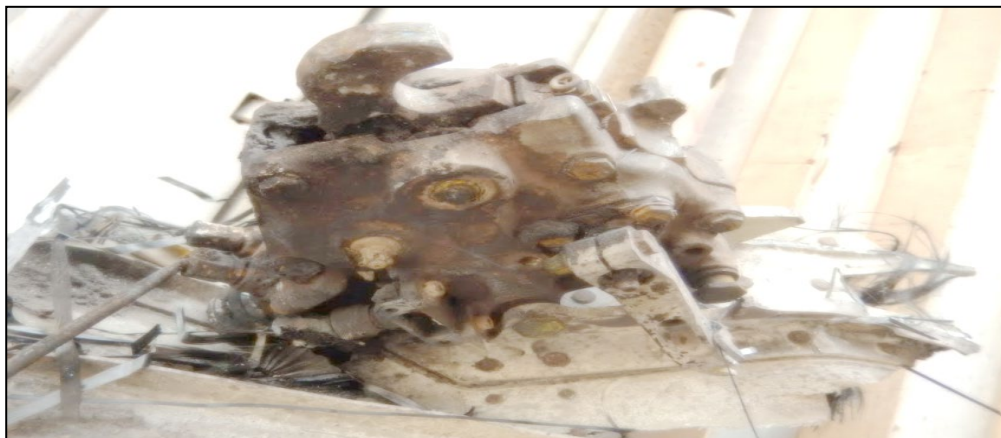
(iii) NLG uplock was found with its hook in open position. The rigging pin holes of the free fall input lever and of the uplock body were almost aligned. The alignment of the rigging pin holes corresponds to the normal position when the free fall lever is stowed.

Figure 59 – NLG Uplock with its Hook in Open Position and its Free-Fall Input Lever in Position “Not Used”

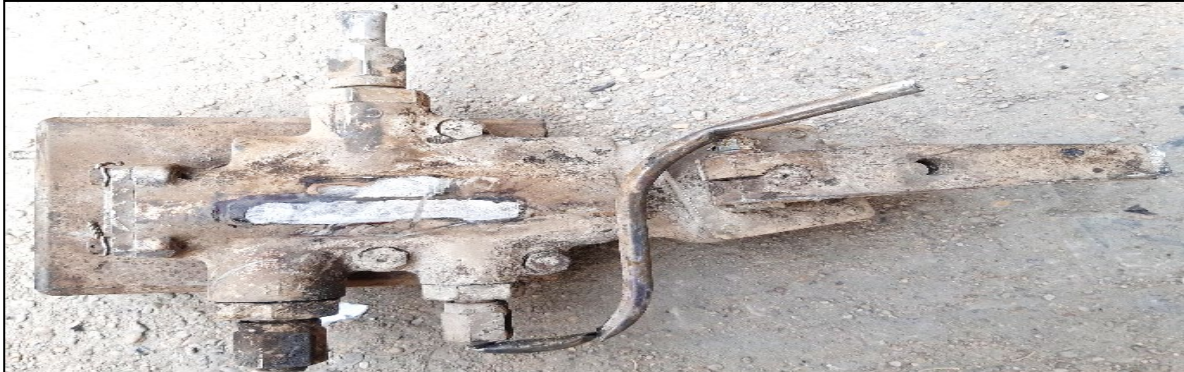
(iv) A vent valve (MLG or NLG) was found in the street. The P/N and S/N identification plate was lost during the impact. Vent valve is activated by the free-fall extension handle to release the remaining pressure of the Landing Gears hydraulic circuit. The rigging pin holes of the free fall input lever and of vent valve body were almost aligned. The alignment of the rigging pin holes corresponds to the normal position when the free fall lever is stowed.

Figure 60 – MLG or NLG Vent Valve with the Free-Fall Input Lever in Position “Not Used”

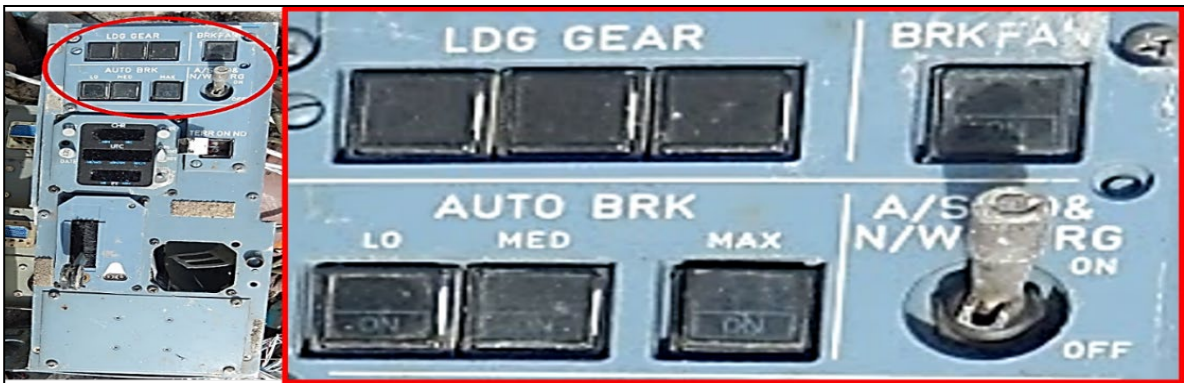
1.12.4.3. **Braking** – On the Landing Gears and Braking Mode Control Panel, the Auto-Brake Medium (AUTO BRK - MED) switch was selected and the Anti-Skid (A/SKID) Nose Wheel Steering switch was ON.

Figure 61 – AUTO BRK MED Switch Selected and A/SKID-Nose Wheel Steering Switch ON

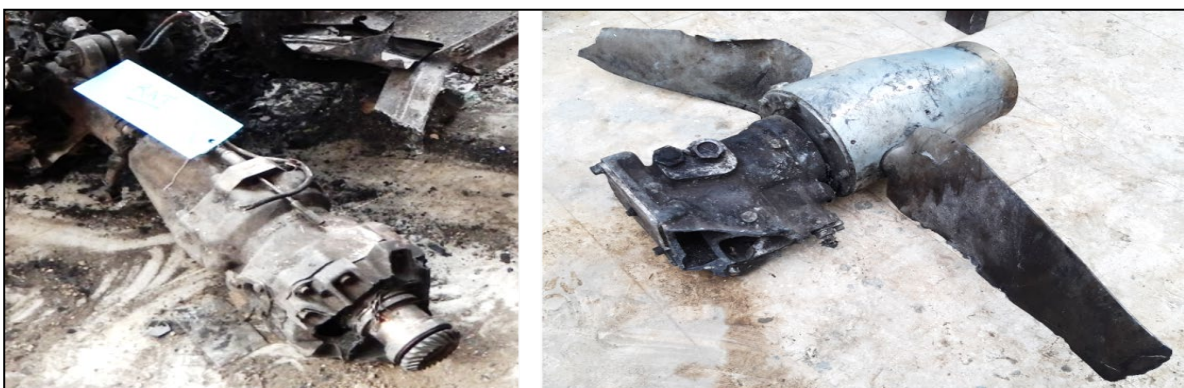
Figure 62 – RAT

1.12.4.4. **Ram Air Turbine (RAT)** – Measurement of RAT cable was 95 mm. The RAT was found broken in two parts.

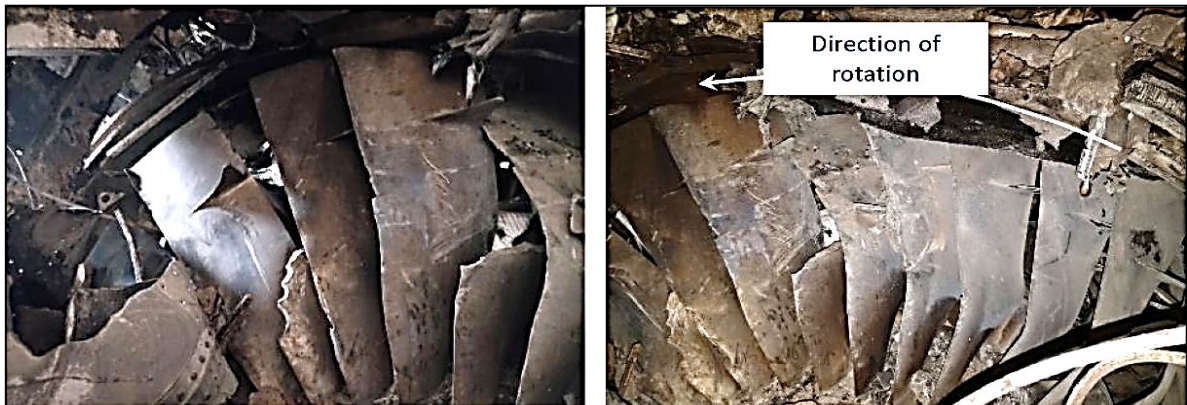
Figure 64 – Fan Blades Damaged and Bent

(i) At the time of impact, the fan case was compressed disturbing the round geometry of the fan case and causing the fan blades to curl. Engine was running at a very low RPM.

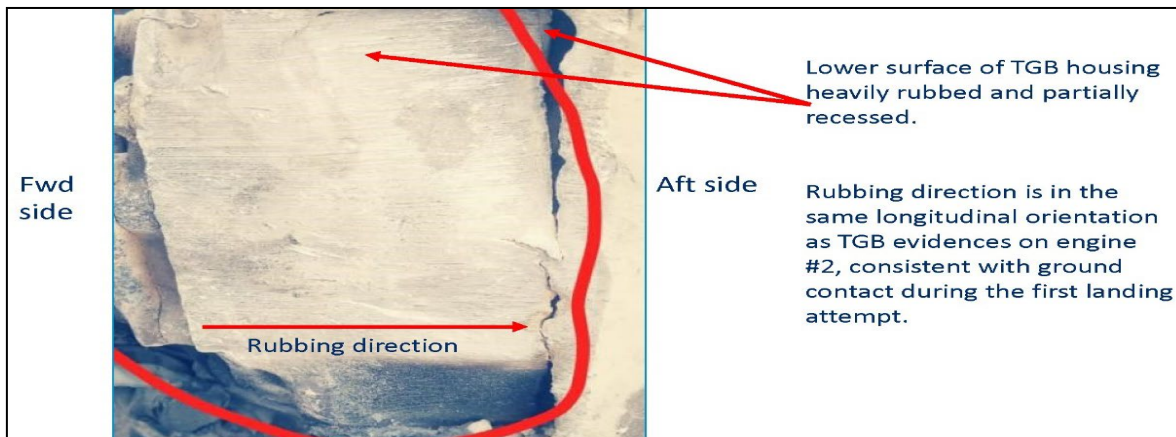
Figure 66 – TGB Housing Condition

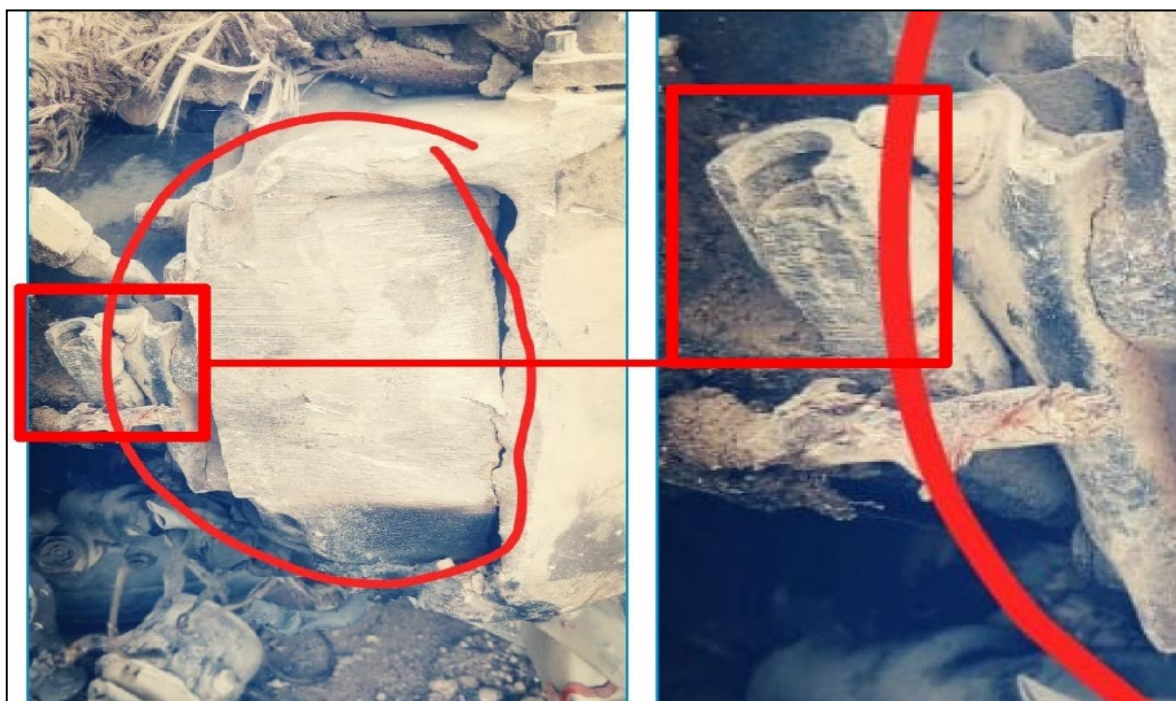
Figure 67 – Heavy Rubbing on End Fitting Installed on Hose

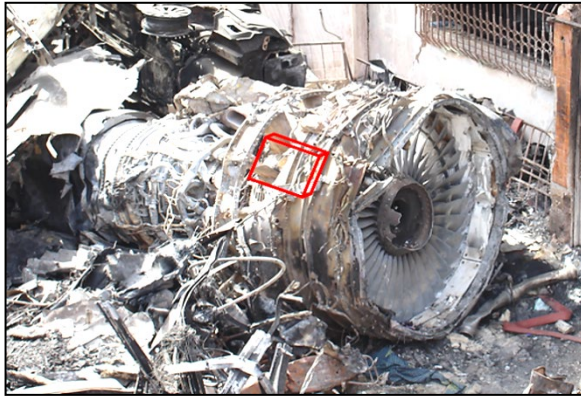
Figure 68 – ECU is Missing

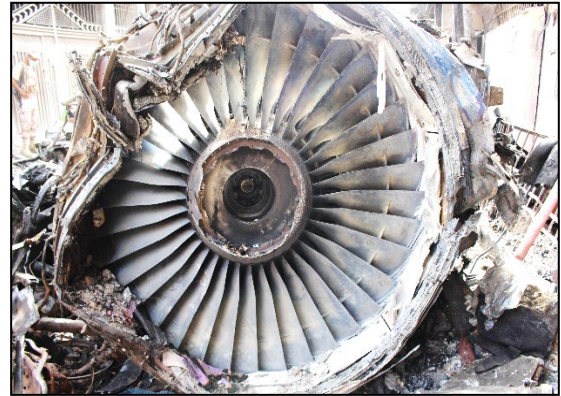
Figure 69 – Front View of Fan Blades not bent. No indication of Soft Body (i.e. birds) Impact Damage

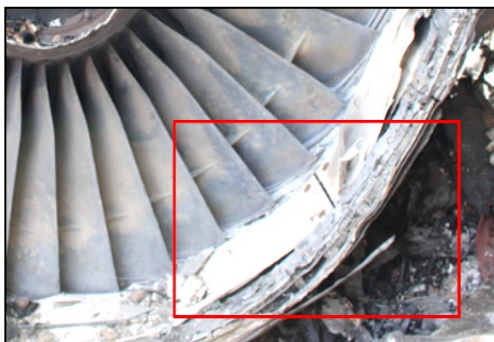
Figure 70 – Rubbing on Abradable Coating between 9 to 12 O'clock (AFT looking forward) assumed due to Displacement of the Engine during Rescue Operation

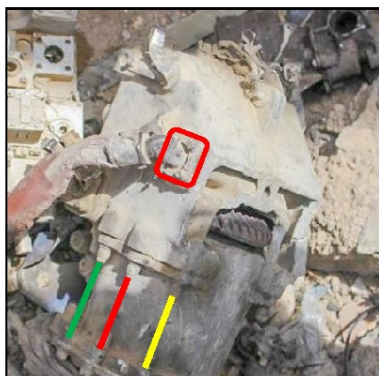
Figure 73 – Damaged TGB

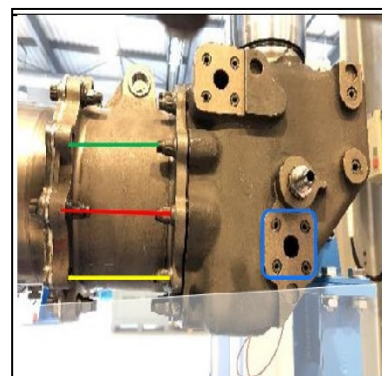
Figure 74 – Engine's TGB with Missing Part on New Engine (in Grey Shade)

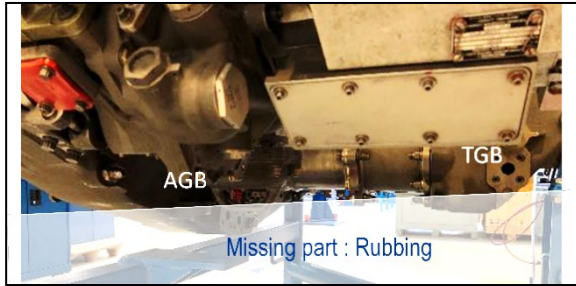
Figure 75 – Engine’s TGB and AGB with Missing Part on New Engine (in Grey Shade)

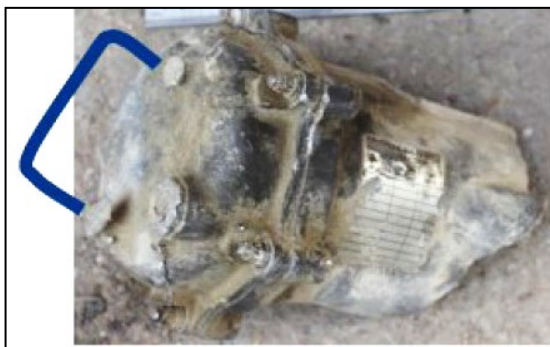
Figure 80 – Fuel Filter Cover with Missing Handle (Accident Case)

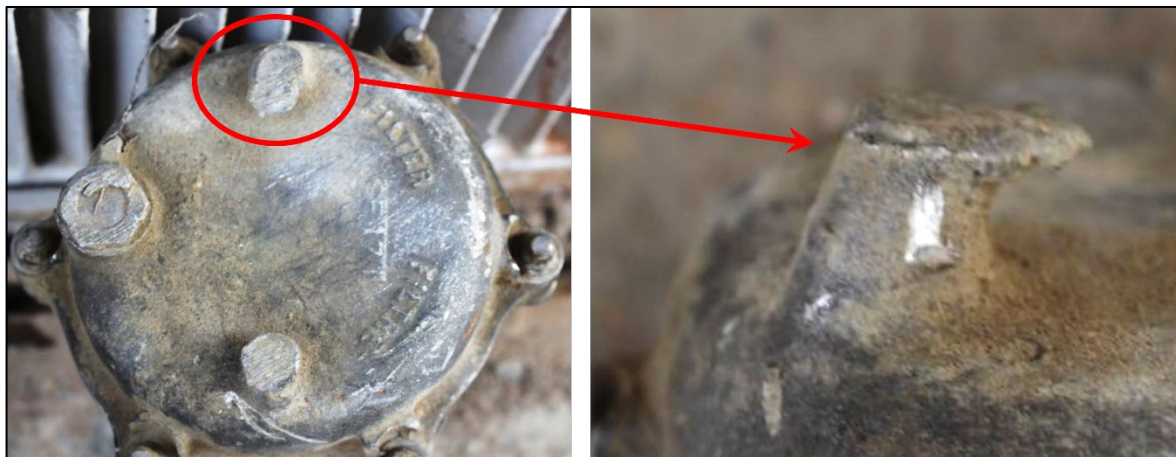
Figure 82 – Fuel Filter Cover with Missing Handle  
(Accident Case): Heavy Rubbing

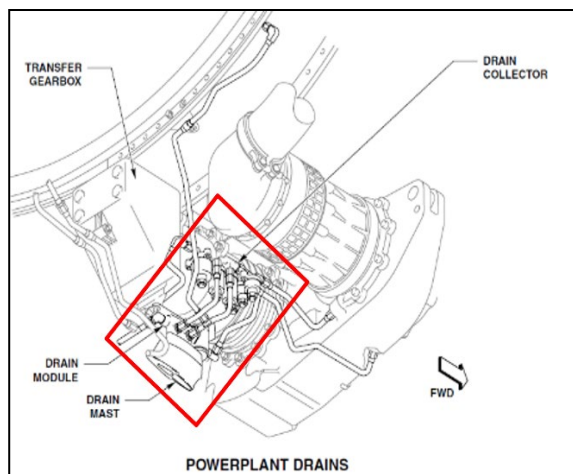
Figure 83 – Drain Collector Assembly

- (c) **Drain Case Assembly** – These lines are provided on Engines to collect waste fluids and vapours that come from Engine systems and accessories and drain them overboard. The system consists of a Drain Collector Assembly, a Drain Module and a Drain Master. Drain Collector Assembly is installed exactly at 6 O'clock position on the Engine. One Drain Case Assembly found from the accident site and it the corresponding Engine could not be identified. Accident Drain Case Assembly was compared with undamaged Drain Case Assembly. It was found that it made ~ 20° roll angle when rubbing with the R/W during the first landing attempt.

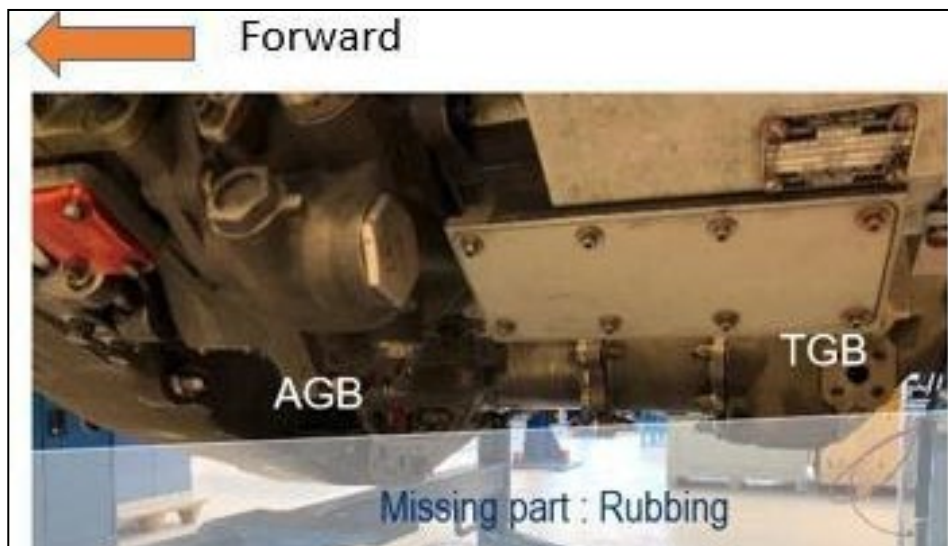
Figure 140 – TGB Missing Part
