Investigation Report

Type of Occurrence: Accident
Date: 15 May 2023
Location: Hohn Military Airport

Aircraft: Airplane
Manufacturer: Learjet Corporation
Type: Learjet 35A

State File Number: BFU23-0311-1X

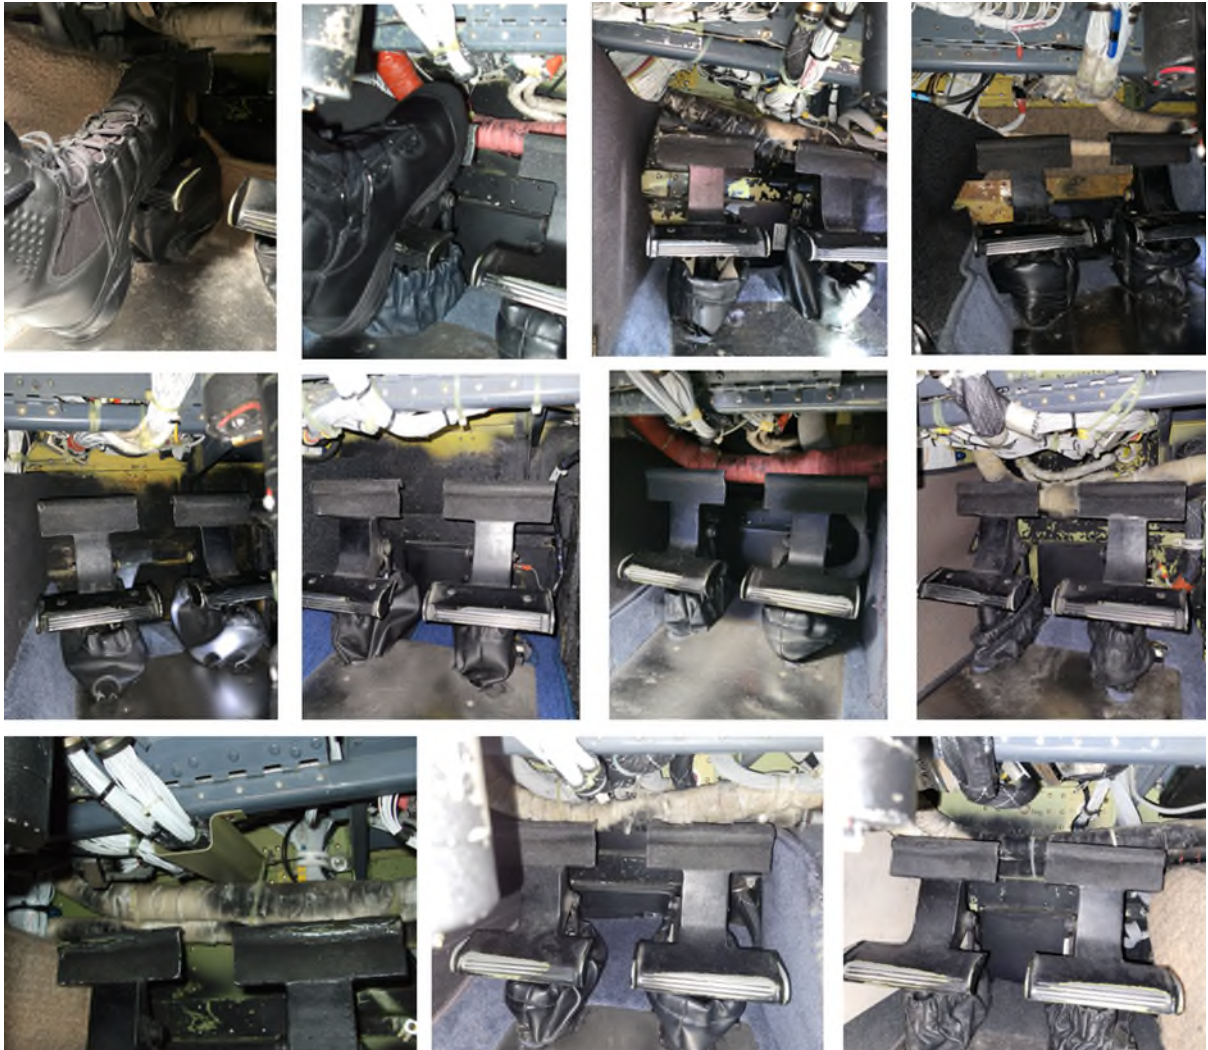
Fig. 5: Leg room of the left cockpit side in several Learjet 35A/36A

In the context of the investigation, the leg area of the left cockpit side of the operator's Learjet fleet was inspected and photographs were taken (Fig. 5). Different equipment status and wiring tracks above and behind the rudder pedals were found. Depending on the position of the foot, heel on the floor or in the air, a shoe can extend beyond the pedal (comparative photos were taken with size 44).

The CVR recording included a conversation of a flight prior to the accident flight, where one pilot was talking about his proficiency check on 11 May 2023 with another Learjet, where he had not pushed the rudder pedal far enough during a simulated engine failure, because he had bumped against some wiring⁵ in the leg room and erroneously interpreted it as complete pedal travel.

⁵ The investigation determined that it must have been an air pipe of the air conditioning

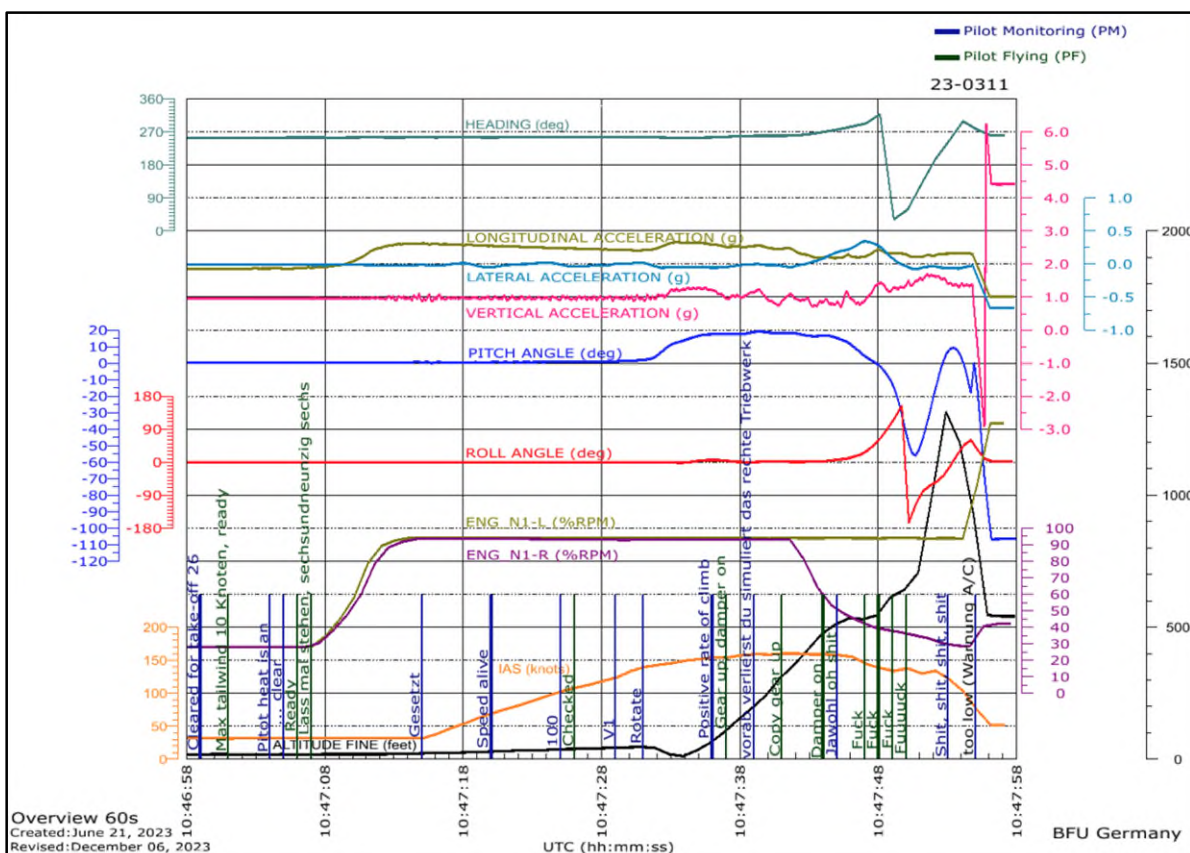
Fig. 8: Recorded flight data during the last 60 seconds including CVR recordings (below)

of flight data had been recorded. Data of the occurrence flight had also been recorded (Fig. 8). From 1047:07 UTC, thrust of both engines increased. From 1047:15 UTC, indicated airspeed increased. The callouts “100”, V_1 and “Rotate” corresponded with the recorded speed values. At 1047:31 UTC, the fuselage nose rose, the airplane took off and began to climb with about 18° . At 1047:41 UTC, right engine thrust was reduced. Lateral acceleration increased immediately. From 1047:44 UTC, the airplane rolled right. At 1047:47 UTC, maximum lateral acceleration was reached. From this time on, the flight data of all axes showed strongly fluctuating parameters. At 1047:56 UTC, the impact occurred.

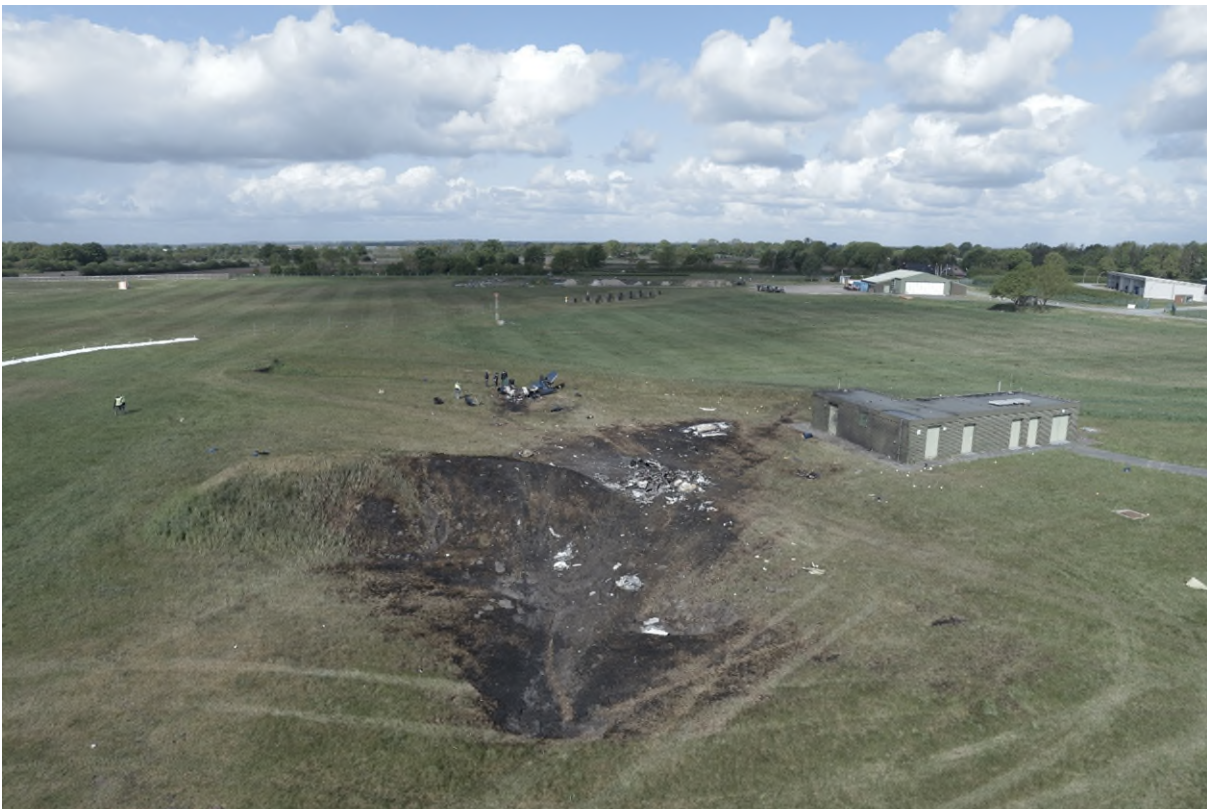
Fig. 10: Accident site, view direction about 260°

The accident site (Fig. 10) was located at the military airport about 200 m north of the end of runway 26. The main wreckage had the coordinates 54°18'41N/9°30'57O. The area over which the largest part of the wreckage had been scattered was limited in the north by a low building, in the east by apron 5, in the south by an earth wall and in the west by a ditch. Some smaller fracture pieces had passed over the building and the ditch. Parts of a flight bag was lying on the roof of the building.

Traces of the initial ground contact were found in approximately 290° about 40 m from parking position 50 at apron 5. From this point on, the ground was covered in a fan-like pattern, approximately at an angle of 45° to the left and right, with scorched vegetation and upturned earth. To the left, this area extended to the centre of the earth wall and ran across it. To the right, the fan-like pattern ended after about 10 m. After that, the traces continued approximately straight in the direction of about 290°.

Approximately 9 m behind the initial ground traces, wreckage parts of a tiptank were found. The main wreckage, consisting of the cockpit, the cabin and the right wing, was lying about 25 m from the initial ground traces, a little behind the north end of the earth wall. The left wing was found about 15 m in the direction of 290° from the main wreckage. In the area of the main wreckage, the main course of the accident site changed to about 250°. The two engines and the empennage were found in this direction about 30 m away.

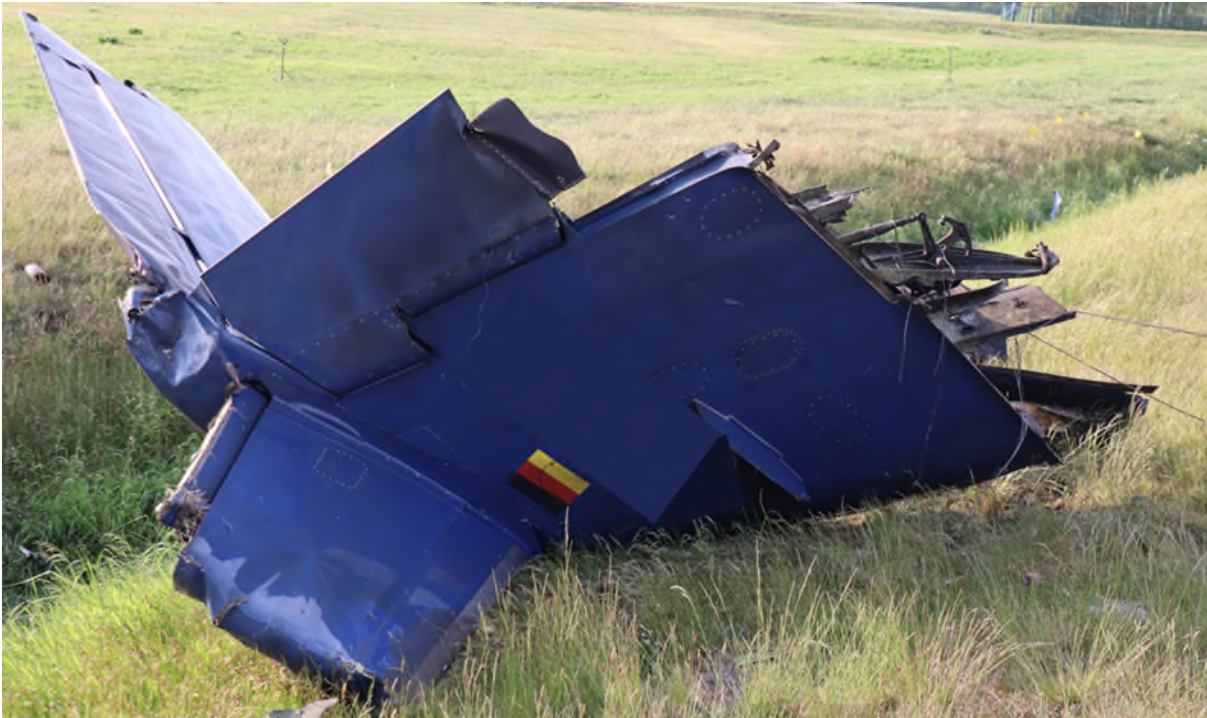
Fig. 11: Empennage including damage at the rudder

The empennage was lying on the upper surface of the horizontal stabiliser. Structurally, it was separated from the fuselage tail in the root area. One ruder control cable and one antenna cable were still attached to the rear fuselage. The other control cables for rudder and elevator were torn. The left elevator was bent upward at the centre and torn

off. It was lying about 5 m north of the empennage. The right horizontal stabilizer showed some deformations.

The upper half of the rudder was still attached to the empennage, the lower half was torn off. The actuator tube for the rudder, the rudder trim mass and the servo including control rod for the rudder trim tab were found in the area of the destroyed cabin. The servo arm was in about 90°, i. e. almost neutral position. These components were surrounded by strongly melted and burnt aluminium residues. Remnants of torn control cables were also found in this area.

Since the lower part of the rudder, into which the rudder is articulated, had been torn off, the rudder, the fracture surfaces of the rudder skin and the rudder torque tube were examined. There were no indications of fatigue fracture or pre-existing damage. The disconnection in the rudder, the fracture of both skin sides and the fracture of the torque tube were the result of impact-related overload.

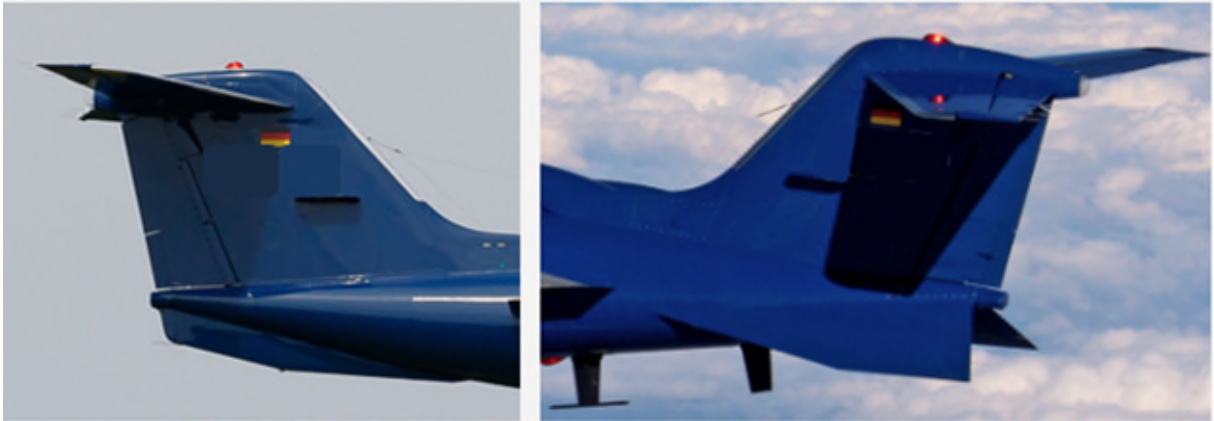
Fig. 12: Tail section of a Learjet without (original) and with Avcon Fins

increase stability in all three axes and reduce air drag by smoothing the air flow in the area of the rear cone. In the case of the Learjet 35/36, they eliminate the certification and dispatch requirements for a functional yaw damper system.

The airplane involved was one of two aircraft of the operator's fleet which was not fitted with Avcon Fins / Strakes at the tail. Therefore, it had less directional stability and required immediate reaction by the PF to control attitude in case of engine failure with take-off thrust and still low airspeed.

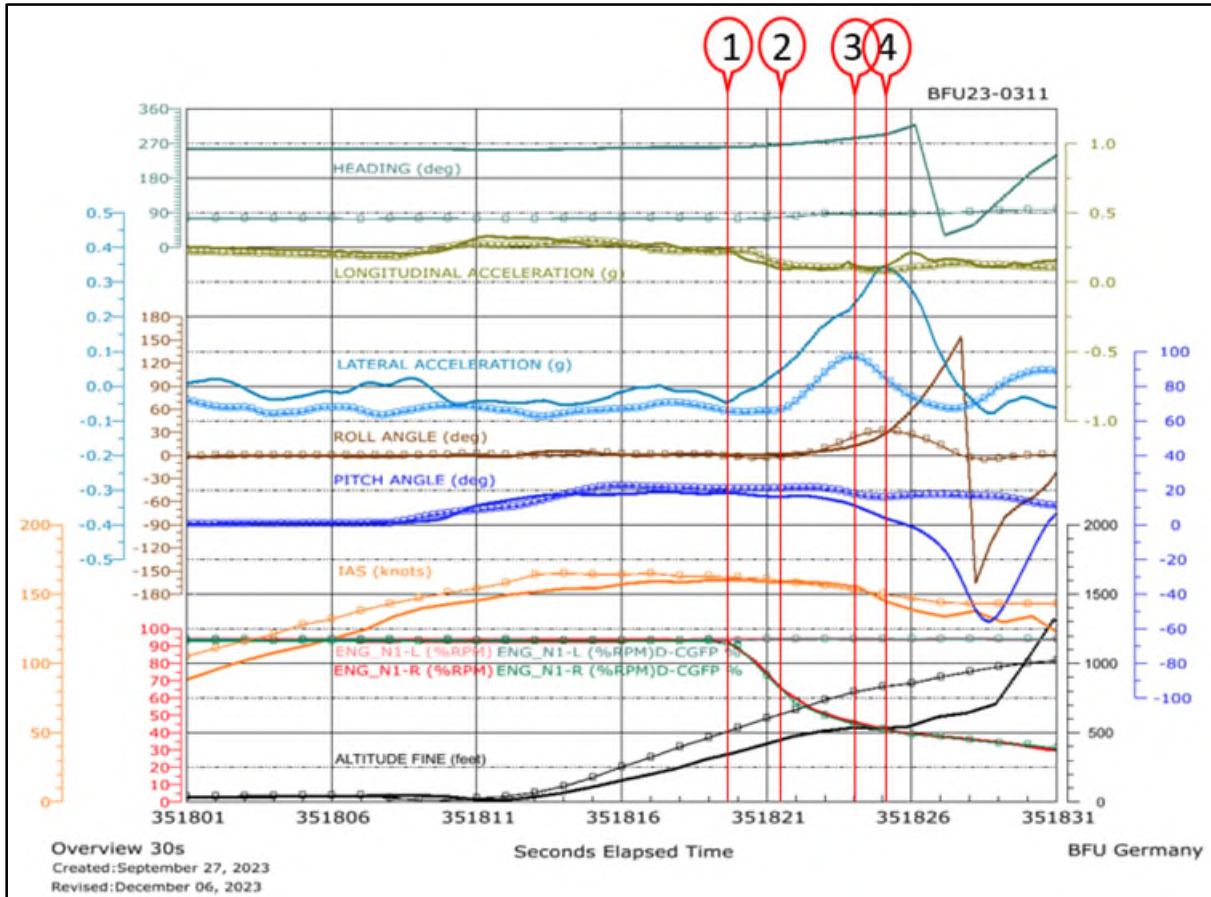
Appendix 1: Comparison accident flight data (solid lines) with take-off on 11 May 2023 with temporary insufficient rudder deflection and roll (thin lines with boxes per data point)

- 1: Engine thrust is reduced in both aircraft
Aircraft involved yaws immediately
Comparison aircraft keeps the lateral acceleration constant for about 2 seconds, i. e. pedal input / rudder deflection is sufficient.
The roll is controlled in both aircraft.
- 2: The comparison aircraft is in yaw condition as well, rudder deflection is no longer sufficient to compensate further one-sided thrust reduction
- 3: At the comparison aircraft, yaw is actively controlled by full pedal input / rudder deflection
- 4: Aircraft involved, expletive “fuck” and the beginning of the yaw reduction, the airplane continues to roll
Comparison aircraft, after the yaw is reduced the roll angle reduces towards neutral

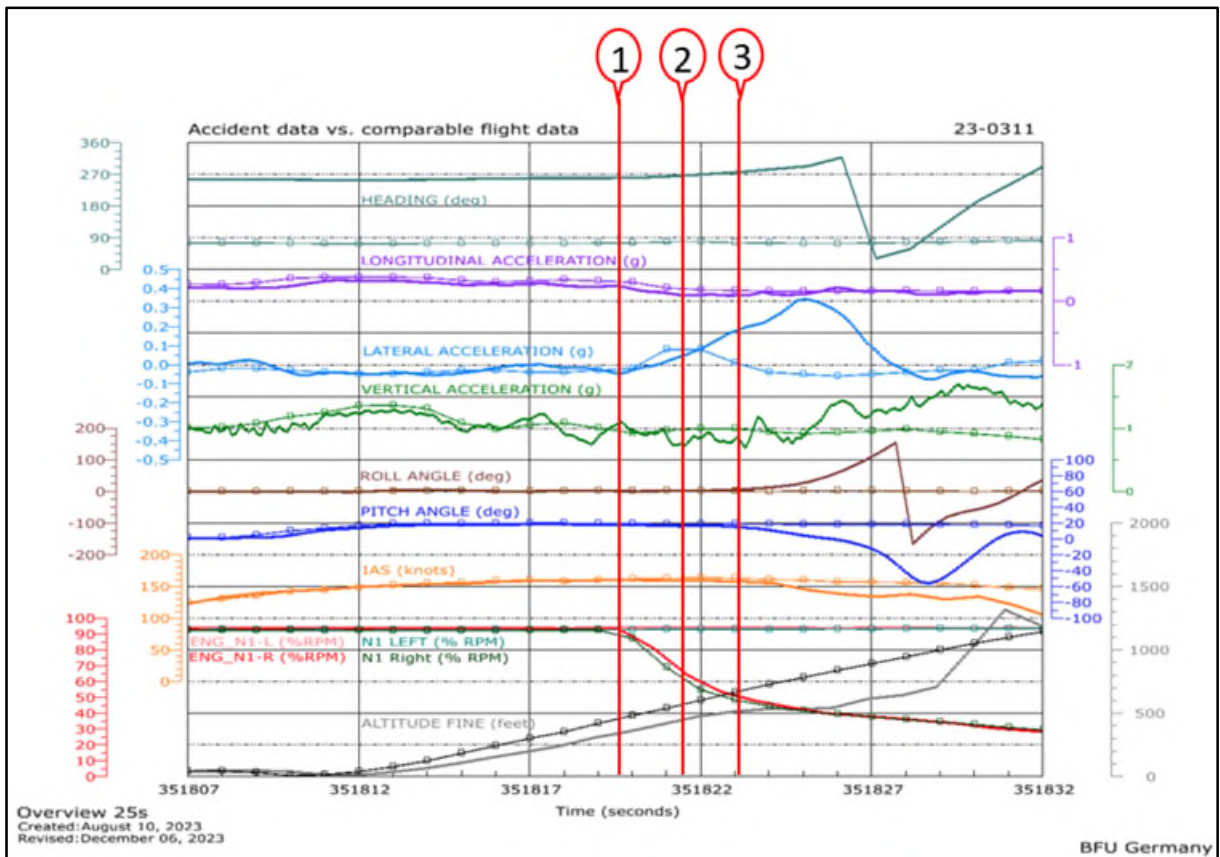
Appendix 2: Comparison accident data (solid line) with the successful single-engine operation (thin line with boxes per data point)

- 1: Engine thrust is reduced in both aircraft
Both aircraft yaw immediately
The roll is controlled in both aircraft.
- 2: At the comparison aircraft, yaw is controlled and reduced by rudder deflection.
Flight attitude is under control
- 3: With the aircraft involved, the roll cannot be held with the ailerons during the heavy yawing condition
