# **Final Report No. 2415**

concerning the accident involving the air-  
craft Cessna 208 “Caravan”, D-FLIC,

on 30. März 2022

Grüehorn, in the Säntis massif (SG)

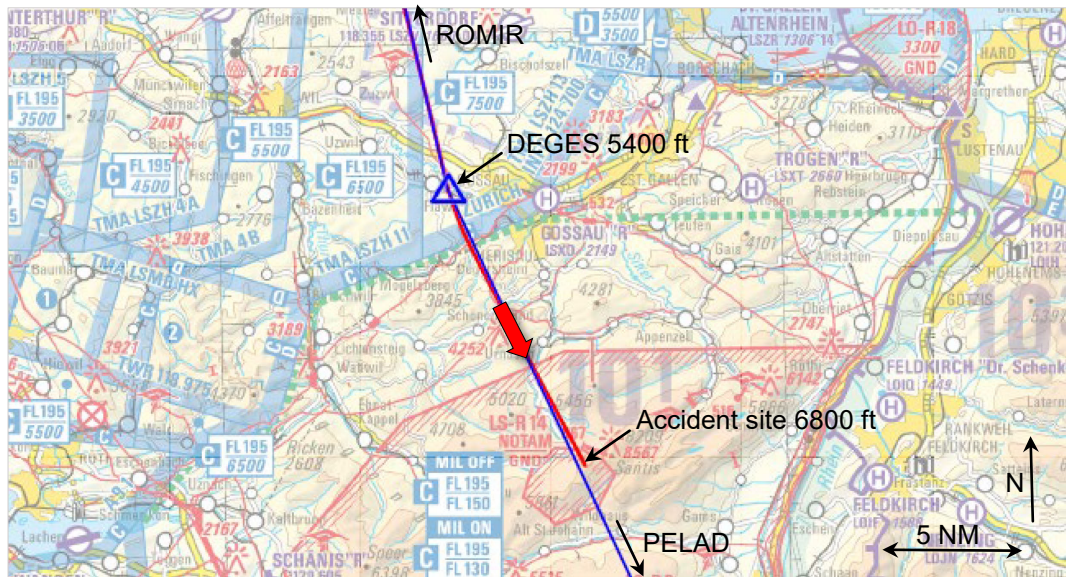
On 30 March 2022 at 09:02 UTC, the pilot took off alone on board the D-FLIC from the German airport Siegerland (EDSG) on a visual flight to the airport Arezzo (LIQB) in Italy. At 10:19 UTC, he passed the waypoint DEGES at 5400 ft AMSL (cf. figure 1). He was in radio contact with FIC<sup>6</sup> Zurich, which had instructed him to remain under the Zurich terminal area (TMA). This airspace has a lower limit of 7500 ft AMSL at DEGES.

**Figure 1:** Planned flight path (blue) and flight path recording (red) of the D-FLIC, shown on the aeronautical map of Switzerland (source of map: Federal Office of Topography).

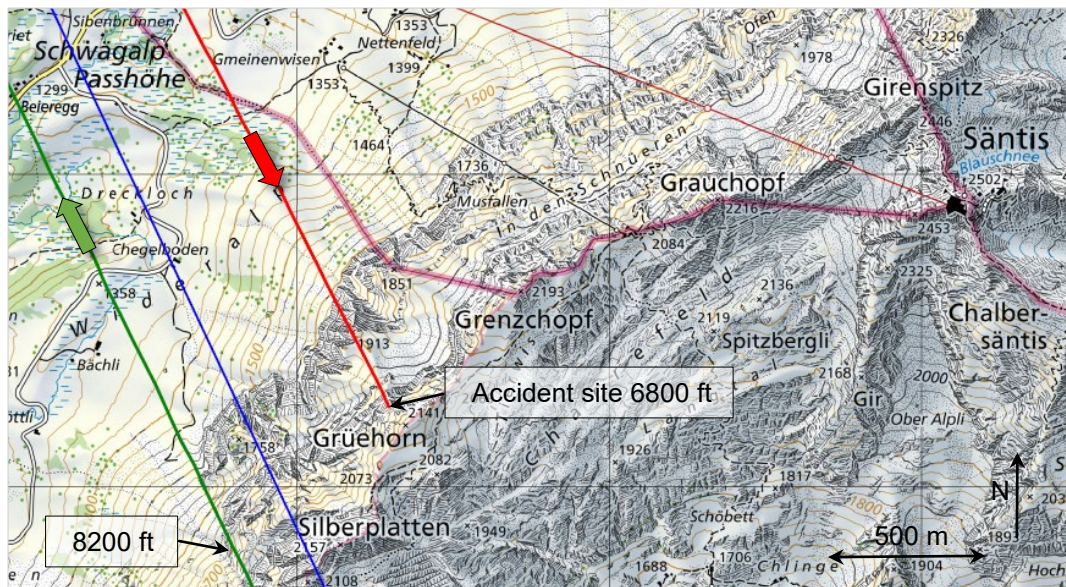
The rate of climb averaged around 550 ft/min. At 10:23 UTC, the aircraft collided with the northern flank of the Grühorn in the Säntis massif at an altitude of 6800 ft AMSL on an unchanged flight path and flying in clouds (cf. figure 2). The pilot was killed and the aircraft destroyed.

**Figure 2:** Planned flight path between DEGES and PELAD (blue), flight path recording (red) and flight path recording of the previous day (green with indication of flight altitude), shown on a topographic map of Switzerland (source of map: Federal Office of Topography).

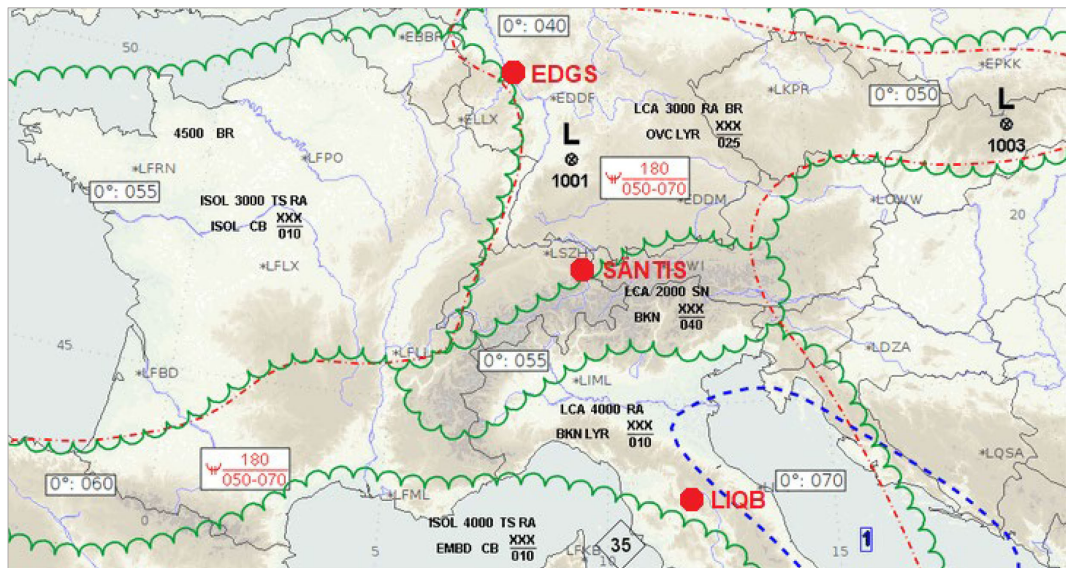
The forecast of flight-threatening weather phenomena available as Low Level Significant Weather Chart (LL-SWC) of the German Weather Service (*Deutscher Wetterdienst* – DWD), valid for Wednesday, 30 March 2022, 10:00 UTC, predicted low-lying clouds with high-level tops covering the mountains and localised precipitation with limited visibility for the entire flight route. In addition, icing conditions were to be expected on the flight levels (FL) between FL 50 to FL 70 and FL 180 (cf. figure 3).

**Figure 3:** Forecast of weather phenomena dangerous to flight for the time 10:00 UTC, shown on the Low Level Significant Weather Chart (LL-SWC) of the German Weather Service (*Deutscher Wetterdienst – DWD*). The Siegerland departure airport (EDGS), the accident site at Sântis and the Arezzo destination airport (LIQB) are shown in red.

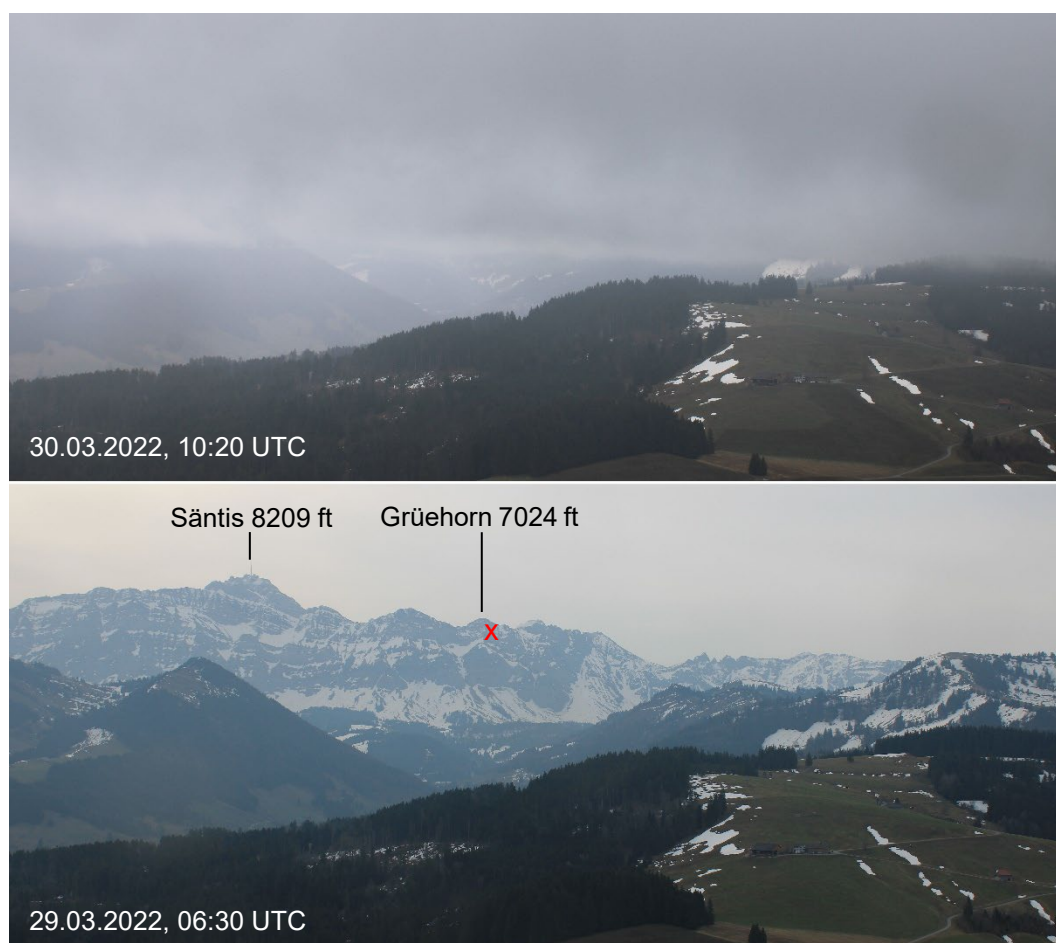
Webcam images show the Säntis and Schwägälp sites in the immediate vicinity of the accident site (cf. Figure 2) in cloud at the time of the accident. The webcam on the 3960 ft high Hochhamm was just below the base of a cloud cover. The location of this webcam is 10 km northwest of the accident site (cf. figure 4).

**Figure 4:** Webcam images taken from the Hochhamm mountain inn at 3960 ft, looking south-east. Above is the photo taken on the day of the accident at 10:20 UTC shortly before the accident (looking in the direction of flight), below for comparison the photo taken the day before at 06:30 UTC when the D-FLIC flew over the area shown in the photo in the opposite direction. The accident site on the Gruehorn (red cross) is 10 km away from the webcam.
