**REPUBLIC OF SOUTH SUDAN
MINISTRY OF TRANSPORT**

AIRCRAFT ACCIDENT INCIDENT INVESTIGATIONS DEPARTMENT

**Final Report of Antonov-26B, EX-126
Accident in Juba-South Sudan**

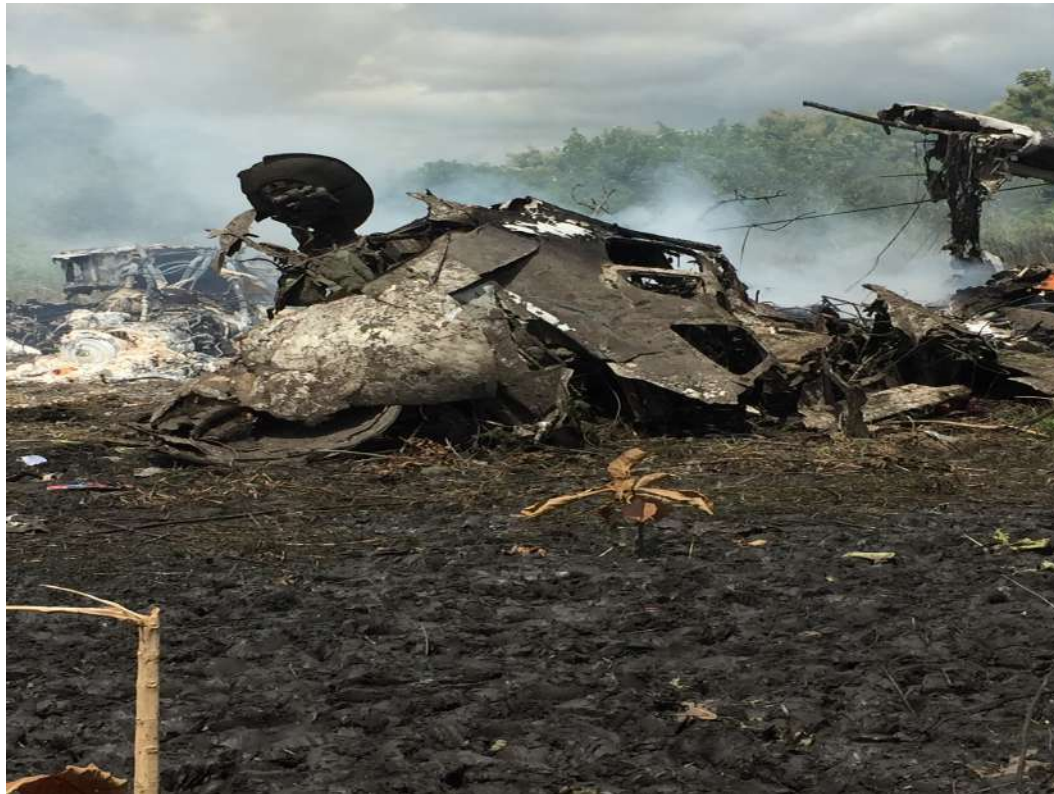
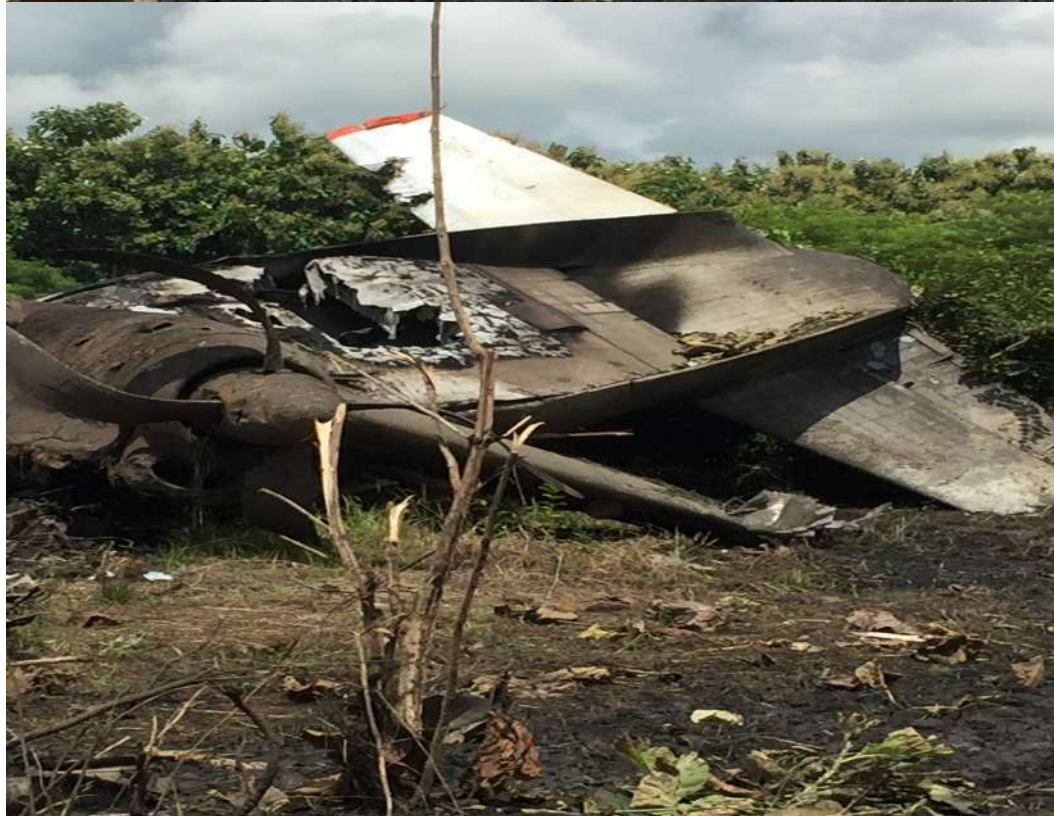
Figure 2: After the Crash of An-26B (EX-126)

When the investigation team, visited the crash site, there was visible total damage and charred remains of the passengers by the continuous inferno of fire to the aircraft fuselage where the cargo Section and the crew were seating. The whole fuselage was compressed due to severe impact to the ground. The cockpit section were scattered and in pieces. The cockpit was compressed and burnt and the vertical stabilizer, horizontal stabilizer, and rudder, elevator were overturned showing serious damage. The LH, and RH wing of aircraft where separate from main fuselage and totally burnt and destroy.

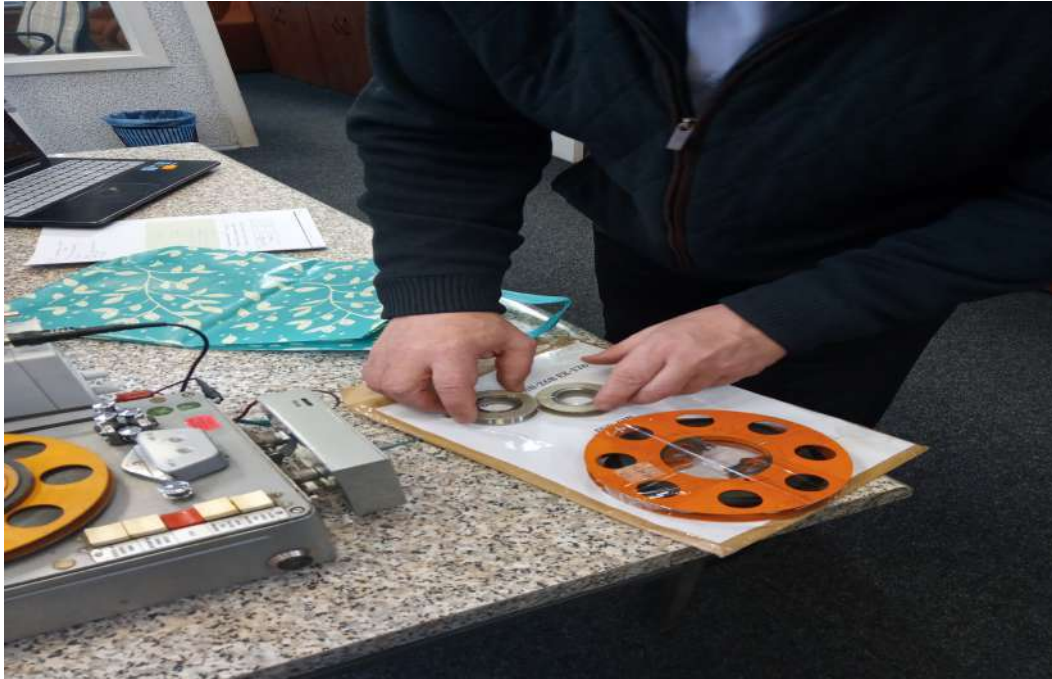
Figure 8: FDR & CVR

During the visual examination of the recording device, there was no damage found to the magnetic tip (FDR) and metal wire (CVR). Therefore, after the inspection a decision was made to readout the recording contained on the magnetic tip (FDR) and on the metal wire (CVR).

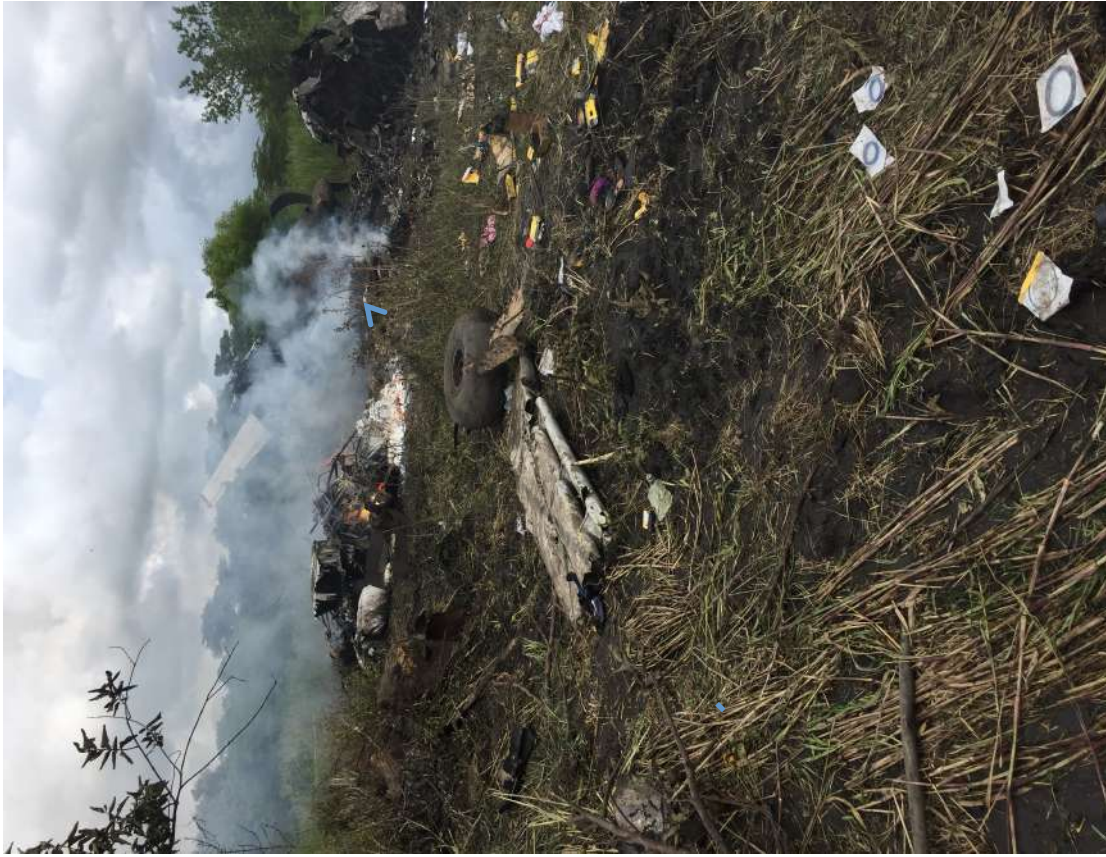
It was visible from far that a total damage was encountered by the aircraft due to the fire to the aircraft fuselage, where the cargo section and the crew were seating.

The whole fuselage was compressed due to severe impact to the ground. The cockpit section scattered into pieces, and the cockpit was compressed and burnt.

The vertical stabilizer, horizontal stabilizer, rudder and the elevator experienced serious damage.

The wing of aircraft LH, RH were separated from main fuselage and burnt totally. In all, the wreckage was scattered to an area of about 150 sq. meters.

Figure 16: Aircraft An-26B wreckage area distribution, destroyed and totally burnt.

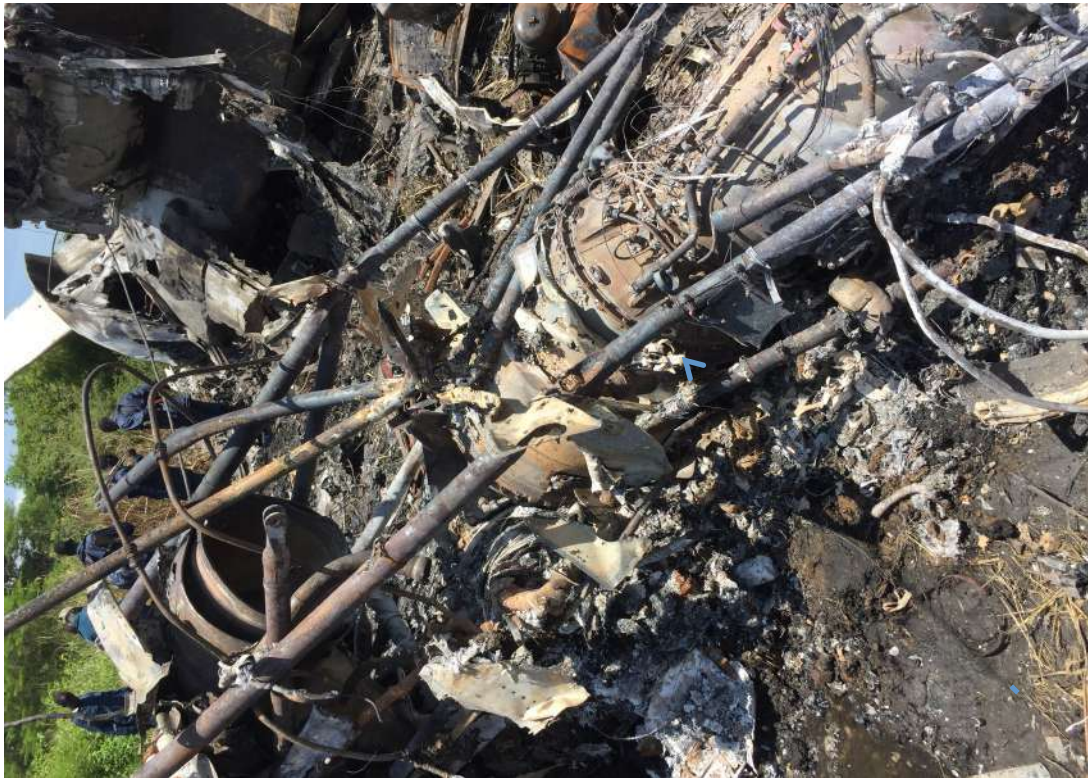
Both engines were completely destroyed especially the left engine was total burnt with propellers 1,2,3,4 separated from reduction gearboxes of LH gearbox. The right engine also destroyed and propellers still attached to engine on RH.

Figure 17: Right Engine totally burnt.

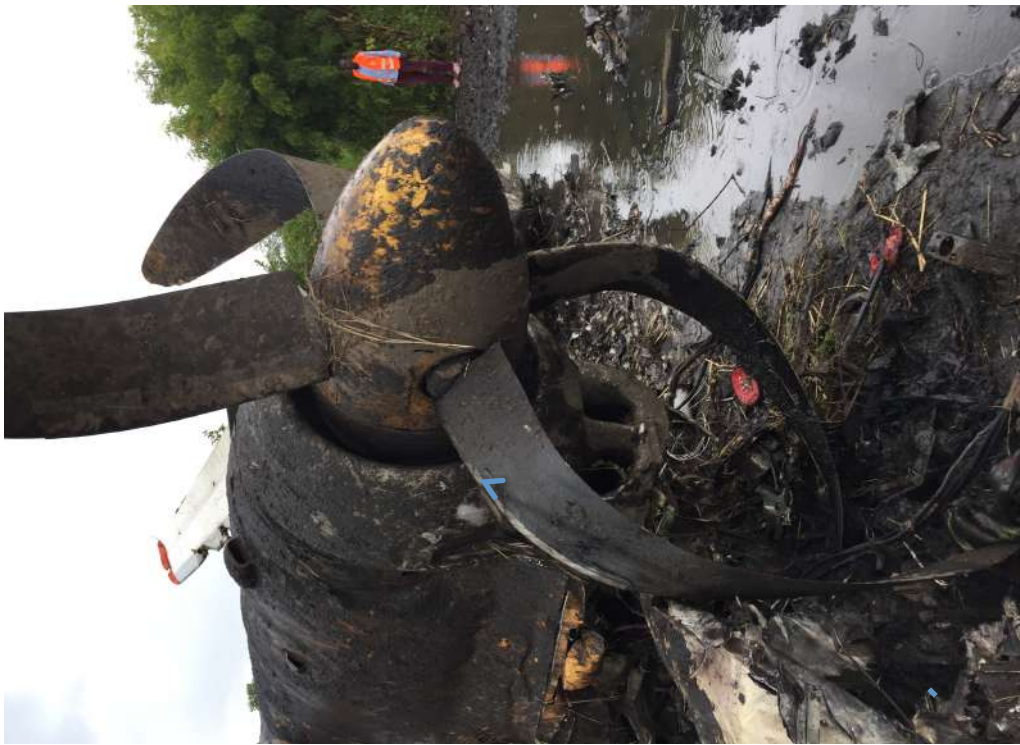
Figure 18:Left Engine Destroyed
The left engine indicated mangled propellers and engine cowling as fire broke out on it and burnt totally.

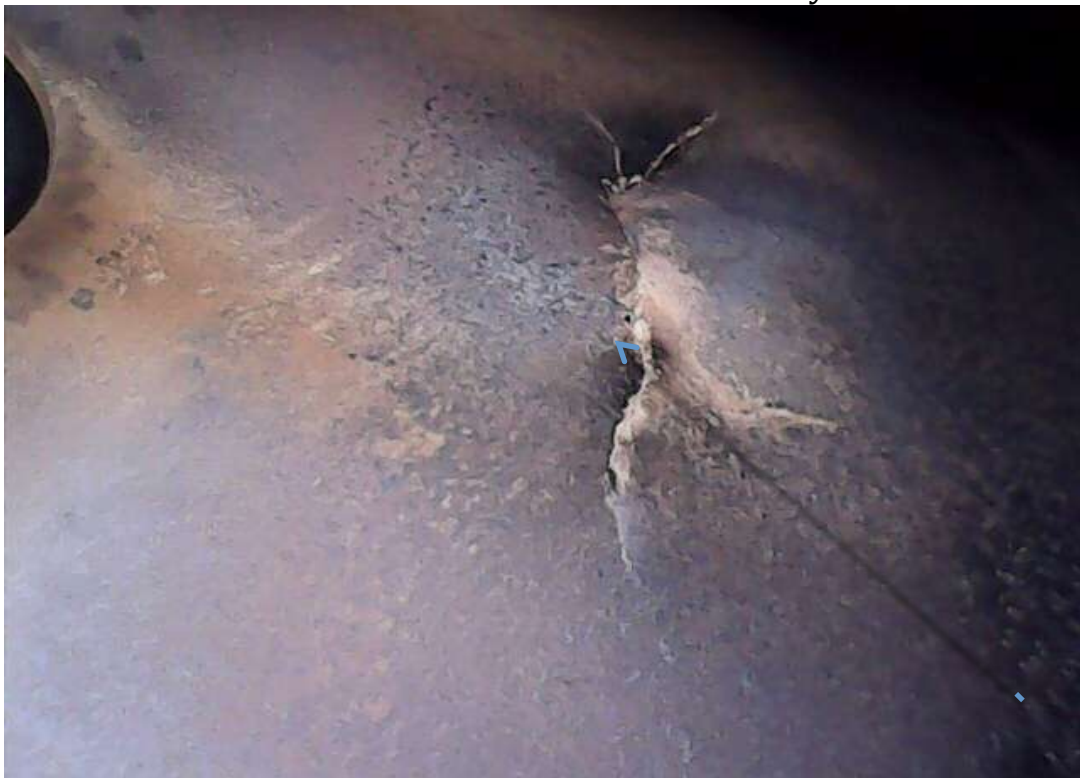
Figure 19: Cracked length in combustion chamber

- The investigation committee found the evidence of fatigue damage in combustion chamber.

3. All types of Antonov operating in South Sudan must introduce maintenance programs including Corrosion Prevention Control Programs (CPCP).
