Aviation Investigation Final Report

Location:	Miami, Florida	Accident Number:	DCA22FA132
Date & Time:	June 21, 2022, 21:38 UTC	Registration:	HI-1064
Aircraft:	McDonnell Douglas MD80	Aircraft Damage:	Substantial
Defining Event:	Landing gear collapse	Injuries:	4 Minor, 136 None
Flight Conducted Under:	Part 129: Foreign

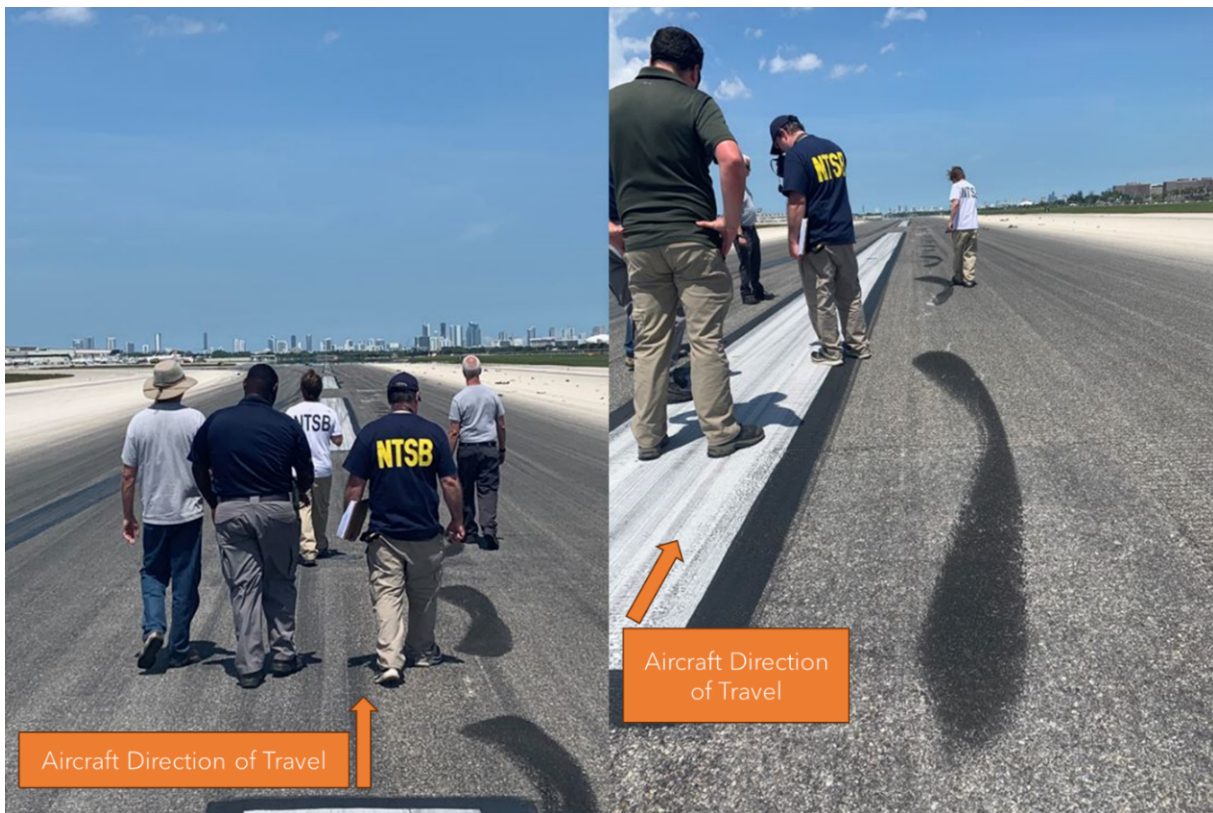
The focus of this analysis is the cause of the left main landing gear collapse. Particularly (1) the left shimmy damper's failure to adequately dampen vibration during landing and (2) the failure of the left main gear downlock mechanism due to excessive vibration. Figure 1 is a representation of how vibrations are typically dampened by a fully functioning shimmy damper. Figure 2 shows the rubber tire transfer markings that indicate the left main landing gear was shimmying down the runway.

Figure 2. Photos showing the left landing main landing gear tire transfer marks indicating shimmying of the landing gear.

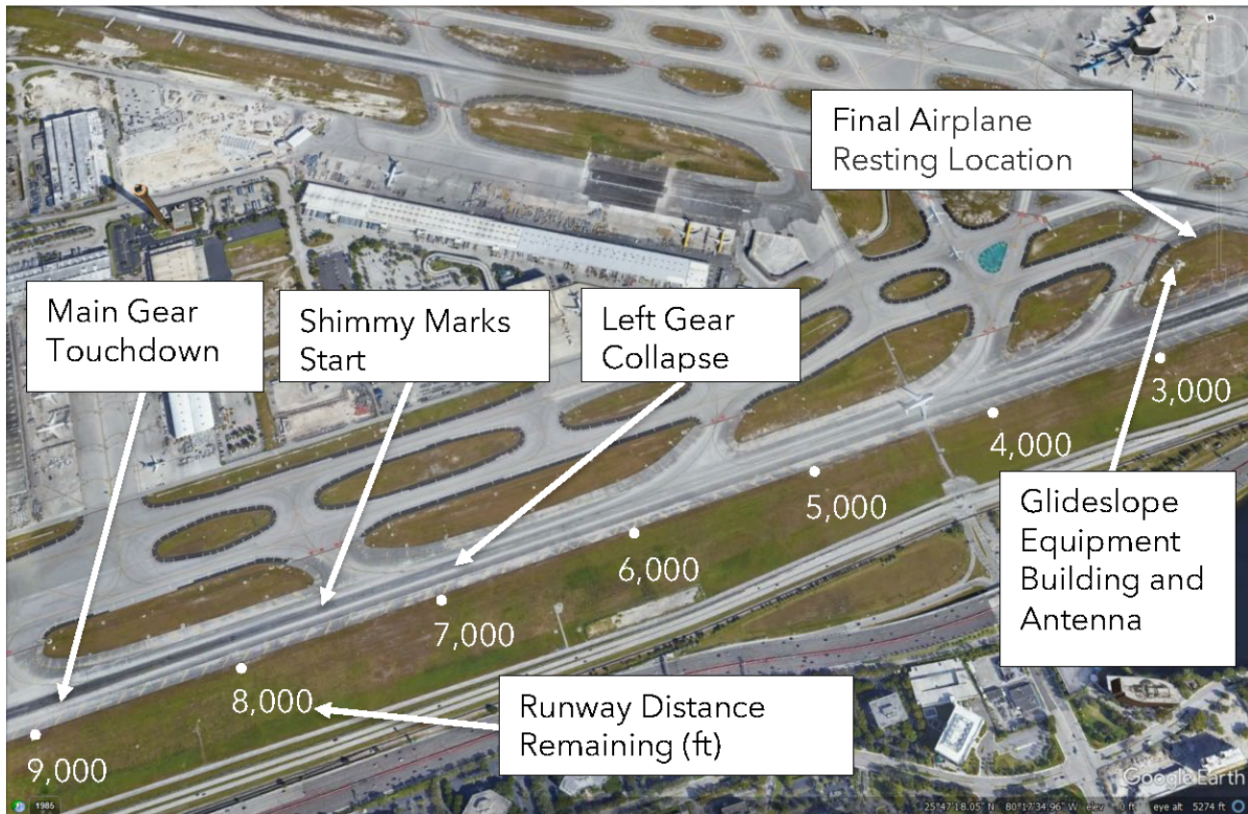
Figure 3. Overview of events during accident landing.

Note: Tire shimmy marks from the No. 1 tire were found with 7,480 and 7,120 ft of runway remaining. Tire shimmy marks from the No. 2 tires were found with 7,300, 7,200, and 7,020 ft of runway remaining.

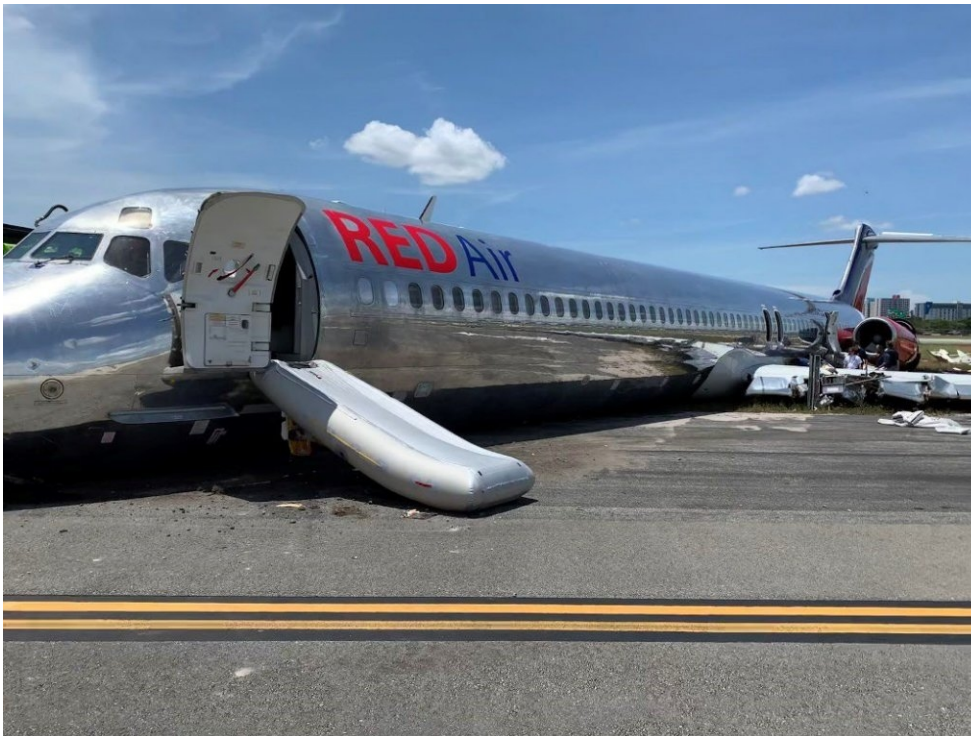
The airplane was found resting on its fuselage with all landing gear collapsed, as shown in figure 8. The L1 and L2 doors were opened with their evacuation slides fully inflated. The forward right overwing window exit and both left overwing window exits were opened. The R1 door, tailcone, and aft right overwing window exits were not opened.

Figure 8. Airplane resting location as viewed from the left side.

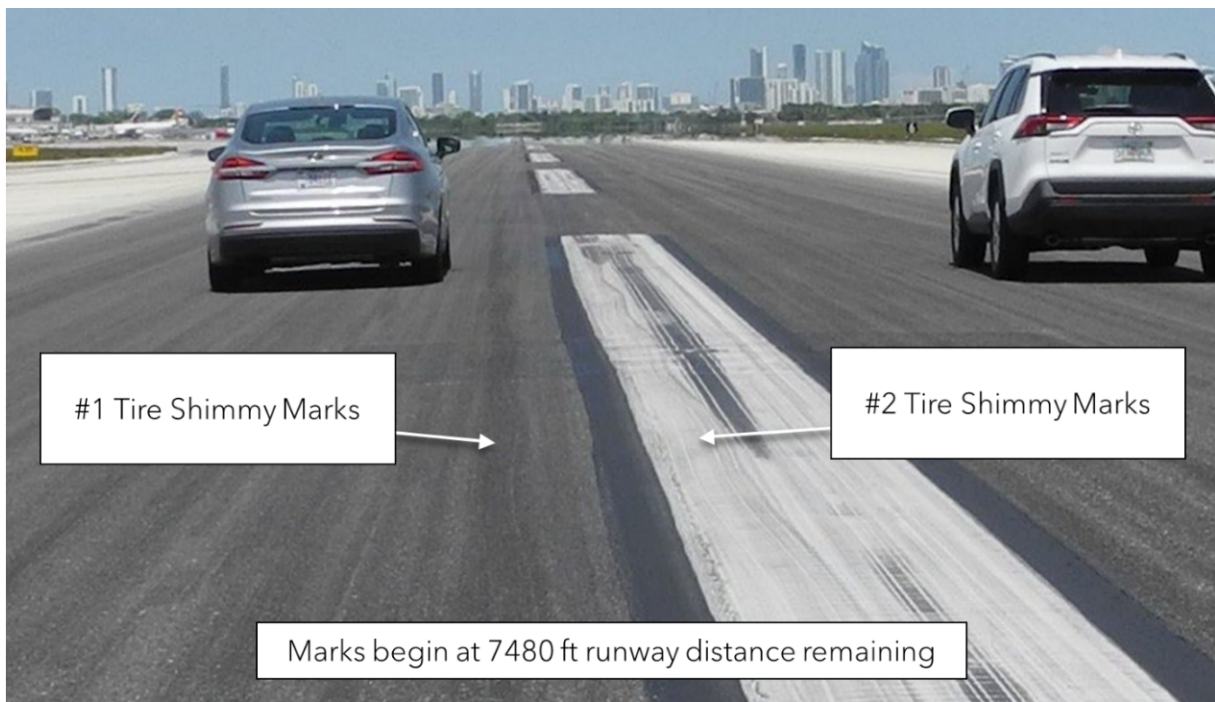
Rubber deposits from the left MLG tires were found on the runway (see figure 9). These deposits grew in amplitude, indicating an increasing shimmy. The initial markings were continuous and were consistent with side-to-side oscillations. The markings became more arched and noncontinuous, consistent with the axle/wheels turning about the vertical axis. The markings then changed from a two-tire pattern to a single-tire pattern and were located on the opposite side of the runway centerline, consistent with the tire sidewall contacting the runway after the left MLG collapsed (see figure 2). The first debris located on the runway (about 1,840 ft from the touchdown point and with 7,060 ft of runway remaining) was a small piece of rubber that was later determined to be from the outboard side of the No. 2 tire.

Figure 9. Start of the left main landing gear shimmy marks. The distance noted is distance to the end of the runway.

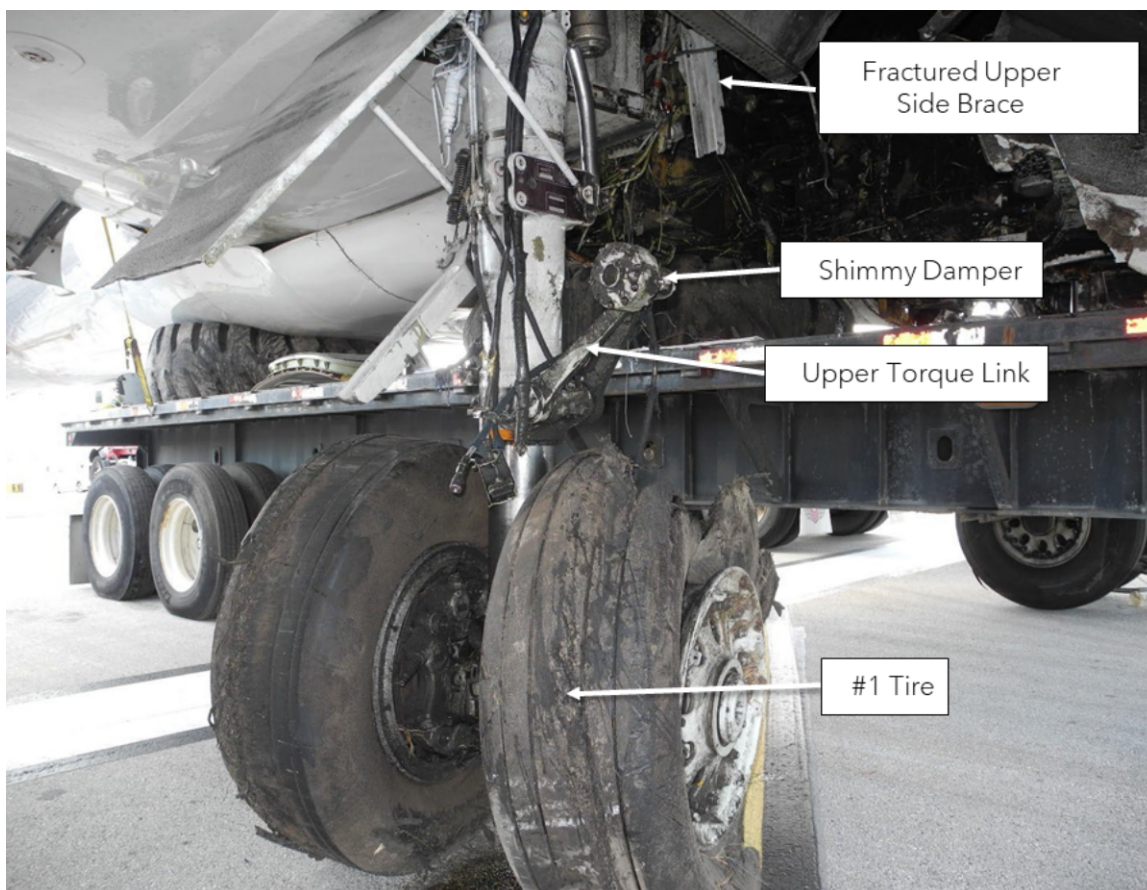
Facing severe undampened axial vibration on rollout, the left main gear lower torque link (downlock) failed due to overload. When the downlock failed, the side braces were free to, and did, fold in the opposite direction from normal as the gear folded inboard and collapsed.

When the airplane was lifted during recovery, the left MLG dropped down to the extended position, and the axle was found to be rotated 90° outboard (with the No. 2 tire forward). The left MLG lower side brace fractured just below the joint of the upper and lower braces. The

lower end of the lower side brace remained attached to the outer cylinder. The upper side brace fractured into upper, middle, and lower pieces. The largest of the three pieces was the upper piece, which remained attached to the airplane (see figure 10). The middle and lower pieces were recovered in the debris field just past the glideslope building. The middle piece showed evidence of impact damage on its forward face. The lower piece had a small piece of black rubber, consistent with tire material, wedged in the joint.

Figure 10. Photo of the left main landing gear after the accident looking inboard and slightly forward. Note that the landing gear assembly is facing outboard in the photo.

Further examination of the left MLG found that all the fractures in the side braces and torque links occurred due to ductile separation consistent with overload; no evidence indicated fatigue failure. The damage on the forward side of the side brace aligned with damage on the outer cylinder near the gland nut, consistent with the side braces moving in the opposite direction of normal. The lower lock link was bent in the aft direction and was sheared. A small segment of the lower lock link, measuring about 3/16 inch, was missing. The upper lock link was bent in the forward direction with corresponding contact marks on the upper lock link and outer cylinder.

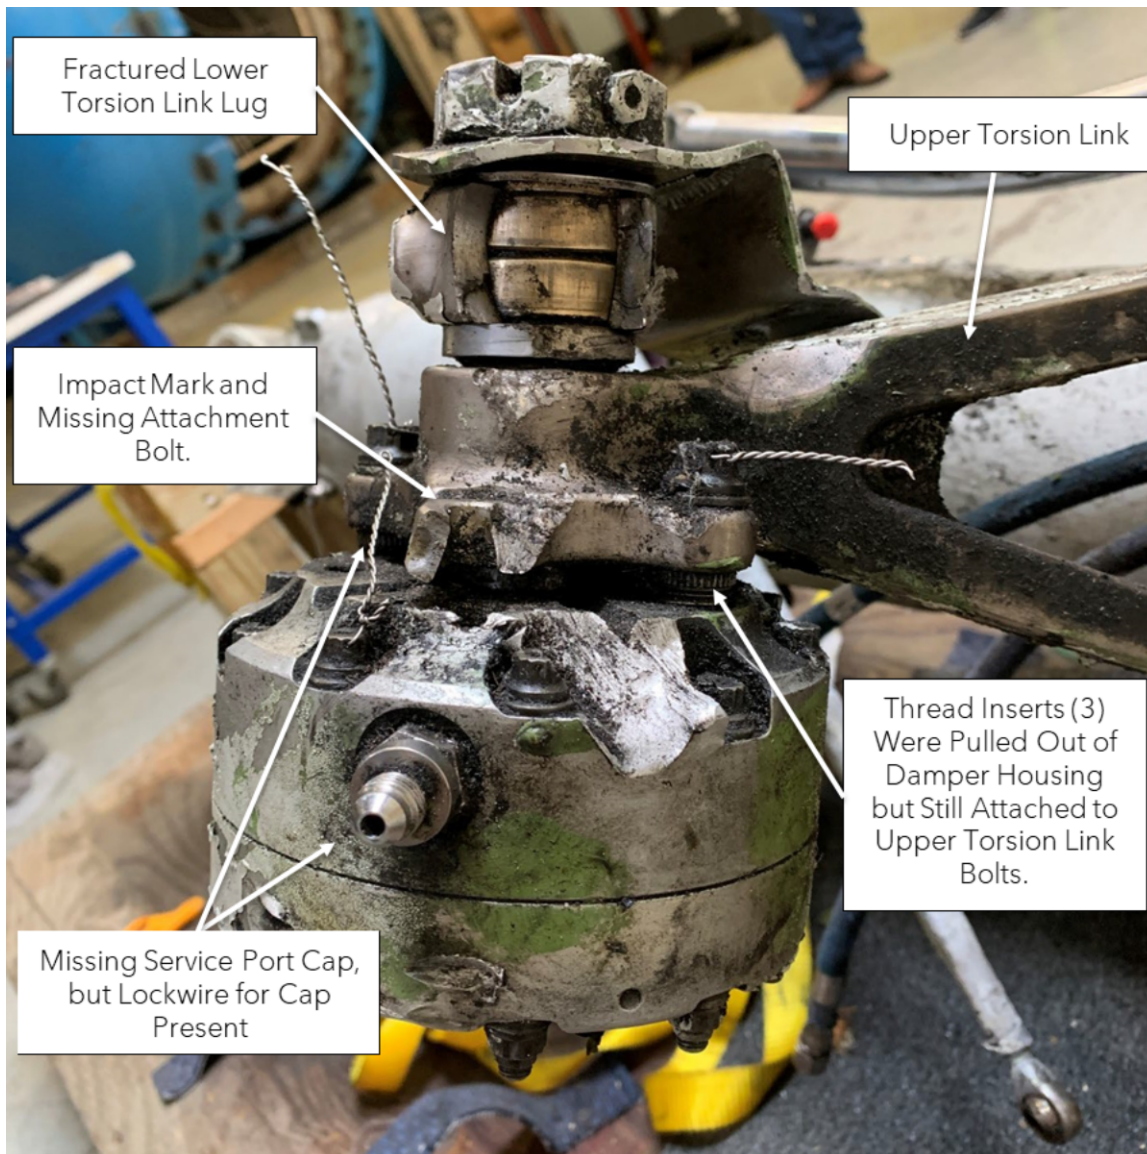
The left shimmy damper was examined and found to be assembled correctly. However, the check valve was found to be leaking and the cap for the check valve service port was missing. The damper requires sufficient hydraulic fluid to adequately dampen normal vibrations in the

system. For a significant amount of fluid to leave the damper, there would have to be failure of both the check valve and the cap for the service port.

The shimmy damper on the left MLG was missing its service port cap and hydraulic reservoir (see figure 11). The reservoir pieces were subsequently found in the grass area located about 200 ft north of the runway 9 centerline. The area where the reservoir was threaded into the damper housing had a large impact mark that deformed the area, and the threads were stripped.

Figure 11. Left main landing gear shimmy damper as recovered.

Further examination of the shimmy damper revealed impact damage to the cap, housing, and several of the 10 housing bolts. Each bolt was numbered clockwise, with No. 1 as the bolt in the 9:00 position, and the reservoir was at the 12:00 position as viewed from the cap side. Breakout torque was measured for each housing bolt. The specified torque was between 116 and 126 inch-pounds, but none of the measured torques were within that range.

The check valve/service port was removed from the housing, and the valve cap was not present. A lockwire was found on the nut for bolt No. 8 with an intact loop on the end that would have been connected to the service port cap. Breakaway torque was measured at 259 inch-pounds; nominal breakaway torque was 80 to 100 inch-pounds. The check valve passed the 5-pounds per square inch gauge (psig) allowable leakage rate test but failed the test performed at 1,000 psig. The valve was then cleaned, and the leakage tests were repeated, with the valve failing the tests at 5 and 1,000 psig. (The first test at 5 psig had a leakage rate of one drop/3 minutes, and the failed test at 5 psig had a leakage rate of two drops/3 minutes.)
