Aviation Investigation Final Report

Location:	Kaupo, Hawaii	Accident Number:	ANC23FA008
Date & Time:	December 15, 2022, 21:14 Local	Registration:	N13GZ
Aircraft:	RAYTHEON AIRCRAFT COMPANY C90A	Aircraft Damage:	Substantial
Defining Event:	Inflight upset	Injuries:	3 Fatal
Flight Conducted Under:	Part 91: General aviation - Positioning

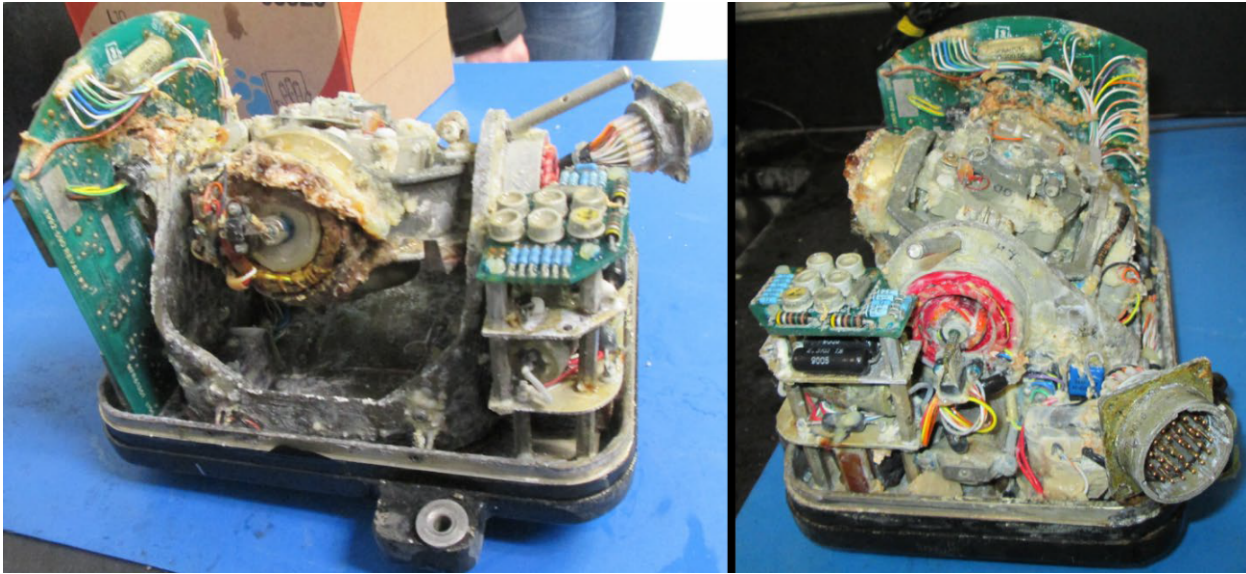
Figure 7. Corrosion and marine growth inside the vertical gyro.

appeared to be recessed. The preservation sealing tape around the base of the unit was removed. Water was present and was drained from the unit. The cover was removed. The interior of the unit was covered in marine growth and deposits. The unit was washed with de-ionized water and some of the marine growth was removed (see Figure 7).

The slip ring was damaged, and the damage appeared to correspond to the crushed cover. Several components on the unit were observed to be crushed. The S1 switch was broken, and the damage appears to correspond to the crushed cover. Damage to wire wound resistor (R61) on terminal board 7 (TB7) was observed. The resistance across the resistor was measured at 83.5 ohms as found. One of the wires between the resistor and the board was cut to isolate the resistor. The resistance across the resistor was re-measured at 83.4 ohms. (Note that the R61 resistor has a nominal value of 82 ohms.)

Continuity checks were performed on the electrical connector of the unit. Operation of the unit was not possible due to deposits on the unit. The area where the R61 resistor was located showed some corrosion deposits but no thermal damage. No other anomalies were observed during the examination.

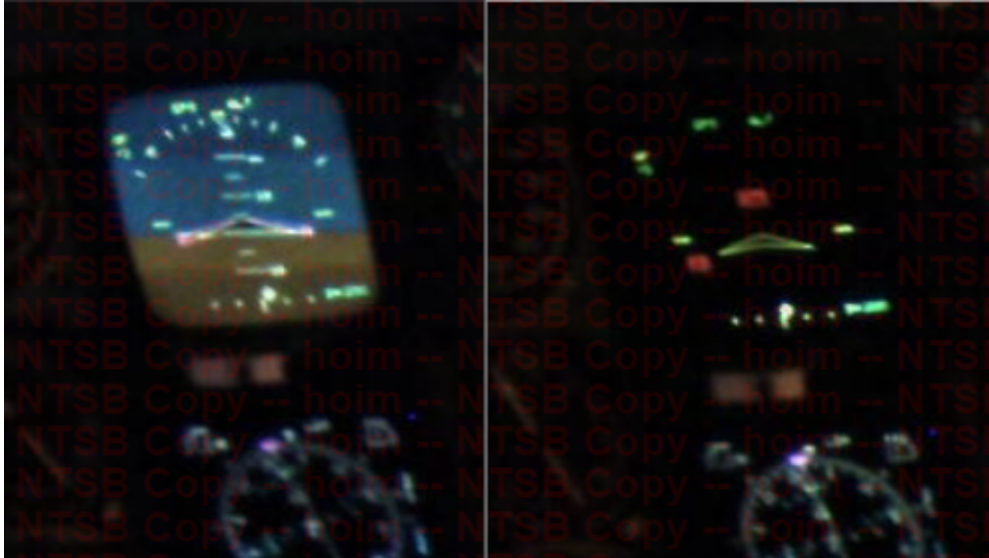
Figure 9. Appareo image of the Electronic Attitude Director Indicator, before and after the failure.

About 2106, the autopilot disconnect alert tone sounded, and the autopilot disconnect light illuminated. The pilot's Electric Attitude Director Indicator (EADI) did not display artificial horizon information for the duration of the flight, red warnings flashed several times, and then remained lit (see Figure 1). The flight nurse asked the pilot if the autopilot had disconnected, and the pilot confirmed to the flight nurse that it had.

The Appareo Vision 1000 cockpit video recording of the accident indicated that the autopilot and the attitude indicator failed at the same time. The only component common to both systems is the vertical gyro. The vertical reference gyro provides 3-wire synchro pitch and roll attitude data to the autopilot and to the attitude indicator.

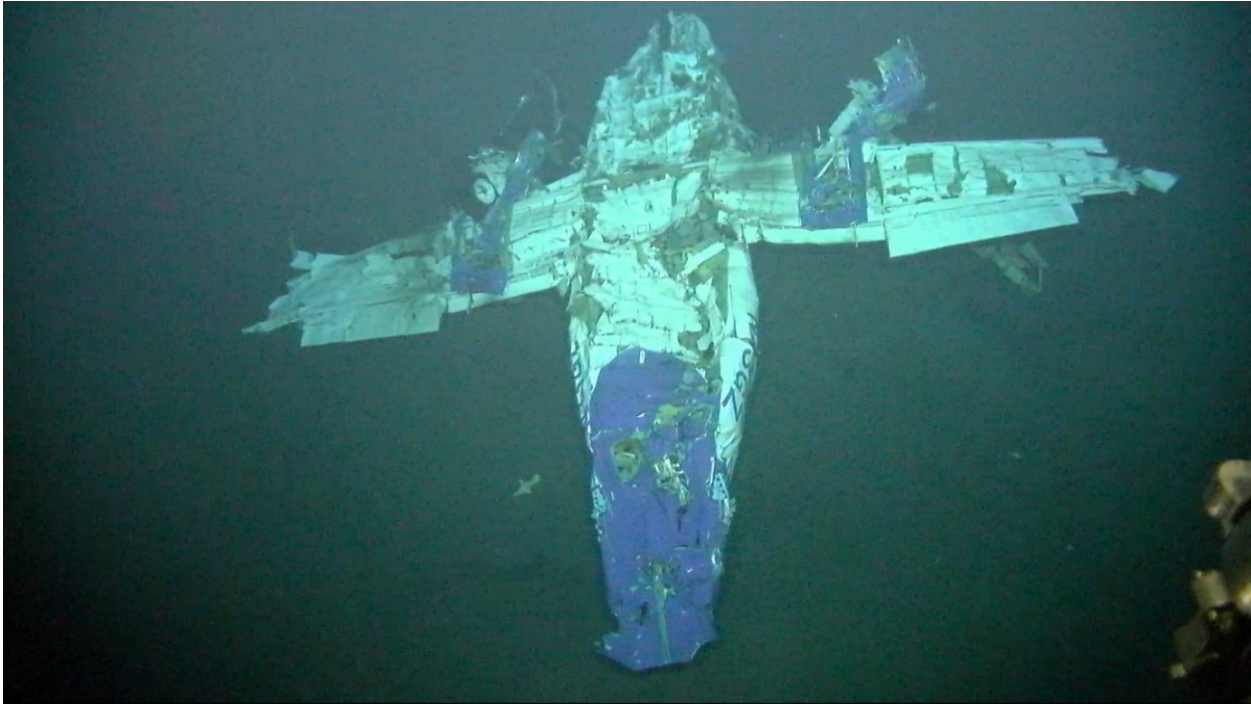
Figure 14. View of N13GZ on the seabed. (Courtesy of Ocean Infinity)

The postaccident examination revealed that the wreckage displayed vertical crush damage consistent with impact at a high rate of descent. The fuselage, from the nose to tail section, was impact damaged and compressed upward. The empennage separated from the fuselage in flight and was not recovered. The left and right wings were mostly intact but damaged from the wing roots out to beyond the end of the outboard flaps; neither wing tip was recovered. The lower surface of the wings had significant upward hydraulic compression damage. All wing separations exhibited signatures consistent with tension overload.
