# Aviation Investigation Final Report

<b>Location:</b>	San Diego, California	<b>Accident Number:</b>	WPR22LA344
<b>Date &amp; Time:</b>	September 9, 2022, 13:14 Local	<b>Registration:</b>	N26FN
<b>Aircraft:</b>	GATES LEAR JET CORP. 36	<b>Aircraft Damage:</b>	Substantial
<b>Defining Event:</b>	Runway excursion	<b>Injuries:</b>	2 Minor
<b>Flight Conducted Under:</b>	Public aircraft

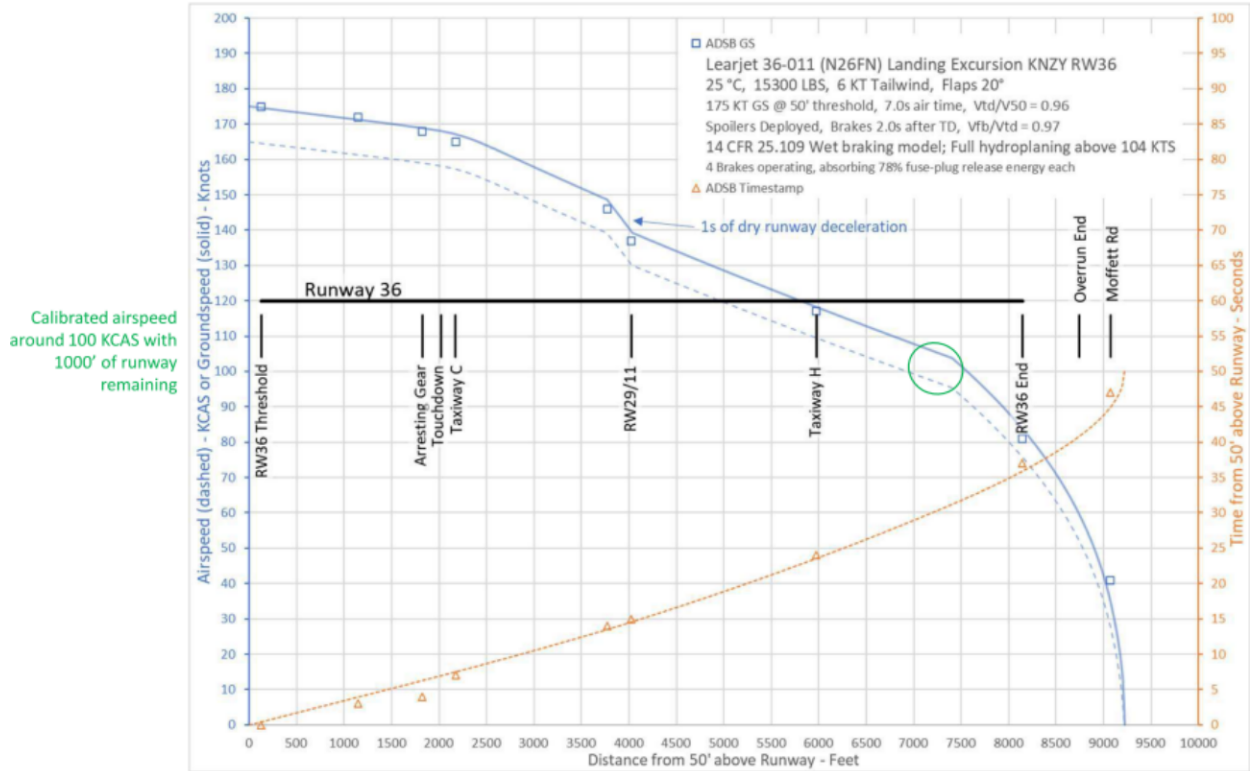
a localized tailwind (which was not present in the weather data), and an inboard brake failure. The study showed that the most likely scenario, based on the available data, was that the airplane touched down with a ground speed well in excess of the 140 kts Vref speed reported by the crew, and that subsequent to the touchdown encountered full hydroplaning at speeds above 104 kts.

The modeling in the study “produced a profile consistent with the factual data when significant hydroplaning was assumed, likely due to the recent heavy rain and continued precipitation on the runway surface combined with a high aircraft ground speed. The model indicated that it was unlikely the high ground speed was due to a severe tailwind, and it also showed that all aircraft brakes were likely operational.” The model that best fit the available data showed that the airplane touched down with a ground speed well in excess of the 140 kts reported by the crew and that, subsequent to the touchdown, encountered full hydroplaning at speeds above 104 kts (See figure, below).

Figure plotting speed with landing distance along with runway features. Note the incorporated ADS-B data of groundspeed and time.
