Aviation Investigation Final Report

Location:	Seligman, Arizona	Accident Number:	WPR22FA345
Date & Time:	September 13, 2022, 11:00 Local	Registration:	N43605
Aircraft:	Piper PA46	Aircraft Damage:	Substantial
Defining Event:	VFR encounter with IMC	Injuries:	2 Fatal
Flight Conducted Under:	Part 91: General aviation - Personal

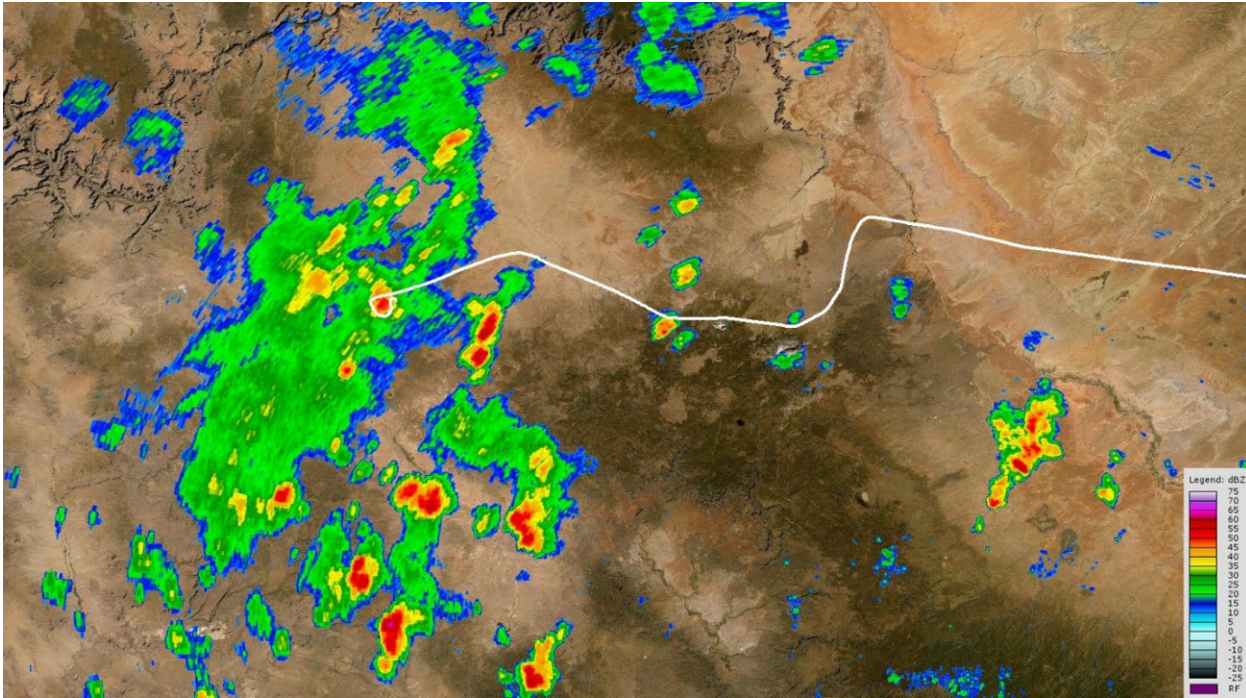
WSR-88D2 Level-II base reflectivity weather radar imagery from the Flagstaff, Arizona, site (KFSX) is presented in Figure 1. The end of the accident airplane's flight path was coincident with a cell of heavy-to-extreme reflectivity.

Figure 1-KFSX 0.484° Level-II base reflectivity product from a sweep initiated at 1059:00. The accident aircraft's flight path through 1100:25 is depicted by the white line. Reflectivity has been "smoothed" and reflectivity values less than 10 dBZ have been masked out.
