# Aviation Investigation Final Report

<b>Location:</b>	Modesto, California	<b>Accident Number:</b>	WPR23FA092
<b>Date &amp; Time:</b>	January 18, 2023, 13:07 Local	<b>Registration:</b>	N4765G
<b>Aircraft:</b>	Cessna 414	<b>Aircraft Damage:</b>	Substantial
<b>Defining Event:</b>	Loss of control in flight	<b>Injuries:</b>	1 Fatal
<b>Flight Conducted Under:</b>	Part 91: General aviation - Personal

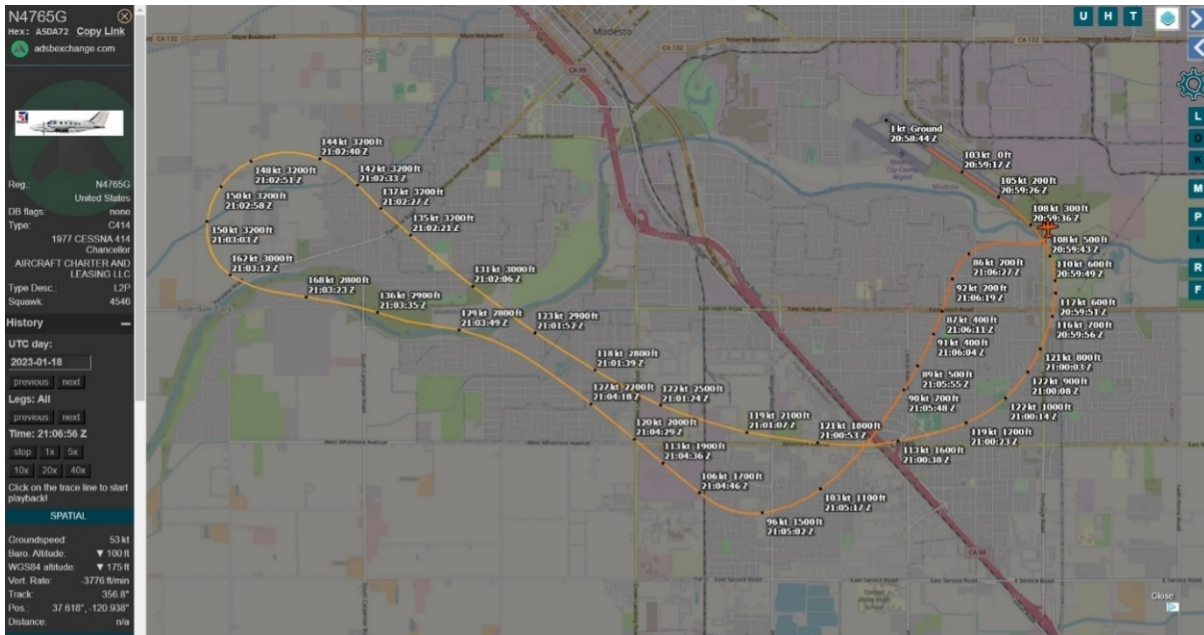
Figure 1 – ADS-B Flight Track

The airplane's flight track showed the pilot flew directly toward the runway aimpoint about 1,000 ft from, and perpendicular to, the runway during the left base turn to final and allowed the airplane to descend as low as 200 ft pressure altitude (PA). The pilot then made a right turn about .5 miles from the runway followed by a left turn towards the runway. A pilot witness near the accident location observed the airplane maneuvering and predicted the airplane was going to stall. The airplane's airspeed decreased to about 53 knots (kts) during the left turn and video showed the airplane's bank angle increased before the airplane aerodynamically stalled and impacted terrain. Postaccident examination of the airframe, engines, and review of recorded engine monitoring data revealed no evidence of any preimpact mechanical malfunctions or failures that would have precluded normal operation.

During the left base turn, the airplane angled further left towards a point about 1,000 ft beyond the runway 28R threshold and maintained a groundspeed of about 90 kts and continued to descend until it reached 200 PA about 0.5 miles from the runway. The airplane then entered a right turn to about a 090° heading before it started a left turn to the north. During the left turn, the groundspeed decreased from about 72 kts to 53 kts and the altitude decreased to 100 ft PA when the last ADS-B return was recorded at 1306:56 near site of the accident (Figure 1).

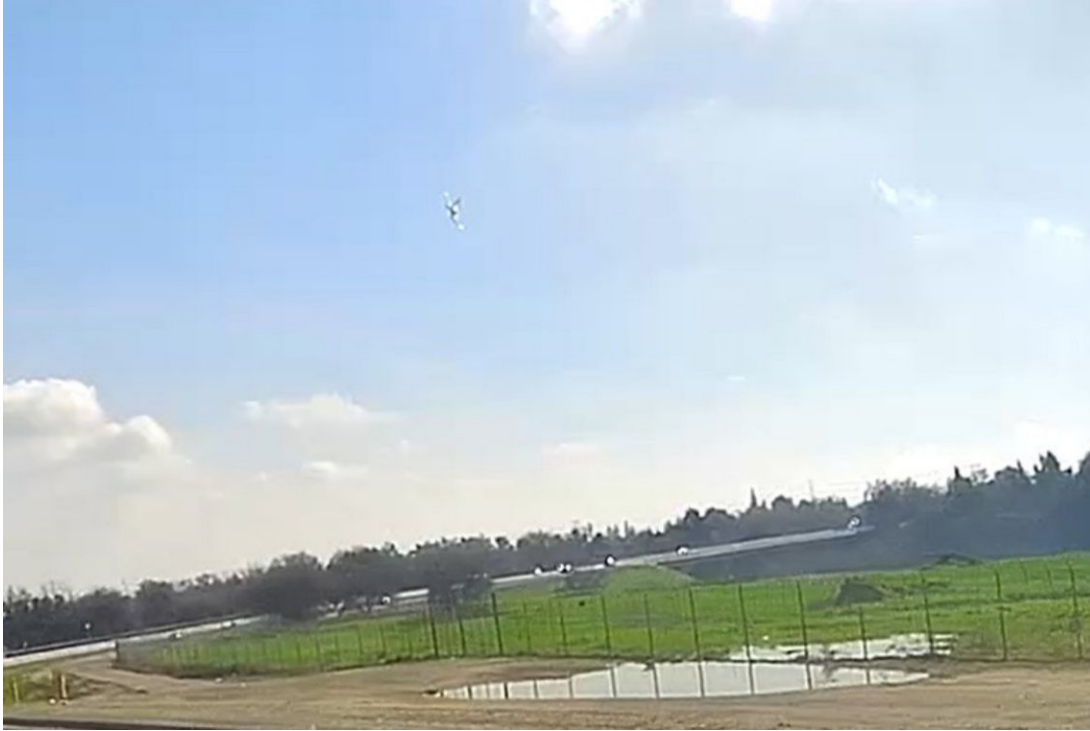
Figure 2 – Dash Camera Capture, 3 Seconds Before Impact

Dash camera video was obtained from an unknown witness that showed the final seconds of the flight. The video showed the airplane’s bank angle increase, the nose drop, and the airplane enter a near vertical left spin (Figure 2).
