FINAL REPORT

AIRCRAFT ACCIDENT INVESTIGATION REPORT

Report / File. No:	- AAIU: 3/1/22/3
Name of Operator	- FLY JAMAICA AIRWAYS
Aircraft Manufacturer	- BOEING AIRCRAFT COMPANY
Aircraft Model/Type	- BOEING 757-200
Nationality & Registration Marks	- N524AT
Place of Accident/Region	- CHEDDI JAGAN INTERNATIONAL AIRPORT (ICAO REFERENCE SYCJ), DISTRICT REGION 4, TIMEHRI, EAST BANK DEMERARA, GUYANA, SOUTH AMERICA
Date of Accident	- 9TH NOVEMBER 2018
Time of Accident	- 06:53 UTC (02:53 GST)

REPORT / FILE #: AAIU 3/1/22/3

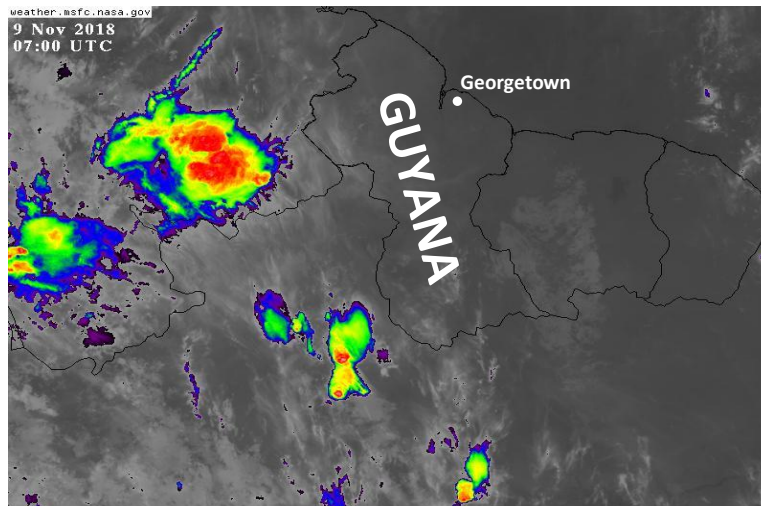
Figure 1: Infrared satellite image valid at 07:00 UTC 9th November 2018

This infrared satellite image valid 07:00 UTC 9th November 2018 indicated that there were no convective clouds within the Georgetown FIR at the time of the emergency landing, thus there was no need for the issuance of a convective SIGMET message in the Georgetown FIR.

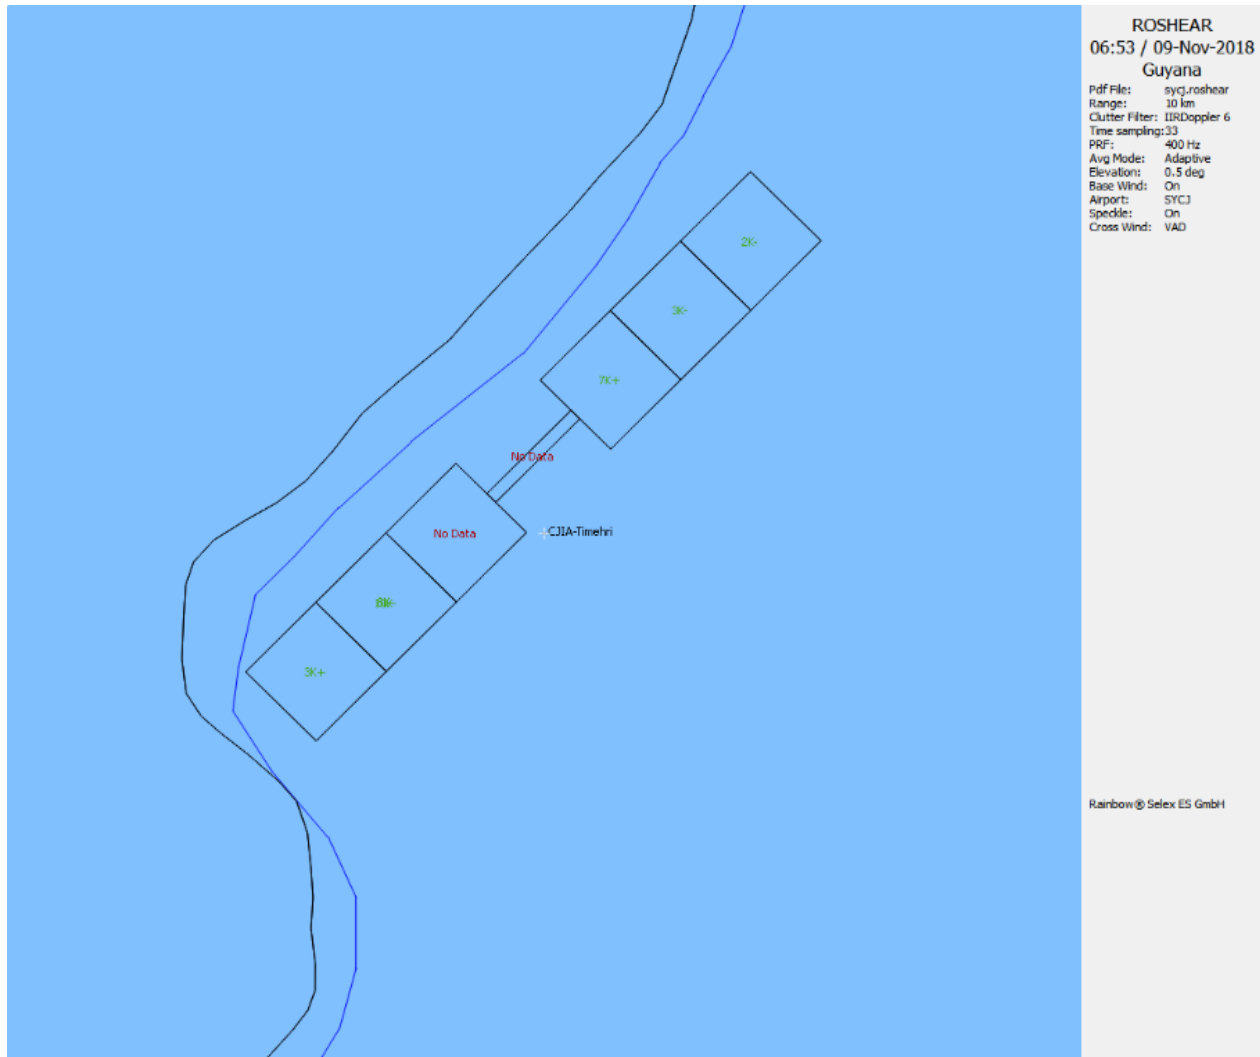
Figure 3: Radar generated Runway Oriented Shear (ROSHEAR) product valid 06:53 UTC 9th November 2018.

The ROSHEAR product showed Loss and Gain less than 10kt along the 3^o path towards and RWY06 and RWY24. This data shows that there was no need for the issuance of a wind shear warning at the time of this scan. Similar scans before the emergency landing also show that the wind shear along the glide path of 3^o, was not significant and hence did not warrant the issuance of a wind shear warning.

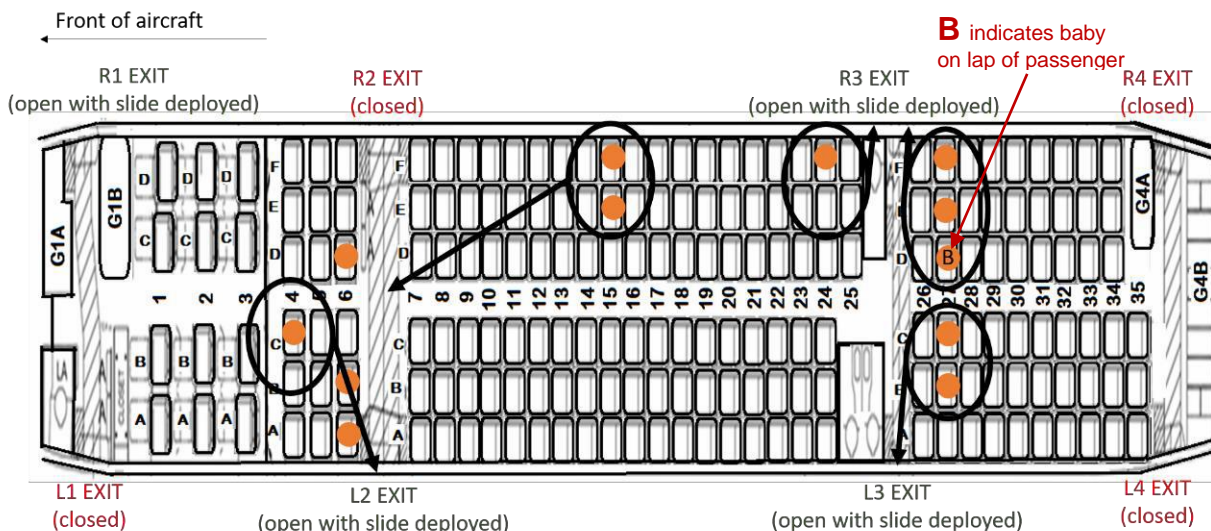
**FIGURE 5: SEAT INFORMATION FOR 14 PASSENGERS.
B INDICATES A BABY ON THE LAP OF A PARENT**

Figure 5 below, illustrates the aircraft layout and exit locations, including the open exits, as observed in post-occurrence images. Of the passenger information available, exact seat allocation was obtained for fourteen of the seventeen passengers. The seat allocation and evacuation routes are also indicated in Figure 5.

Although there were six Cabin Crew on-board, passengers who provided information to the TSB only referenced one Crew Member at the L2 exit and one Crew Member at the L3 exit. Some passengers reported having opened the exits themselves and one mentioned there was no Crew Member attending their evacuation slide.
