Aviation Investigation Final Report

Location:	Oceanside, California	Accident Number:	WPR22FA197
Date & Time:	June 3, 2022, 13:47 Local	Registration:	N7581F
Aircraft:	Cessna 208B	Aircraft Damage:	Substantial
Defining Event:	Landing area undershoot	Injuries:	1 Fatal, 1 Serious
Flight Conducted Under:	Part 91: General aviation - Skydiving

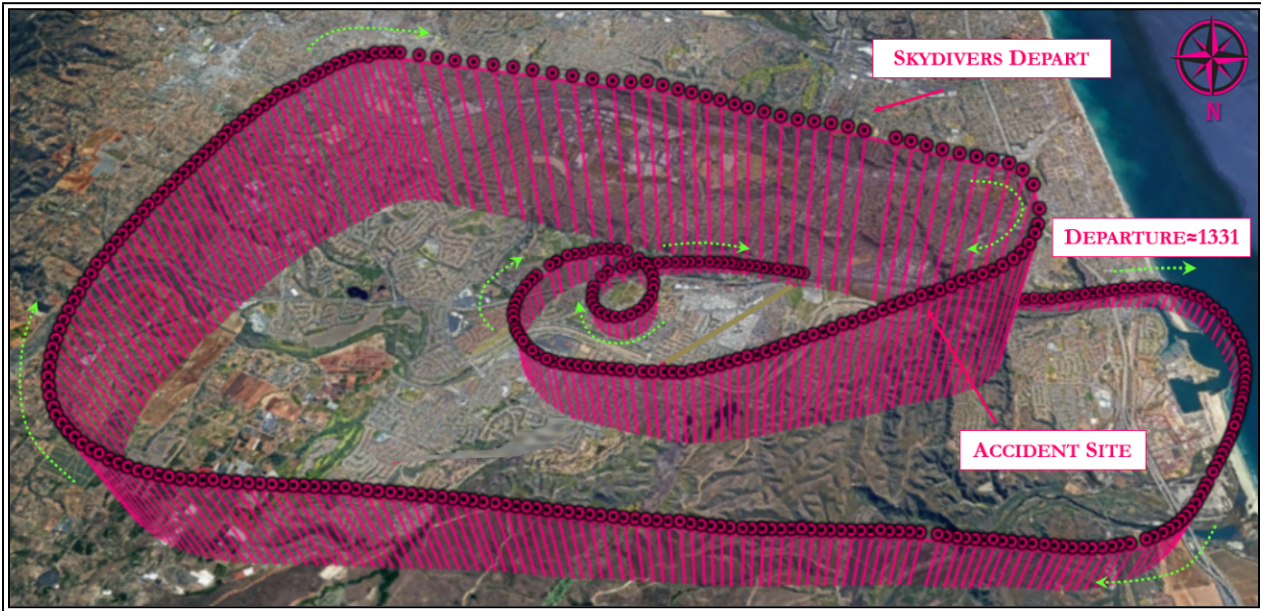
Figure 1: Accident Flight Path

Investigators reviewed the automatic dependent surveillance – broadcast (ADS-B) flight track data covering the area of the accident during the time surrounding the accident. After departing from runway 25, the airplane made a gradual climb to 11,575 ft msl as it circled to the right, back to the airport. The airspeed was reduced to about 80 KCAS (presumably to unload the skydivers) and then the airplane made a steep, turning descent reaching 130 KTAS (110 KCAS) when transitioning to the downwind leg of the traffic pattern. The airplane was at an altitude of about 2,400 ft msl and 2.5 nautical miles (nm) from the approach end of runway 25 when it turned onto final approach. When the airplane was about 2 nm from the runway, it made a 360° right-turn which was about 0.5 nm in diameter (see Figure 1 below).

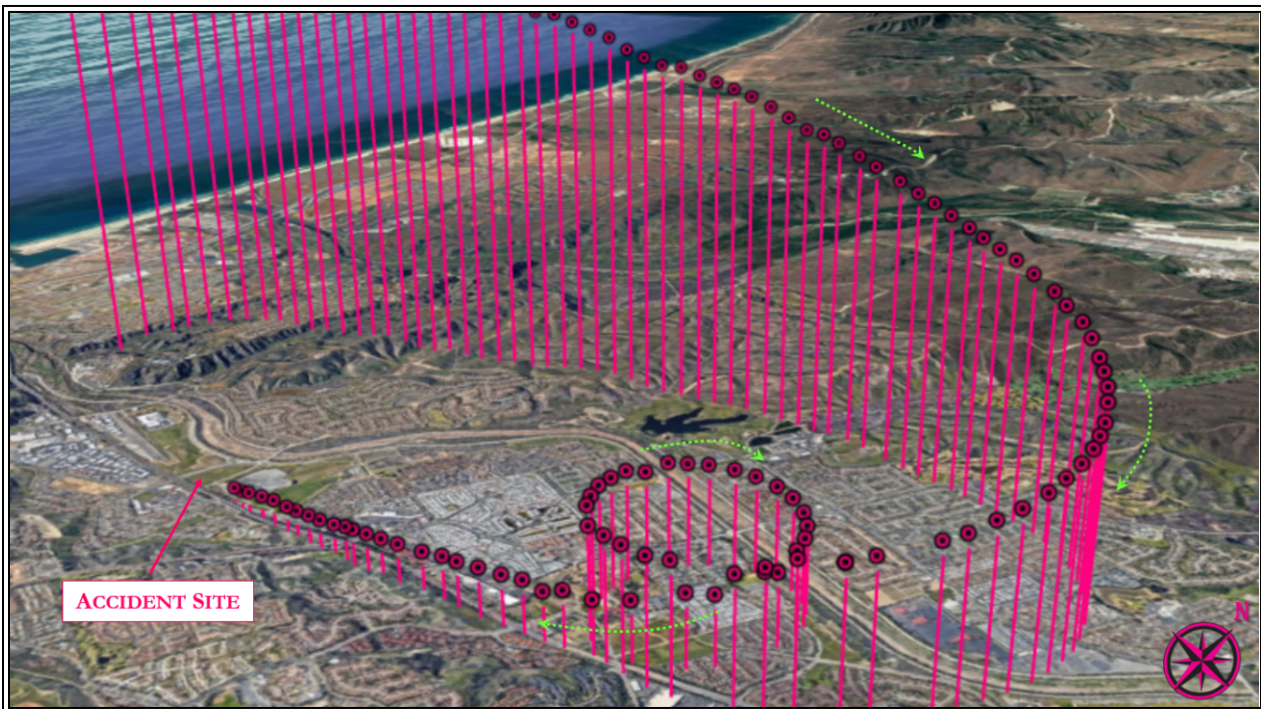
Figure 2: Flight Path on Final Approach

At 1346:10, about 1,025 ft msl, the airplane rolled out of the 360° turn and continued west toward the runway. For the remainder of the flight (one minute), the airplane was roughly following Highway 76 making a gradual descent toward the runway (see Figure 2 below).

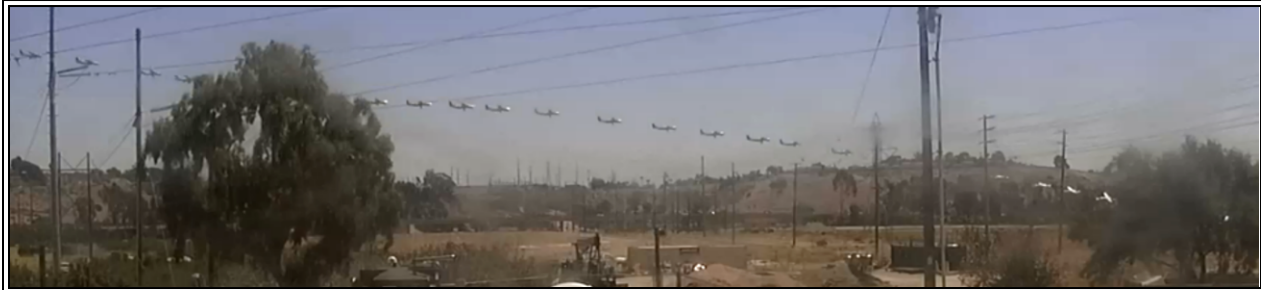
Figure 3: Video Footage Showing the Airplane Before Impact

kts (76 KCAS). Witnesses stated that they observed the airplane flying at a very low altitude (see Figure 3). The airplane then pitched down in a nose-low attitude and banked to the right. The airplane impacted terrain and collided with the side of a berm. A security camera captured the airplane seconds before impact (see Figure 3 below).
