Aviation Investigation Final Report

Location:	Pierre, South Dakota	Accident Number:	CEN24LA020
Date & Time:	October 23, 2023, 16:11 Local	Registration:	N92884
Aircraft:	Piper PA 46-350P	Aircraft Damage:	Substantial
Defining Event:	Fuel starvation	Injuries:	1 Fatal, 1 Serious
Flight Conducted Under:	Part 91: General aviation - Personal

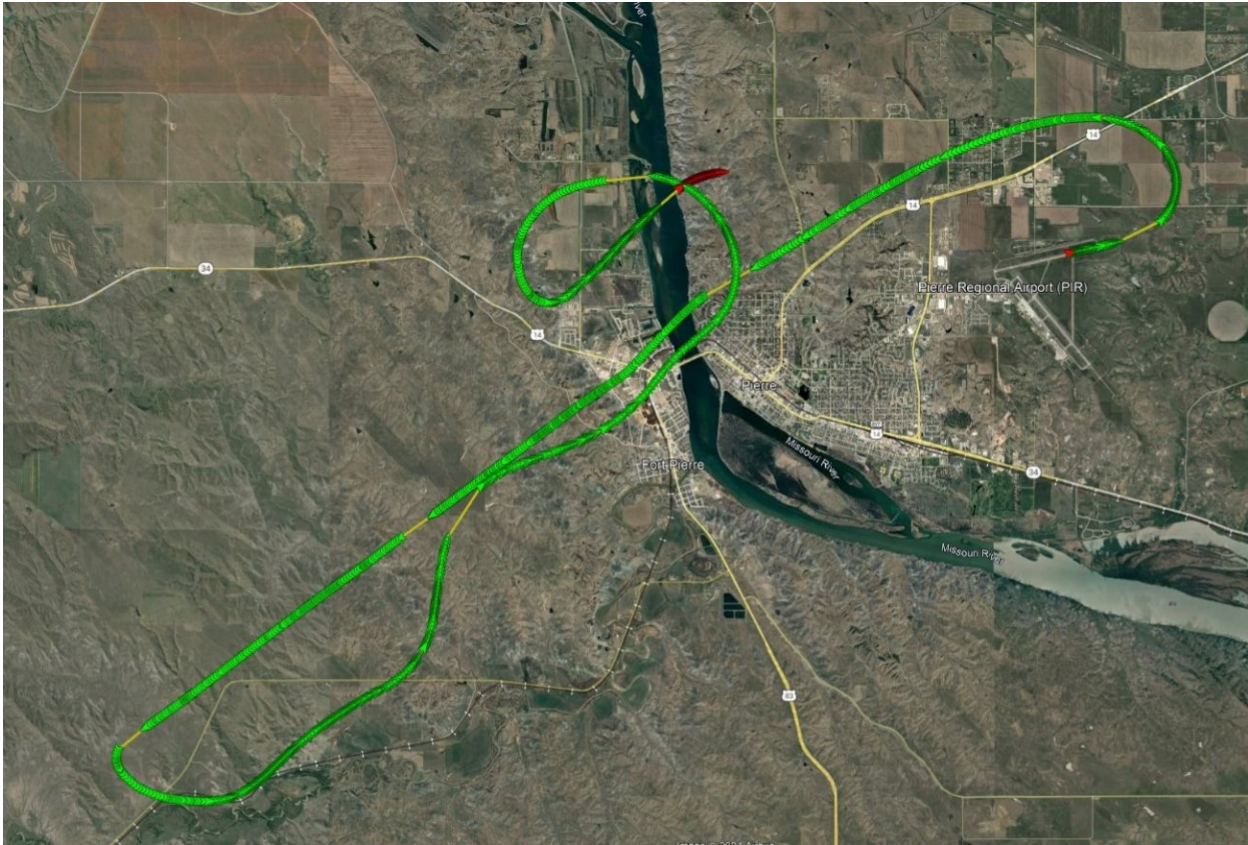
About 11,000 ft mean sea level (msl), air traffic control cleared the pilot to flight level 220. While climbing through 12,000 ft msl, the engine sustained an abrupt loss of power that was confirmed by the loss of torque and engine compressor turbine rpm (Ng) speed. The pilot noted no cockpit warning or abnormal indications before the loss of engine power. The pilot declared an emergency and then executed a 180° turn back to PIR (see Figure 1).

Figure 1. Overhead view of the flight track.

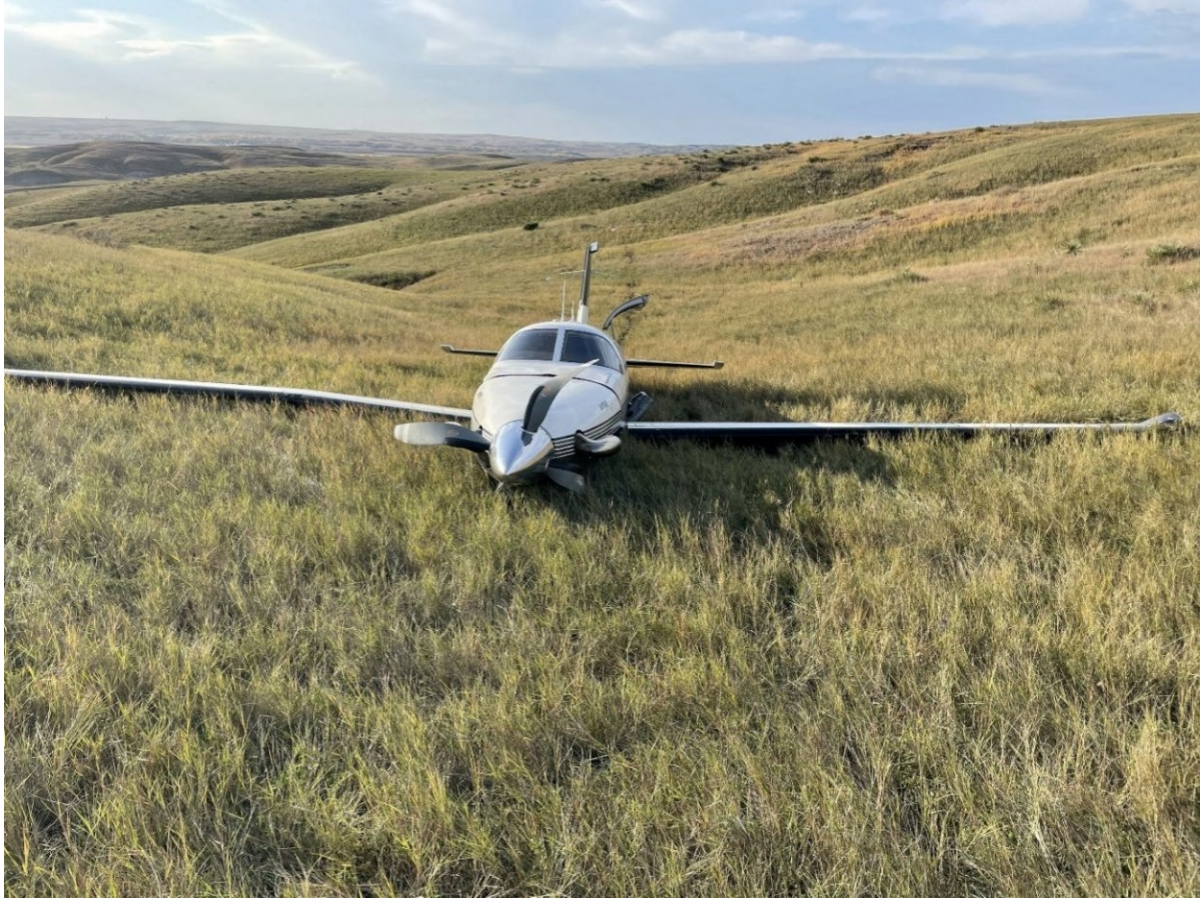
Figure 2. Airplane as it came to rest in the rolling terrain.

The airplane impacted the terrain, came to rest upright, and sustained substantial damage to the fuselage and both wings.
