BELIZE DEPARTMENT OF CIVIL AVIATION

Aircraft Accident Investigation Unit (AAIU)

FINAL REPORT

Date:	16 OCTOBER, 2023
Time:	3:50 am Local Time
Location of the occurrence:	PLACENCIA AIRPORT
Latitude/longitude:	Lat: N 17°17.1812" Long: W 089° 01.030"
Aircraft (Make / Model)	C208EX CARAVAN
Operator:	MAYA ISLAND AIR
Category of the occurrence:	ACCIDENT
Involved States:	BELIZE, USA

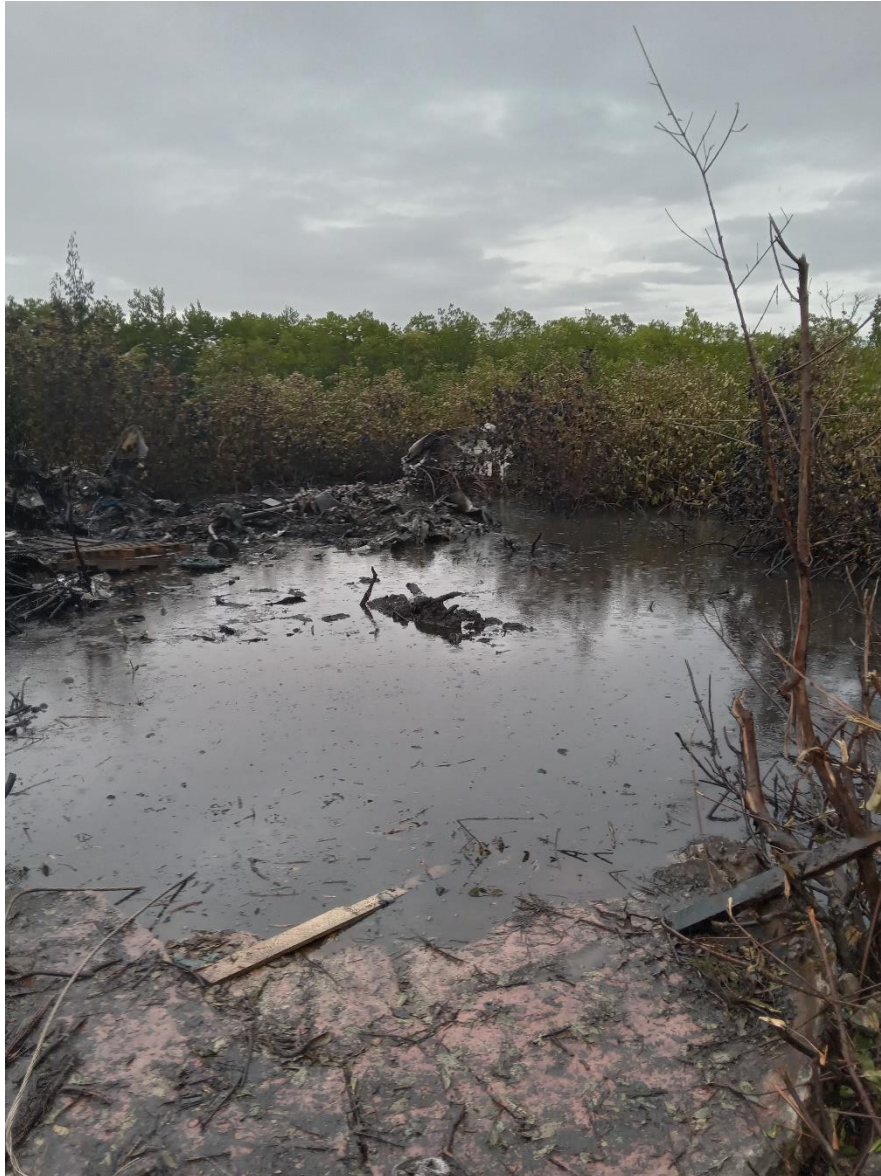
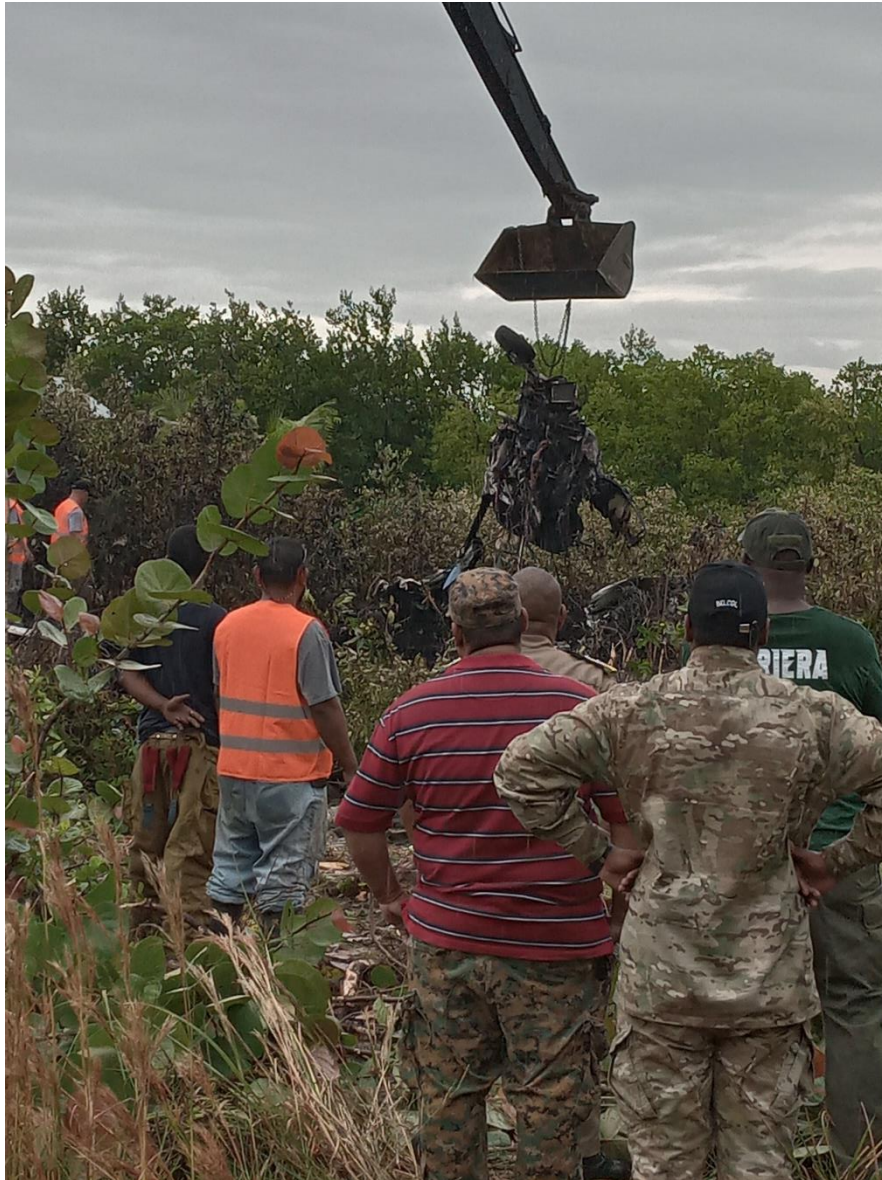
APPENDIX A – CRASH SITE

1.12. **Wreckage and impact information:** The wreckage of the aircraft was located approximately 30 feet from the roadside and 0.5 nm North from the Placencia Airport where the aircraft hit an electrical transformer and impacted the ground causing the aircraft to be completely destroyed by fire.

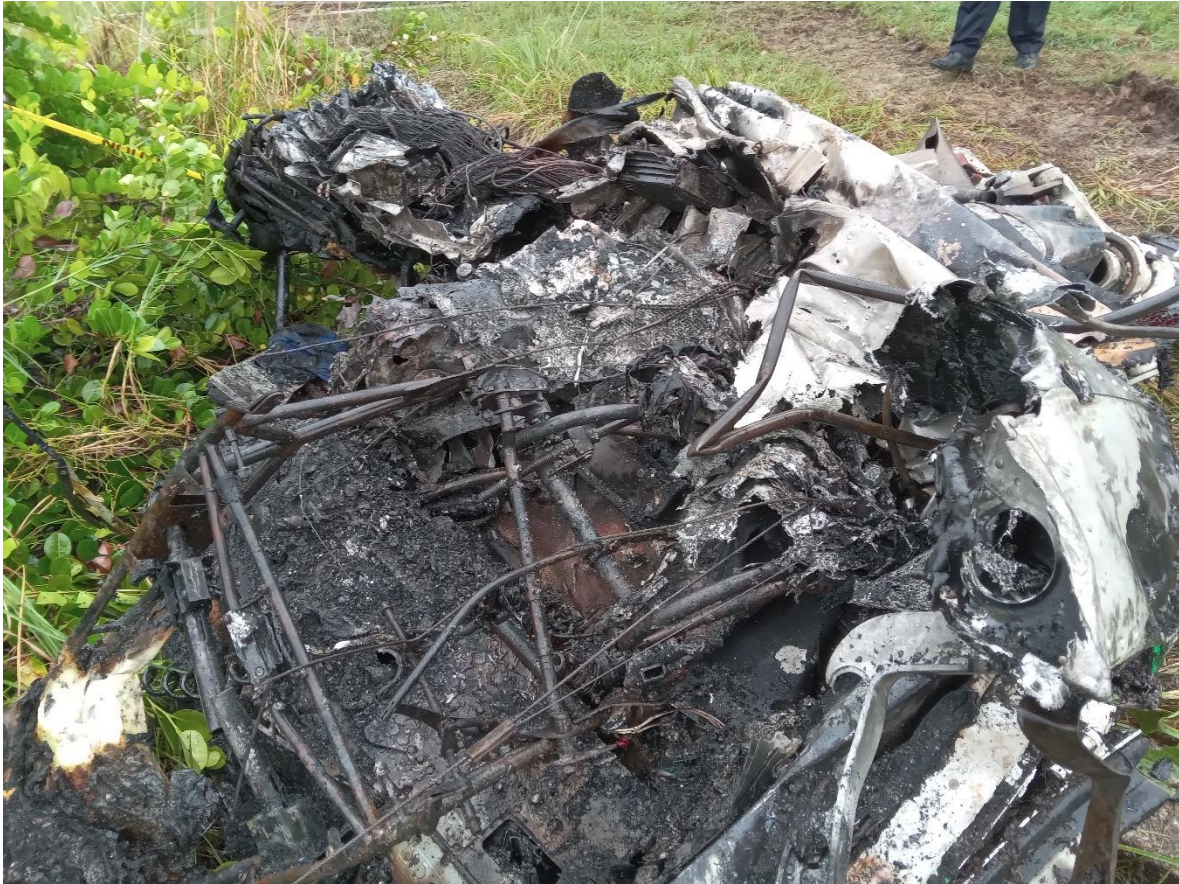
APPENDIX B

LOCAL AUTHORITIES AT ACCIDENT SITE AND WRECKAGE

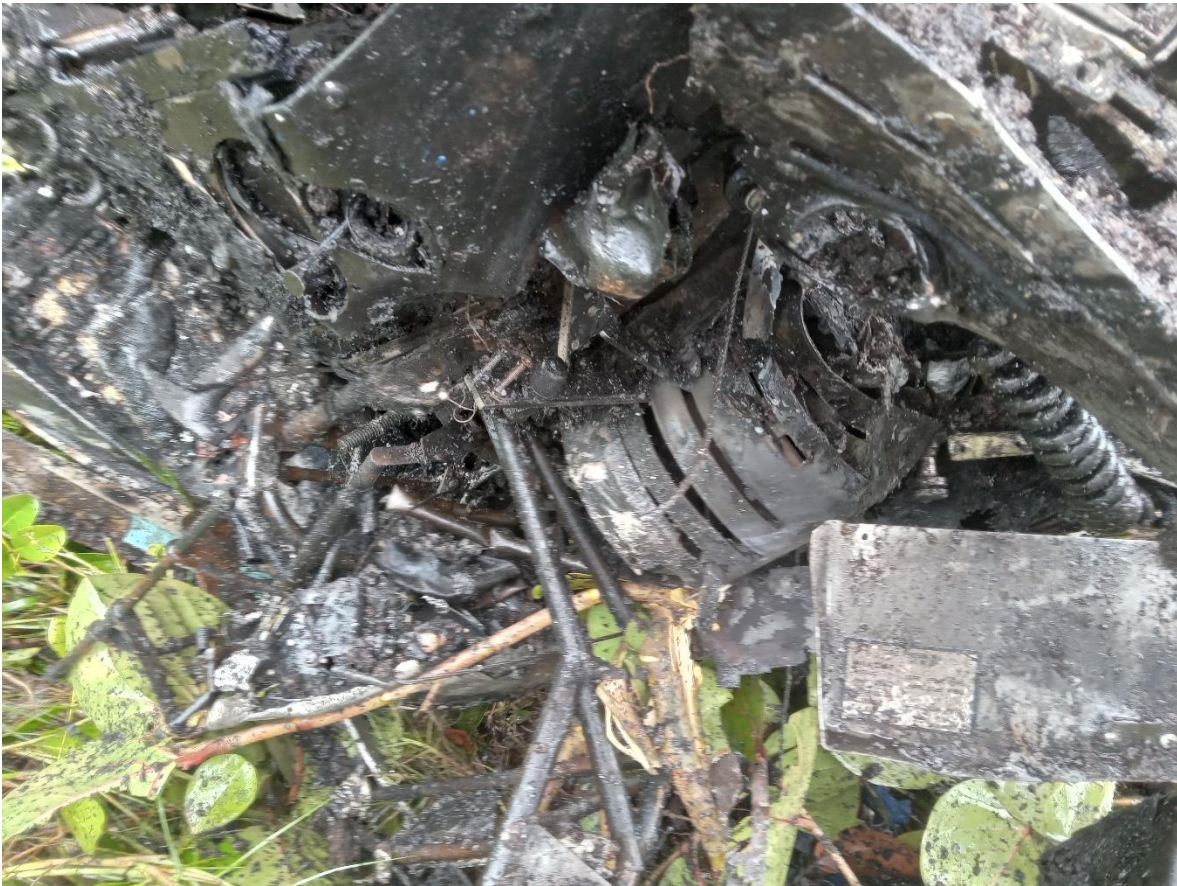
APPENDIX C

ENGINE AND COCKPIT
