# Fuel starvation and forced landing involving Piper PA-31-350, VH-HJE

11 km south of Archerfield Airport, Queensland, on 7 April 2023

**ATSB Transport Safety Report**

AO-2023-017

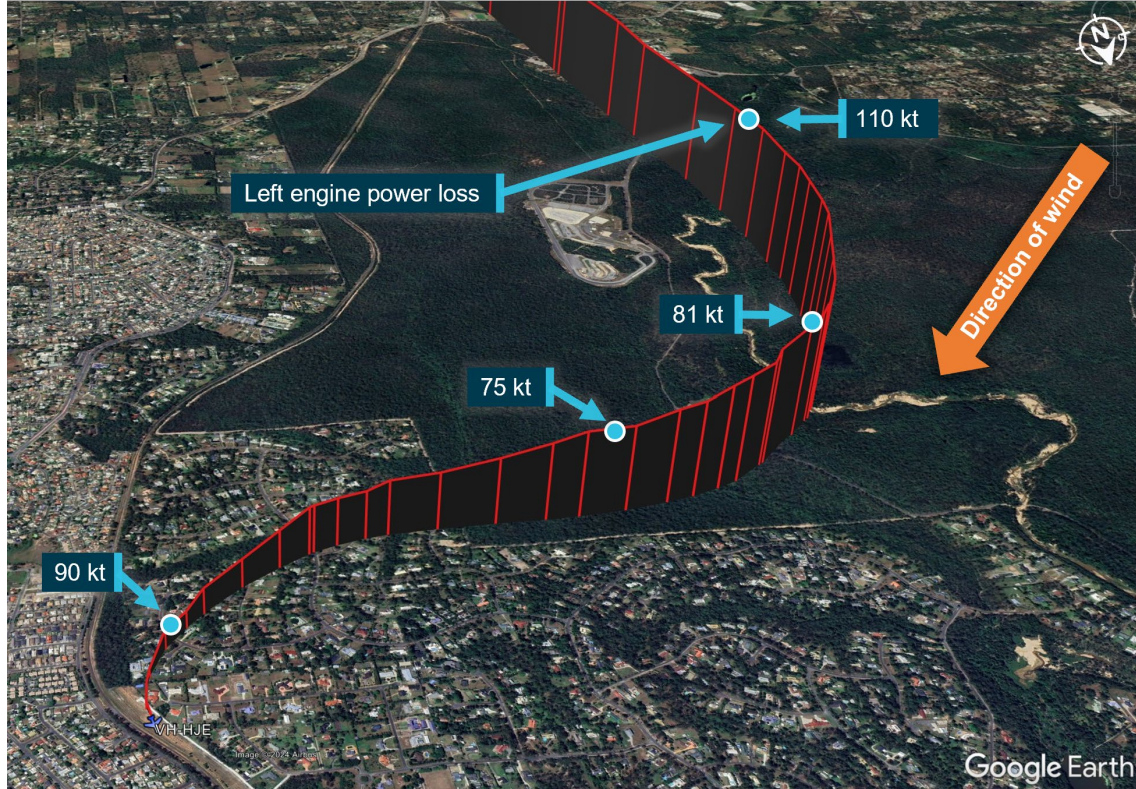
**Figure 1: Flight profile showing recorded groundspeed**

groundspeed fluctuated from 110 kt to a low of 75 kt. It was calculated that in the prevailing wind, this would have provided an approximate indicated airspeed of 71 kt; equal to the aircraft’s clean configuration stall speed.<sup>6</sup>

The pilot declared an emergency and advised ATC that they were unable to make Archerfield Airport and would be conducting an off-airport forced landing. With very limited suitable landing areas available (Figure 1), the pilot elected to leave the flaps and gear retracted to minimise drag to ensure they would be able to make the selected landing area.

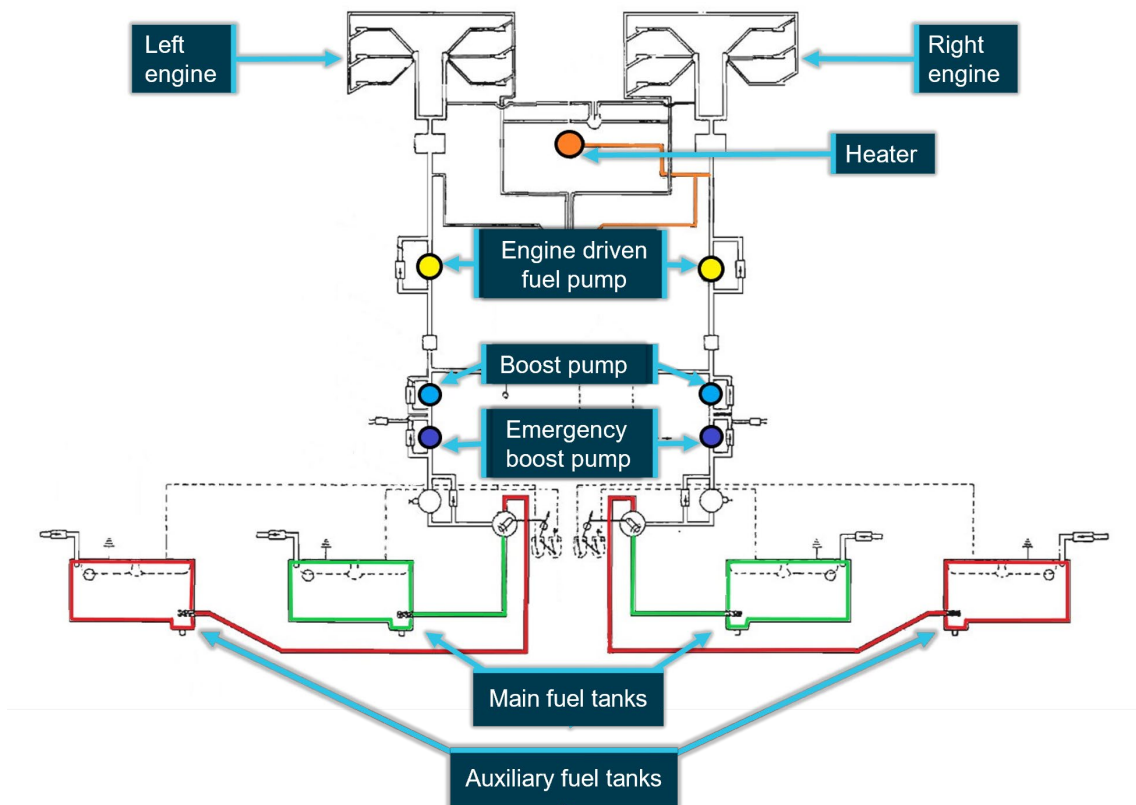
**Figure 3: PA-31-350 Fuel system schematic**

The fuel controls in the cockpit controlled the left and right fuel tanks' supply to their respective engines. Figure 3 shows the layout of the standard fuel system installed in the aircraft.

The pilot operating handbook contained operating instructions for the selection of tanks during various phases of flight. Due to the shape of the tanks and the location of the fuel outlet at the rear of the tanks, certain manoeuvres may cause the fuel to move away from the outlet increasing the likelihood of fuel flow interruption. To avoid this, the manufacturer published guidance around minimum quantities of fuel to be retained in each tank when manoeuvring. Further to this, inboard main tanks were required to be selected for take-off, climb and descent, with the auxiliary tanks only to be used during level co-ordinated flight in cruise. The operator adhered to the manufacturer's guidance with the checklist in Figure 4 serving as a prompt to the pilot to ensure the inboard tanks were selected for descent.

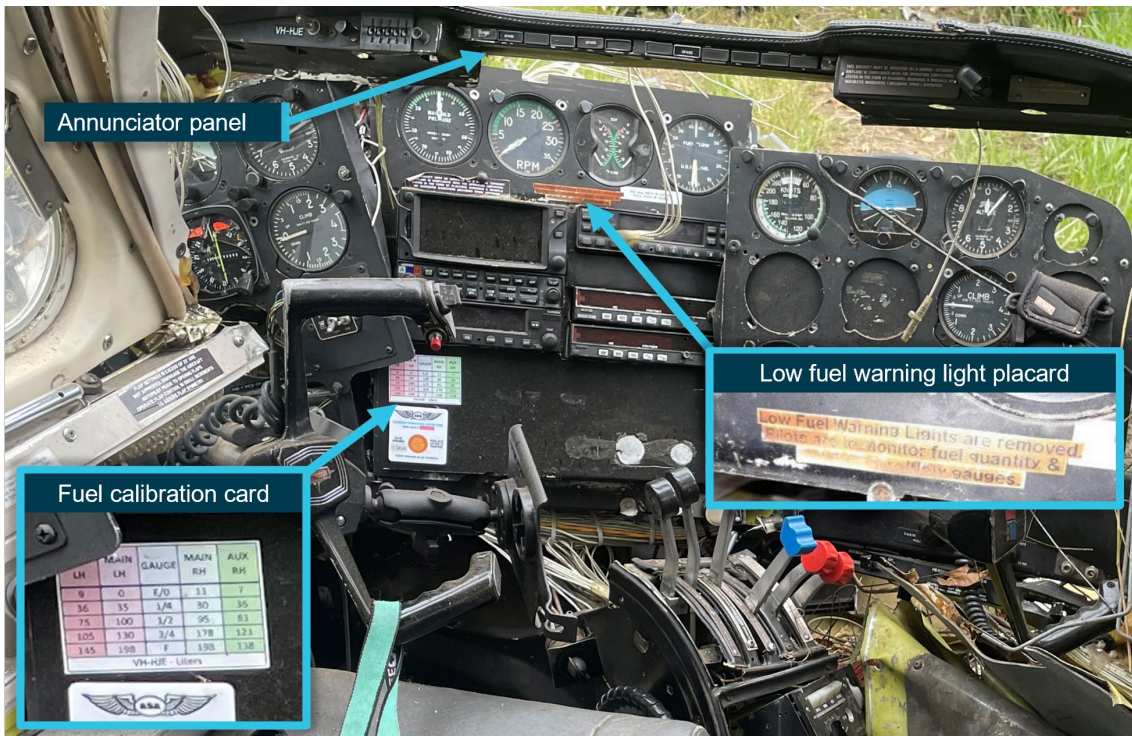
Figure 5: Cockpit

At the time of the accident, the warning system had not been reinstalled and a worn placard was installed in the aircraft (Figure 5).

Image shows the low fuel warning light placard below the engine instruments, the annunciator panel that houses the light it refers to and the fuel calibration card on the instrument panel.  
Source: Operator, annotated by the ATSB

The ATSB noted that the low fuel warning light system had been removed from the aircraft. This system is essentially a low fuel quantity indication for each main tank and would not have provided a warning for low fuel flow from the auxiliary tanks. Given the substantial quantity of fuel found in the main tanks, the absence of this system was not a factor in this occurrence.
