Fuel starvation and forced landing involving Pilatus Britten-Norman Islander BN2A, registration VH-WQA

Moa Island, Queensland on 3 October 2022

ATSB Transport Safety Report

AO-2022-046

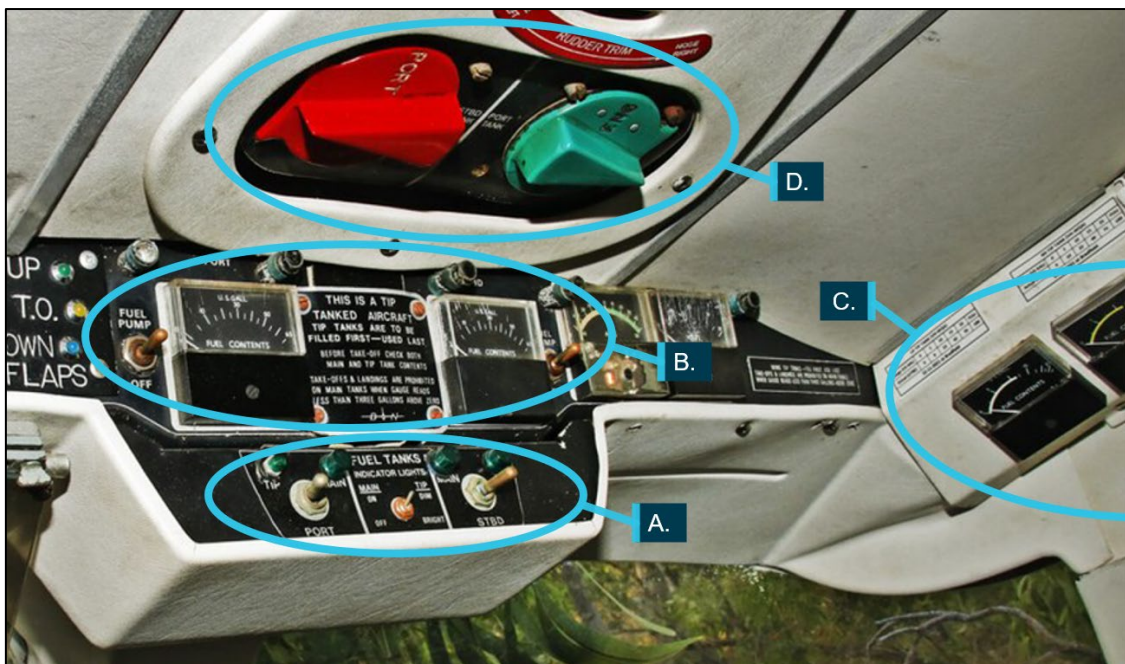
Figure 4: VH-WQA cockpit fuel system configuration

The electrically-actuated tank cocks were controlled via an overhead panel, located above the windscreen central pillar. The panel consisted of port and starboard switches that selected either the wing tip tank or main tank. There was a corresponding indicator light for each selection. The panel also contained a switch that controlled the brightness of the tip tank indicator light when that tank was selected (dim or bright). The same switch also determined the main tank indicator light when that tank was selected, either on or off (for the tip tank light positions of dim or bright, respectively) (Figure 4, Label A).

The main tank contents indicators were located above the fuel tank section panel, with corresponding auxiliary fuel pump switches located either side (Label B). The wing tip tank contents indicators were located on the right side of the cockpit above the side window (Label C). The main fuel cock rotary selectors were located above the main tank contents indicators (Label D).

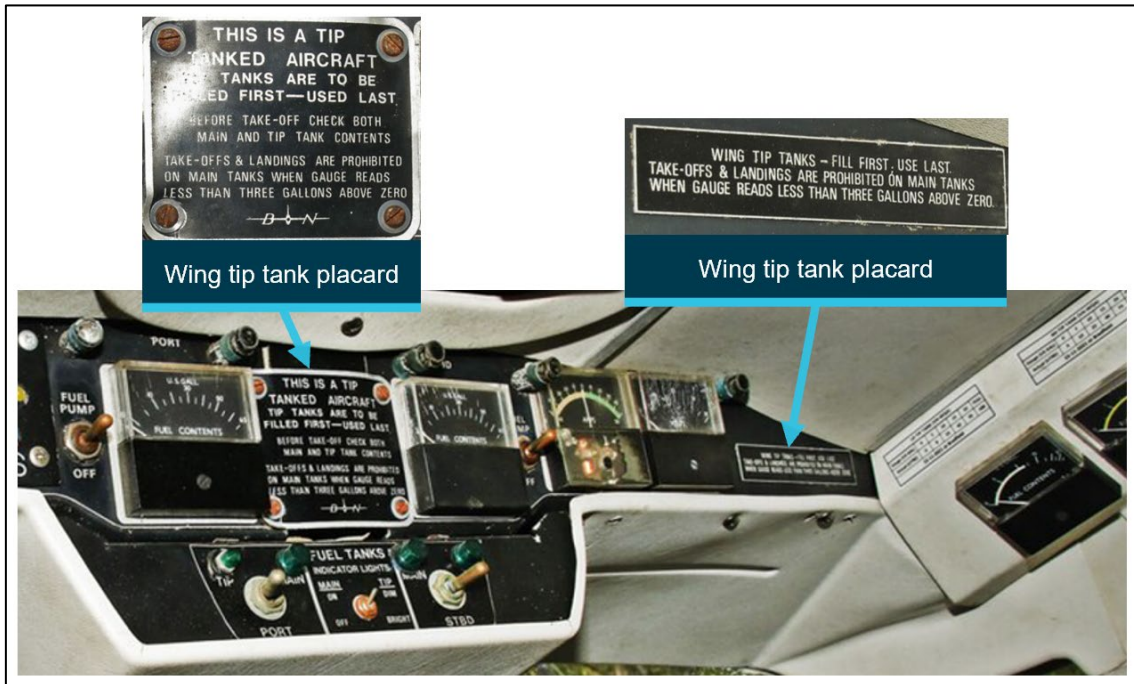
Figure 5: VH-WQA fuel system placards

Fuel system placards,⁴ highlighting the configuration and usage of the fuel tanks, were located between the main fuel contents indicators and to the left of the wing tip tank contents indicators (Figure 5). The placards indicated that wing tip tanks were to be used last (after main tanks), and that main tanks were not to be used for landings when the gauge reads less than 3 gallons.

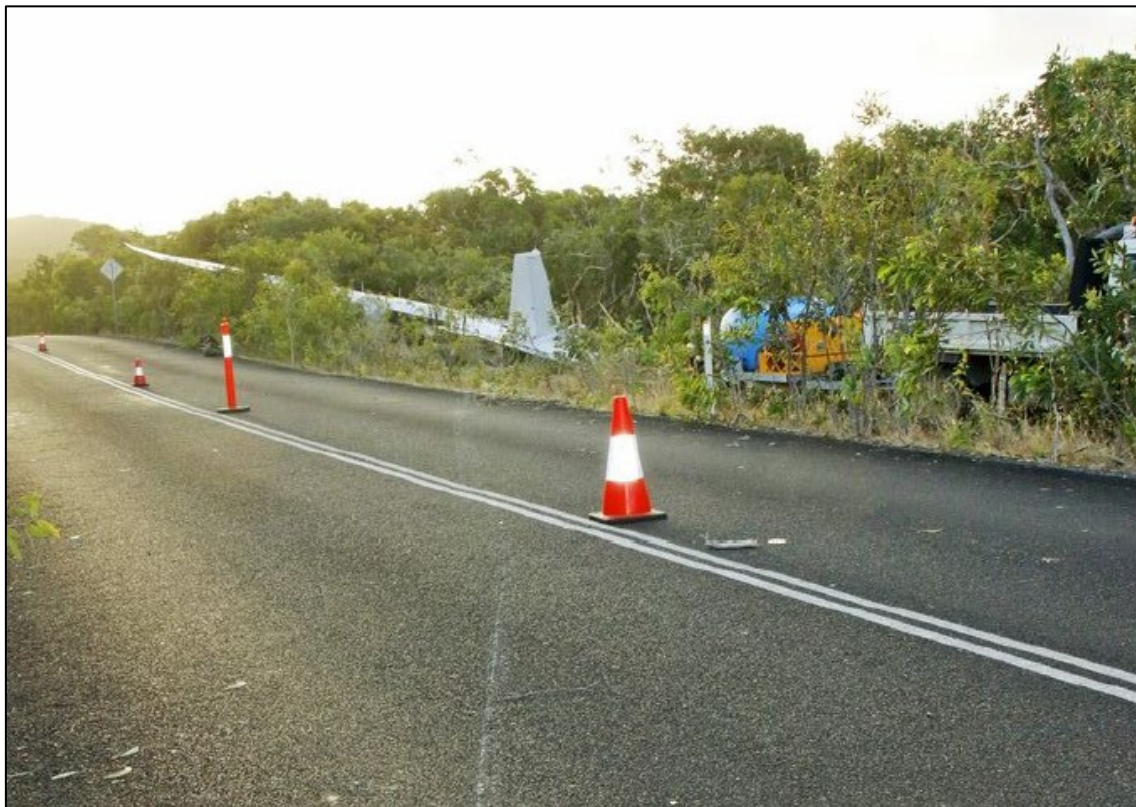
Figure 6: Accident site from road

The wreckage was located a short distance from the road in an area of low foliage approximately 6.5 km ENE of Kubin Airport. The undercarriage and empennage were separated from the aircraft and the fuselage was resting right wing low (Figure 6 and Figure 7). No obvious airframe or engine defects were reported by those that attended the site.

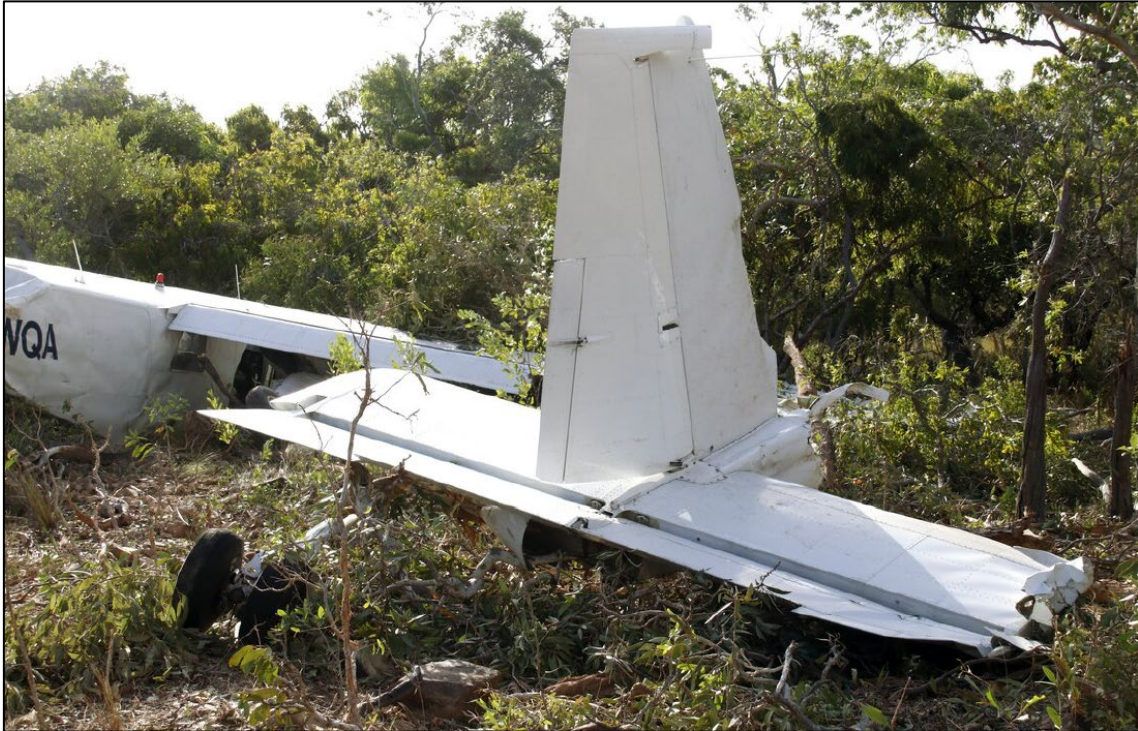
Figure 7: Accident site

The right main tank and wing tip tank were ruptured during the accident sequence. The left main fuel tank and wing tip tank were reported as being intact and found to contain approximately 60 l, and less than 500 ml of fuel respectively. No fuel contamination was apparent and the fuel selectors were found to work correctly when electrical power was applied to the aircraft. Table 1 depicts the positions of the fuel controls as documented in forensic photographs taken shortly after the accident. The wing tip tanks were selected for use, the auxiliary pumps were on and the main fuel cocks were selected 'off', which was consistent with the pilot's recollection of the occurrence.
