**Final Investigation Report**  
**on**  
**Accident to M/S Pinnacle Air Pvt. Ltd,**  
**P-68 Observer 2 Aircraft, VT-TAA**  
**on 27 March 2021**

**Amit Kumar**  
**Investigator-in-charge**

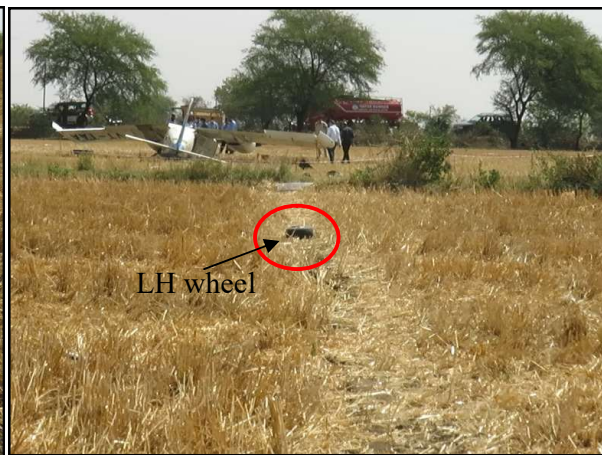
**Fig 5: Dislodged wheel on field**

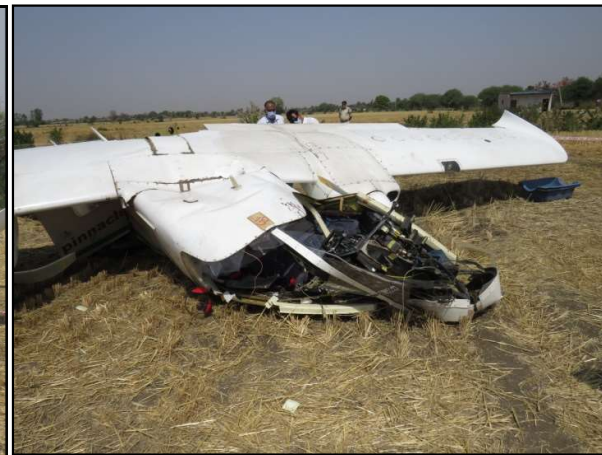
**Fig 7: Front View of Badly Damaged Aircraft**

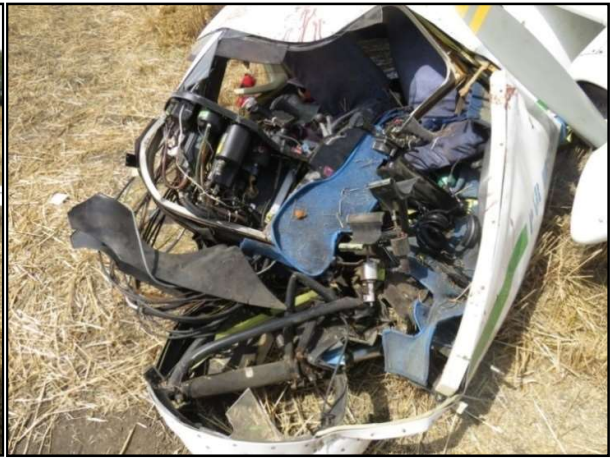
**Fig 9: Front View of Badly Damaged Cockpit**

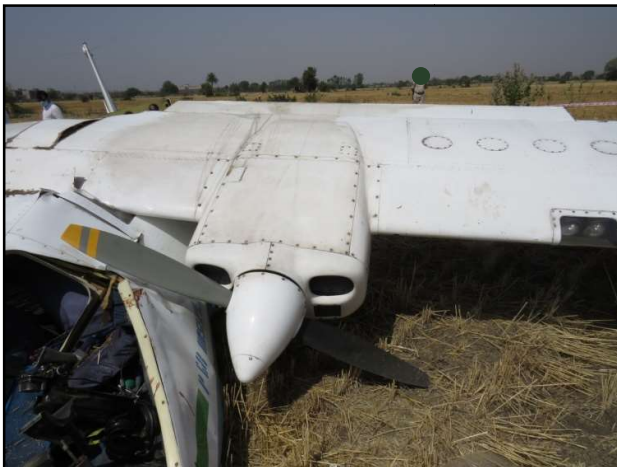
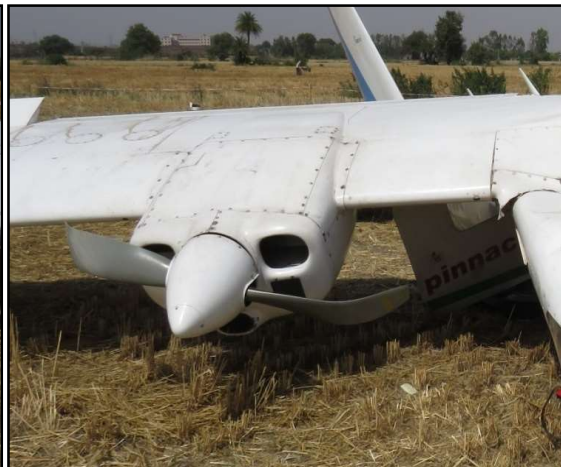
**Fig 12: Left Engine Propeller**

**Fig 13: Right Engine Propeller**

The left engine propeller (Fig 12) is not having any damages indicating engine was shut down at the time of impact. The right engine propeller was found bent rearwards, indicating engine was on power at the time of impact.

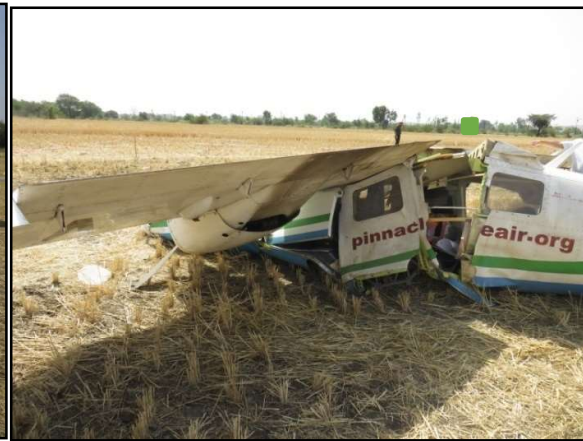
Fig15:View of separated Fuselage

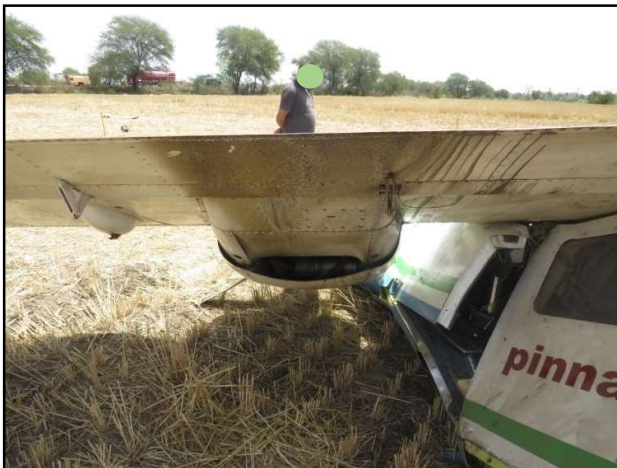
Fig18:View of Left Engine & Left Flap in Up

There were signs of oil splash over the left wing and left fuselage (Refer Fig 18), indicating oil leak from the left engine which resulted in drop in oil pressure and sudden rise in oil temperature. Due to the low oil pressure and reduced oil supply to the propeller governor, the blade angles have come to feathered angle and the aircraft started losing height. The left engine was shut down by the pilots and they attempted returning back to base.

- i. There was a massive oil leak during flight as oil splash signs were available on LH engine and LH wing (Fig 18 refers).
- ii. The oil gauge tube was found to be secured and wire locked with the engine body, however, the oil tube could be rotated by approximately 45° with the wire lock intact. After removing the wire lock, the oil gauge tube could be rotated one full turn in order to positively secure it with the body. The gap created between the oil gage tube and the body due to the improper wire locking of the assembly could be a possible source of leak. However, it is very unlikely that this could generate the quantum of oil splashes that were observed on the left Wing.

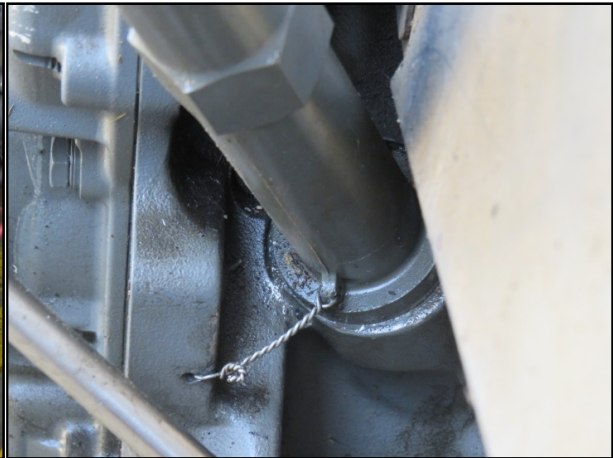
**Fig 21: Oil Splash around Oil Gauge Tube**

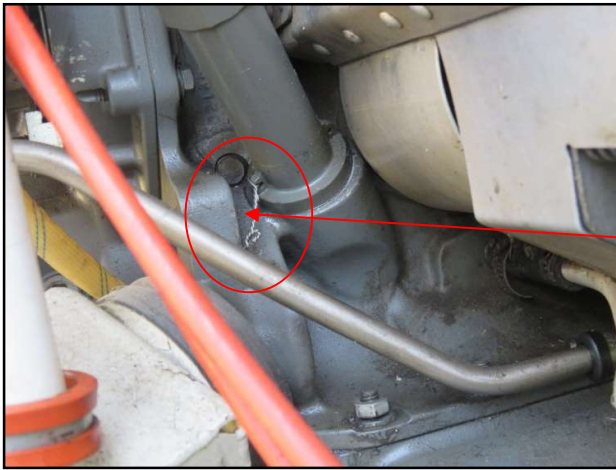
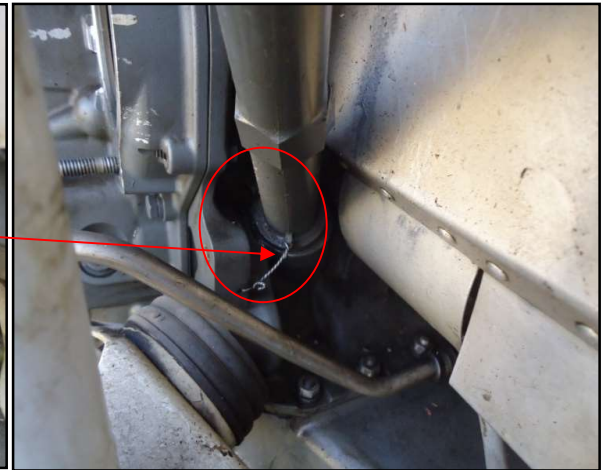
**Fig 22: Oil Filler tube wire lock position**

**Fig 23: Shift in Oil Filler tube wire lock position**

- iii. The broken bearing pieces got accumulated in oil sump and blocked the oil suction screen in the oil sump clogging the lubrication system.
- iv. The only evidence that indicates the source of oil leak on the engine is the loose assembly of oil filler tube.

- v. However, it is highly improbable that the gap created by the loose assembly of the oil filler tube could cause such kind of massive oil leak resulting in engine seizure or bearing failure.

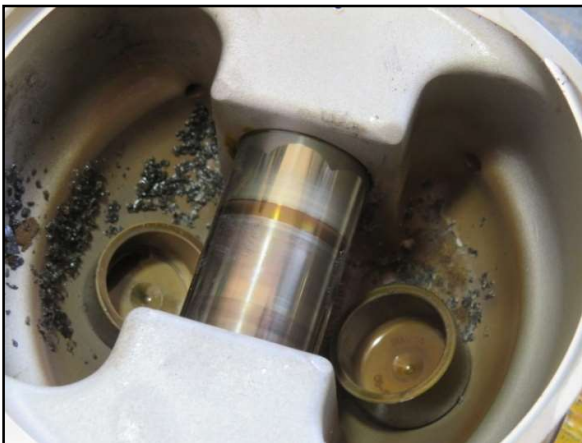
**Fig 24: Metal Particles inside no 4 Piston**

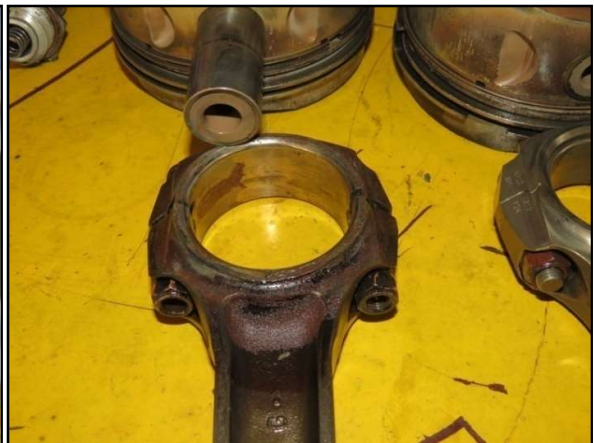
**Fig 25: No 4 Piston Connecting rod without Bearing**

- v. On further dismantling, the no. 4 piston connecting rod bearing was found missing. The oil pump was dismantled, and deep marks were found on the internal body.

- vii. Though the exact source of oil leak could not be established conclusively, the oil leak lead to lubrication starvation resulting in the failure of no. 4 piston link rod bearing. The broken metal pieces of no 4 link rod bearing clogging the oil suction screen in the oil sump is an after effect of the oil leak.

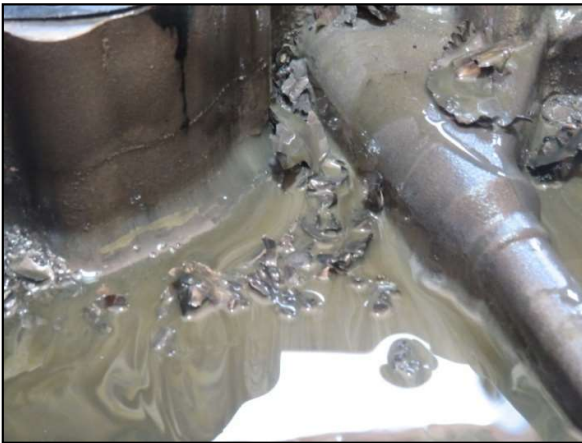
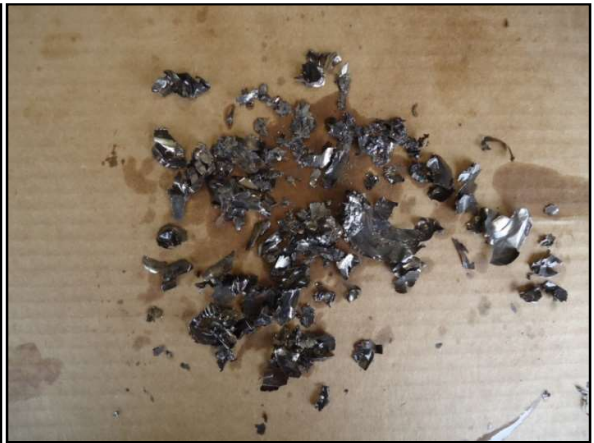
**Fig 26: Broken metal pieces in Oil Sump**

**Fig 27: Metal pieces collected from Oil Sump**

- iv. During the strip examination broken metal chips/pieces were found in the LH engine oil sump and the oil suction screen was found filled with metal chips/pieces.

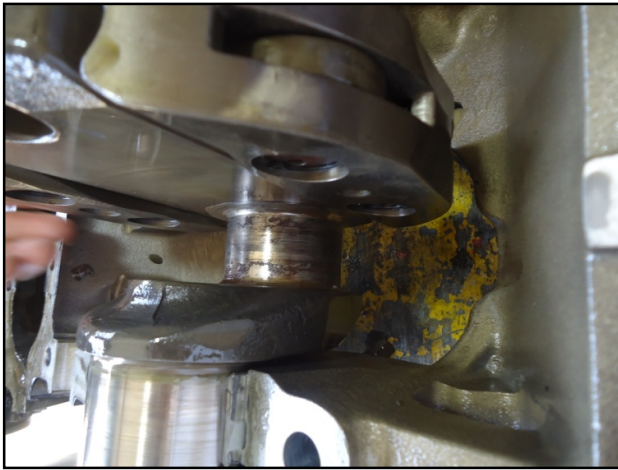
**Fig 28: Abrasion marks on No 4 Crank Shaft**

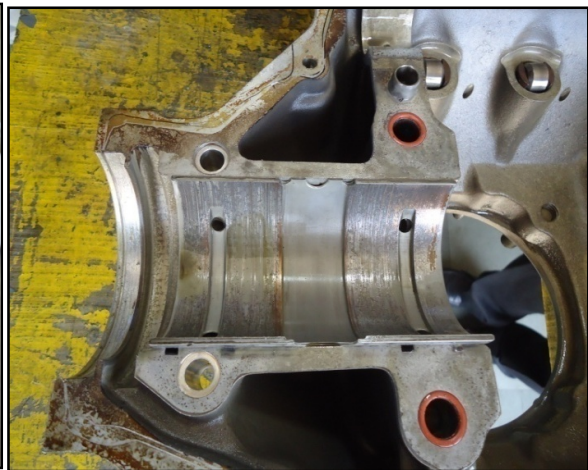
**Fig 29: Scoring marks on Main bearing**

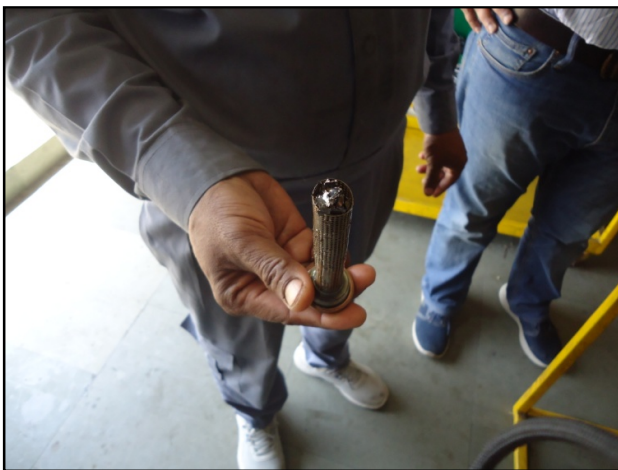
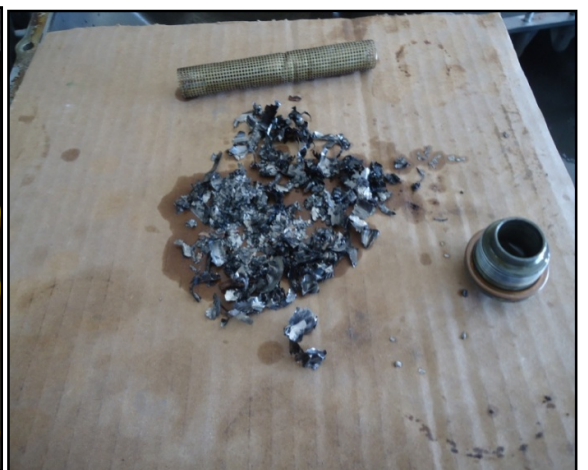
**Fig 30: Suction Screen filled with Metal pieces**

**Fig 31: Suction Screen & Metal pieces**

- vii. Technically, bearing failure is an after effect of lack of lubrication on the bearing. Once the bearing was broken, it would circulate with the oil in the lubrication circuit till the suction screen and get accumulated near the suction screen. This would further create lubrication starvation on the frictional parts.
