LIMITED OCCURRENCE INVESTIGATION REPORT – FINAL

Reference Number	CA18/2/310449						
Classification	Accident	Date	6 May 2024			Time	0910Z
Type of Operation	Private (Part 91)						
Location							
Place of Departure	Crocodile's Nest Private Aerodrome, Thabazimbi, Limpopo Province			Place of Intended Landing	Deza Private Aerodrome, Thabazimbi, Limpopo Province		
Place of Occurrence	Deza Private Aerodrome, Thabazimbi, Limpopo Province						
GPS Co-ordinates	Latitude	24°15'45.57" S	Longitude	027°4'39.05" E	Elevation	3 090ft	
Aircraft Information							
Registration	ZS-MBH						
Make; Model; S/N	Cessna 402B (Serial Number: 402B-0381)						
Damage to Aircraft	Substantial			Total Aircraft Hours	9 125.5		
Pilot-in-command							
Licence Type	Commercial Pilot Licence (CPL)		Gender	Male		Age	33
Licence Valid	Yes	Total Hours	499.3		Total Hours on Type	172.1	
Total Hours 30 Days	37.5		Total Flying on Type Past 90 Days	90.6			
People On-board	1+6	Injuries	0	Fatalities	0	Other (on ground)	0

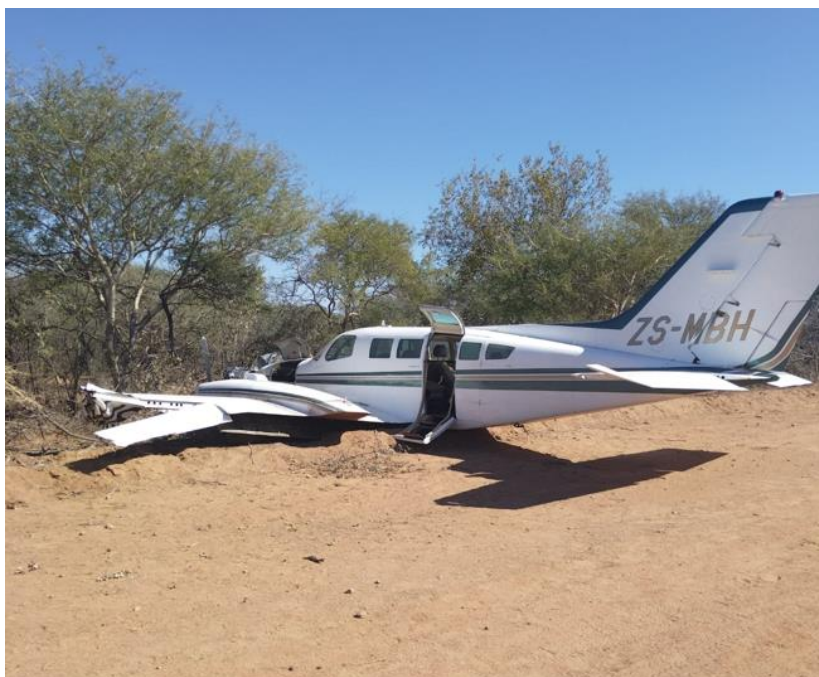
Figure 1: The aircraft after it had stopped. (Source: Pilot)

Loss of directional control during the landing roll which resulted in the left wheel rolling on the soft sand; the aircraft veered off to the left of the runway before the left-wing tip tank and the nose section impacted the trees.

Safety message: Pilots who intend to land on dirt runways are urged to conduct a safety risk analysis as well as thoroughly inspect the area before committing to land.

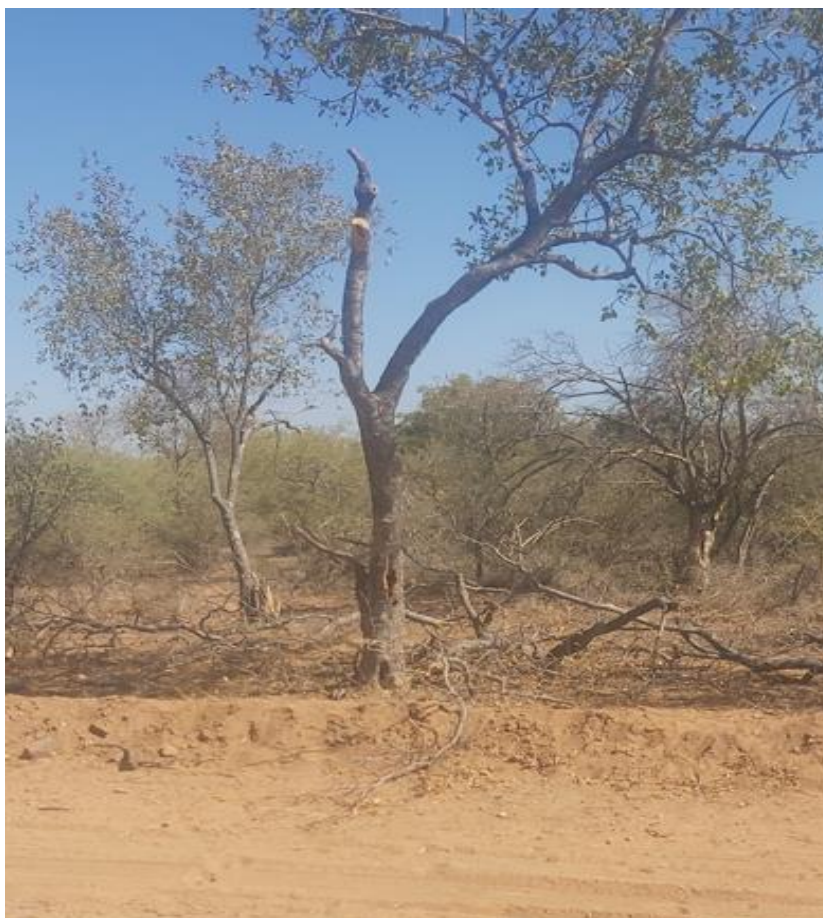
According to the Pilot's Operating Handbook (POH), the wingspan for this aircraft type is 12m. The pilot mentioned in the questionnaire that he misjudged the distance between the trees and the tip tank.

Figure 2: The first tree that the aircraft impacted.

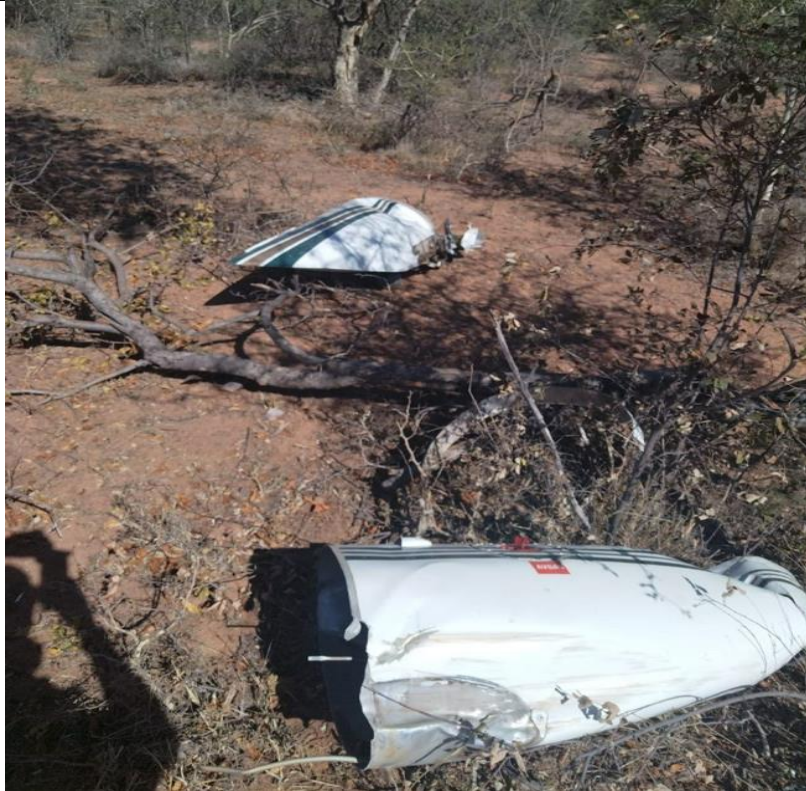
Figure 3: The left-wing tip tank. (Source: Pilot)

- Loss of situational awareness.
- Misjudging the distance between the left-wing tip and the tree.
