<b>Aircraft Type</b>	<b>Fokker 50</b>
<b>Aircraft Registration</b>	<b>5Y-MHT</b>
<b>Aircraft Serial Number</b>	<b>20171</b>
<b>Operator</b>	<b>Silverstone Air Services</b>
<b>Name of Owner</b>	<b>Silverstone Air Services</b>
<b>Number/Type of Engines</b>	<b>Twin engine, PW125B</b>
<b>Year of Manufacture</b>	<b>23/11/1989</b>
<b>Date and Time (UTC)</b>	<b>19/09/2020, 04:55Z</b>
<b>Location</b>	<b>Aden Abdulle International Airport</b>
<b>Type of Flight</b>	<b>Cargo</b>
<b>Flight Phase</b>	<b>Landing</b>
<b>Departure Airport</b>	<b>Mogadishu</b>
<b>Destination Airport</b>	<b>Beletweyn</b>
<b>Persons on Board</b>	<b>Four Crew (Captain, Co-pilot, One Engineer and One Loadmaster)</b>
<b>Injuries</b>	<b>2 Serious Injuries and 2 Minor Injuries</b>
<b>Damage to Aircraft</b>	<b>Aircraft completely destroyed</b>
<b>Pilot's License</b>	<b>YK-3994-AL / YK-8073-CL</b>
<b>Pilot's Age</b>	<b>42 Years / 26 Years</b>
<b>Pilot's Total Flying Experience</b>	<b>12000 Hours / 2249 Hours</b>

A Fokker 50 aircraft operated by Silverstone crash landed at Aden Abdulle International Airport (HCMM) in Mogadishu, Federal Republic of Somalia on 19/09/2020 at 04:55Z.

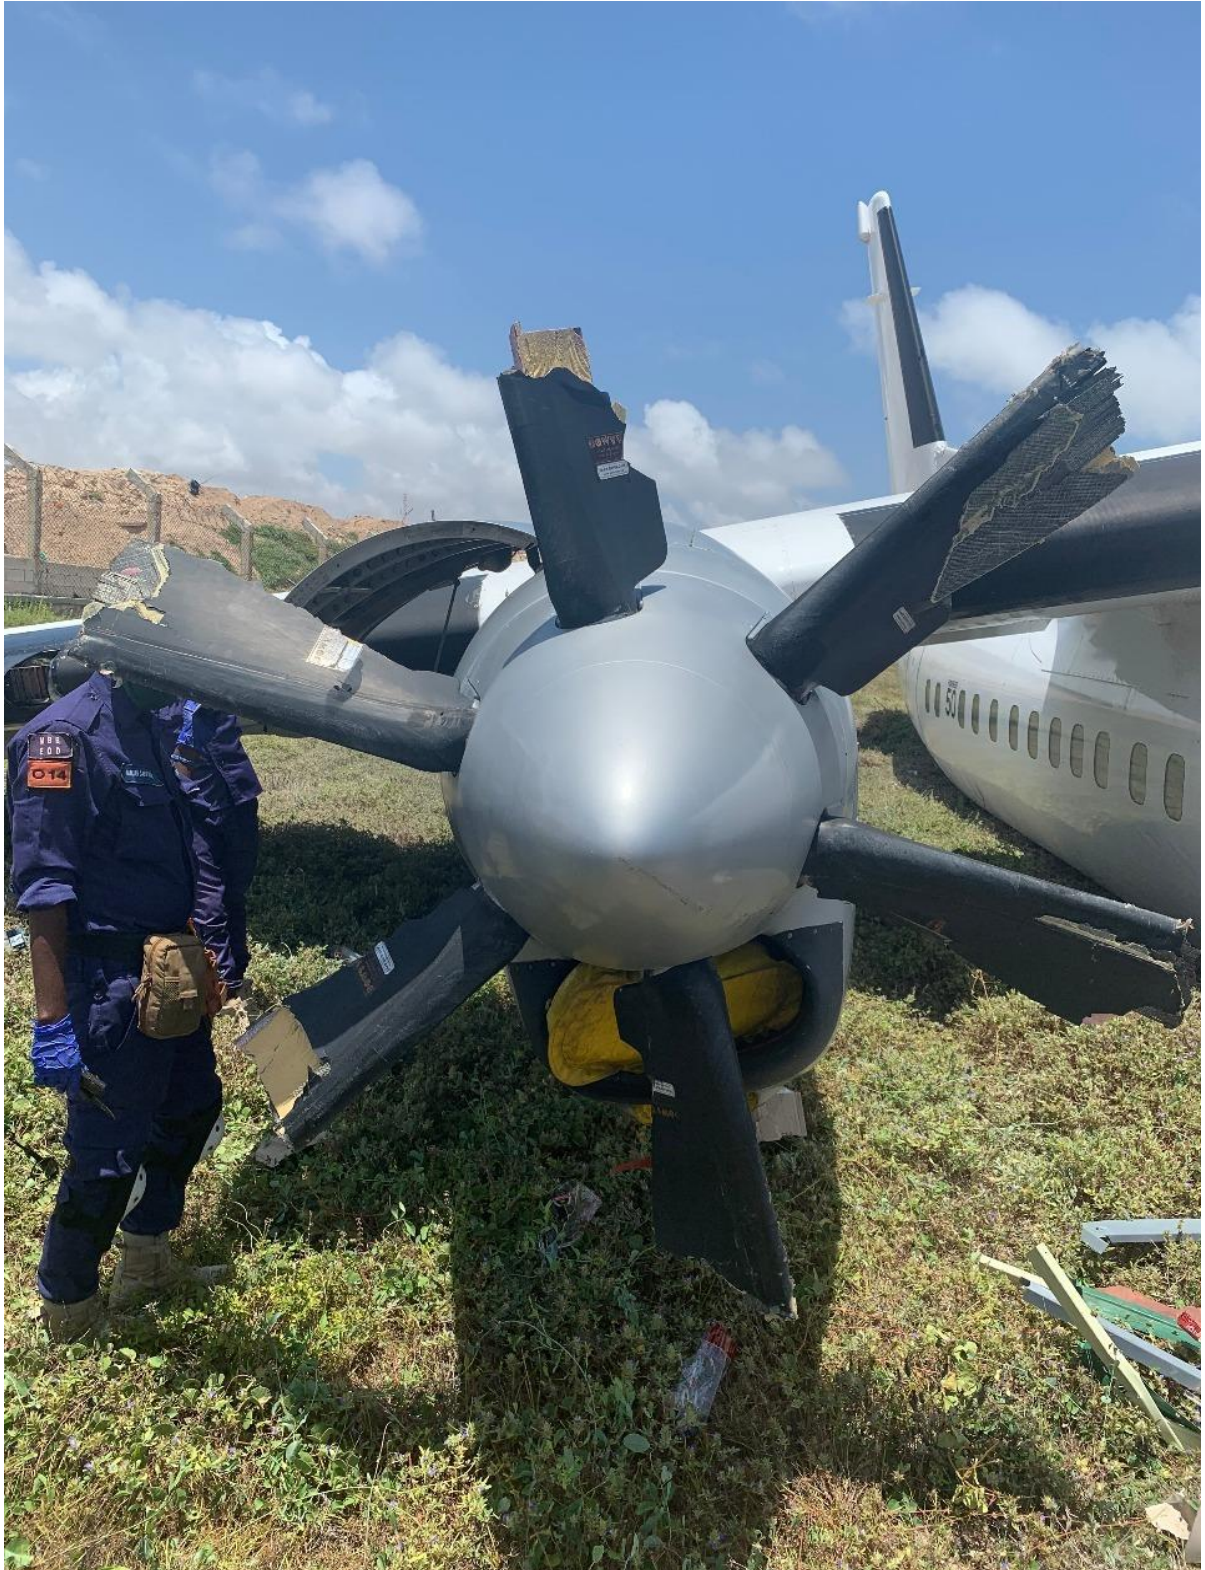
Figure 1: Propeller damage (It is evident that propeller was running which implies the engine was still functioning)

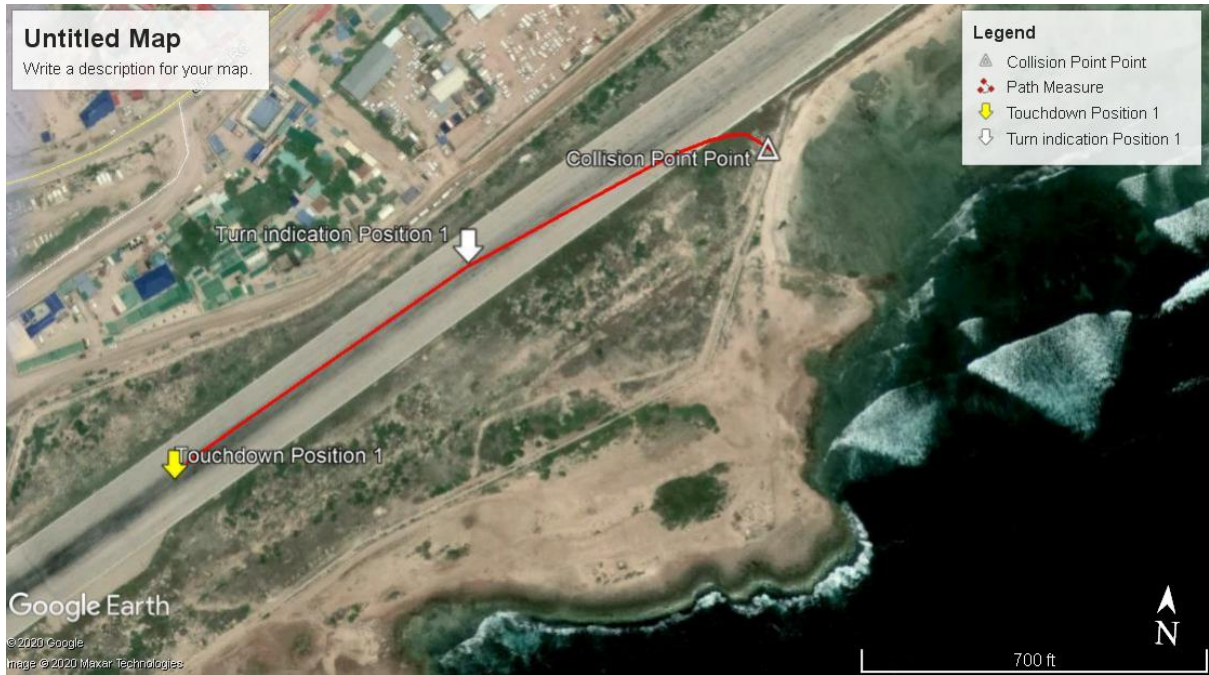
Figure 2: Image of marks made by tires of landing gear

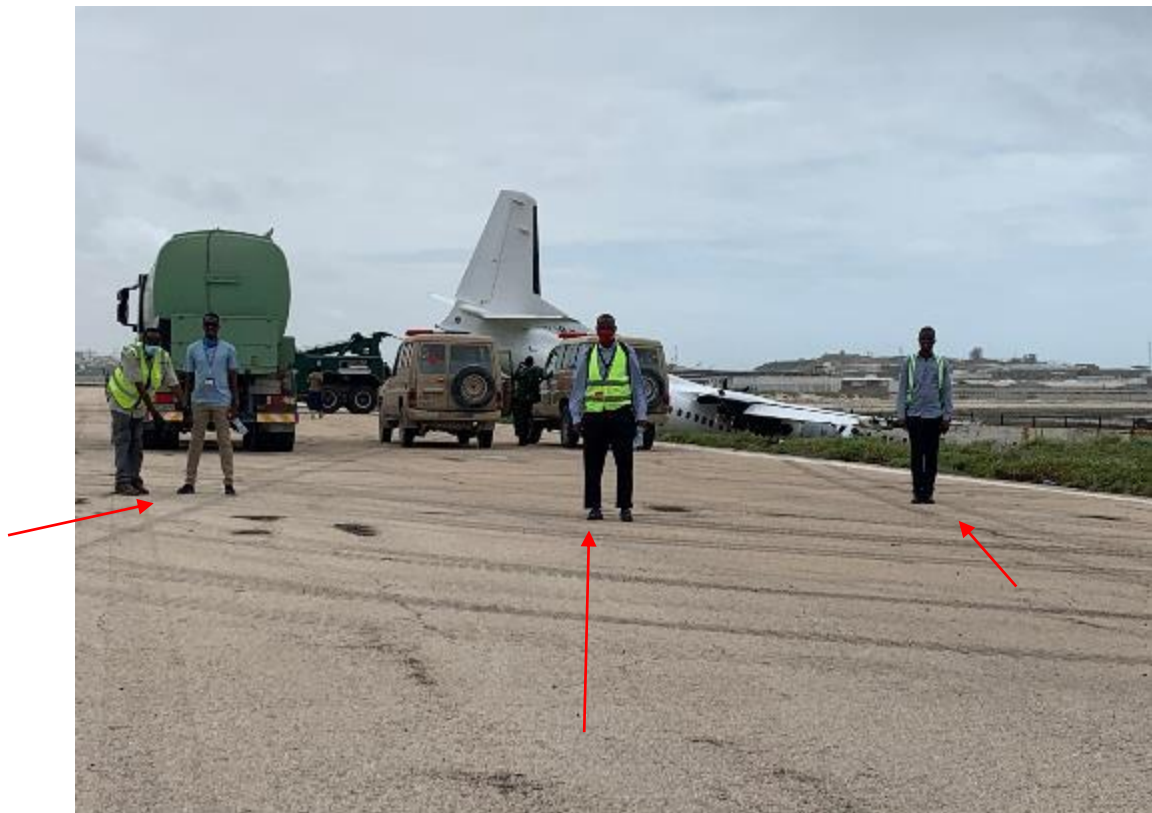
Figure 3: Images of marks made by tires of undercarriage

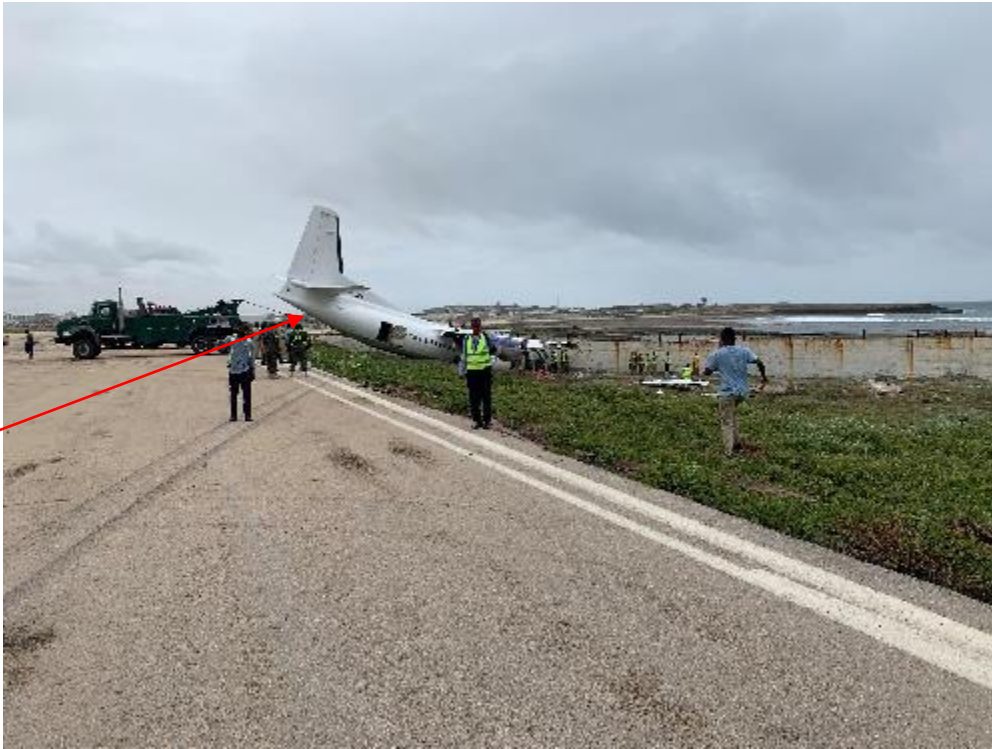
The pilot landed to runway 05 and lost control, veered off on the right and crashed into the airport perimeter wall. The team noticed that the aircraft nose impacted on the perimeter wall. Emergency services, fire fighters from UNSOS, Police, AMISOM, AAIB, Bancroft and SCAA attended the scene. The emergency services saved the crew which was stuck in the cockpit.

Figure 4: Aircraft veered off on the right and impacted to the perimeter wall

- Fire brigade must be equipped with required removal equipment.
- Airport must be licensed.
- It is a requirement to maintain international safety standards.
- The airport perimeter concrete wall must be eliminated immediately.
- All aircraft are required to be inspected.
- Proper rescue equipment is required
- SOPs, training and rehearsals must be implemented.
- Securing the crash side (cordon) is a necessary.
