FINAL INVESTIGATION REPORT

SERIOUS INCIDENT OF PAKISTAN INTERNATIONAL AIRLINES FLIGHT PIA 605, ATR 42-500 AIRCRAFT, REGISTRATION NO. AP-BHP AT GILGIT AIRPORT ON 20TH JULY, 2019

Dated: 04th July, 2024

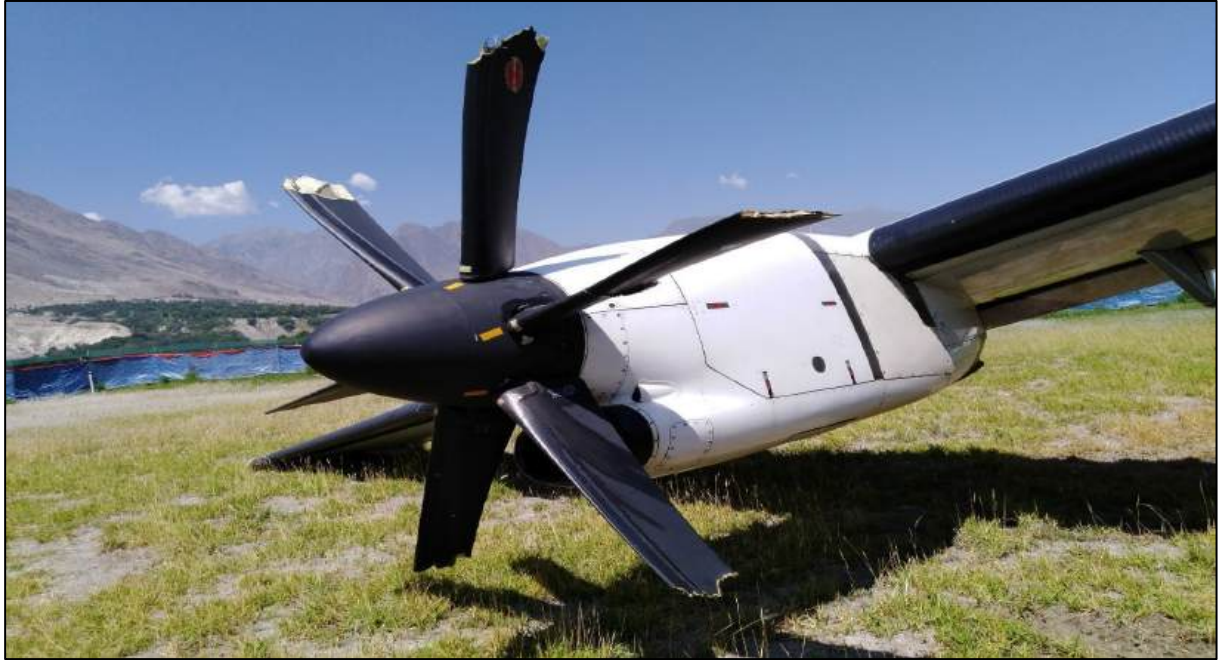
1.3.1 Both engines were running at the time of impact, and the right engine propeller blades struck the ground, causing all the propeller blades to break at approximately one third position from the propeller hub.

Figure 1 Broken Propellor Blades of Right Engine

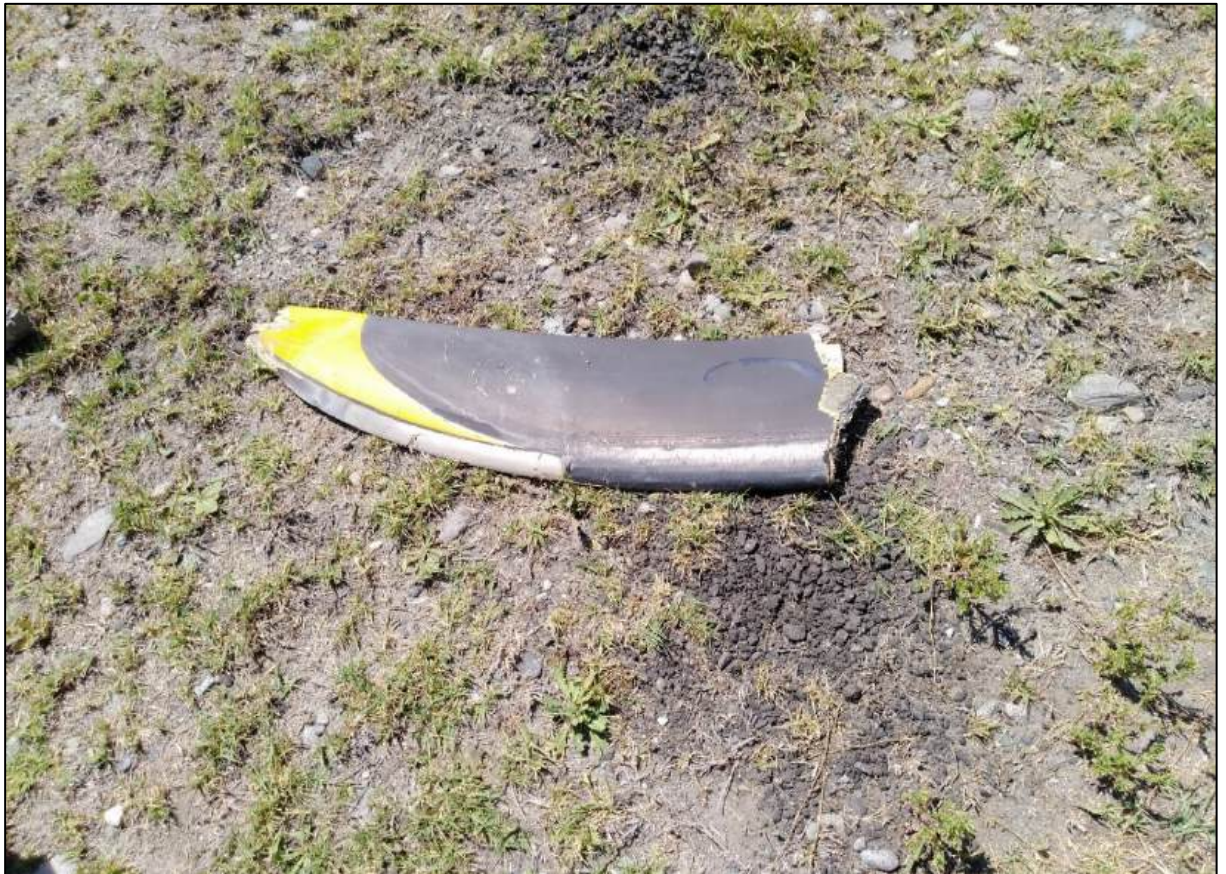
Figure 2 Broken Propellor Blade

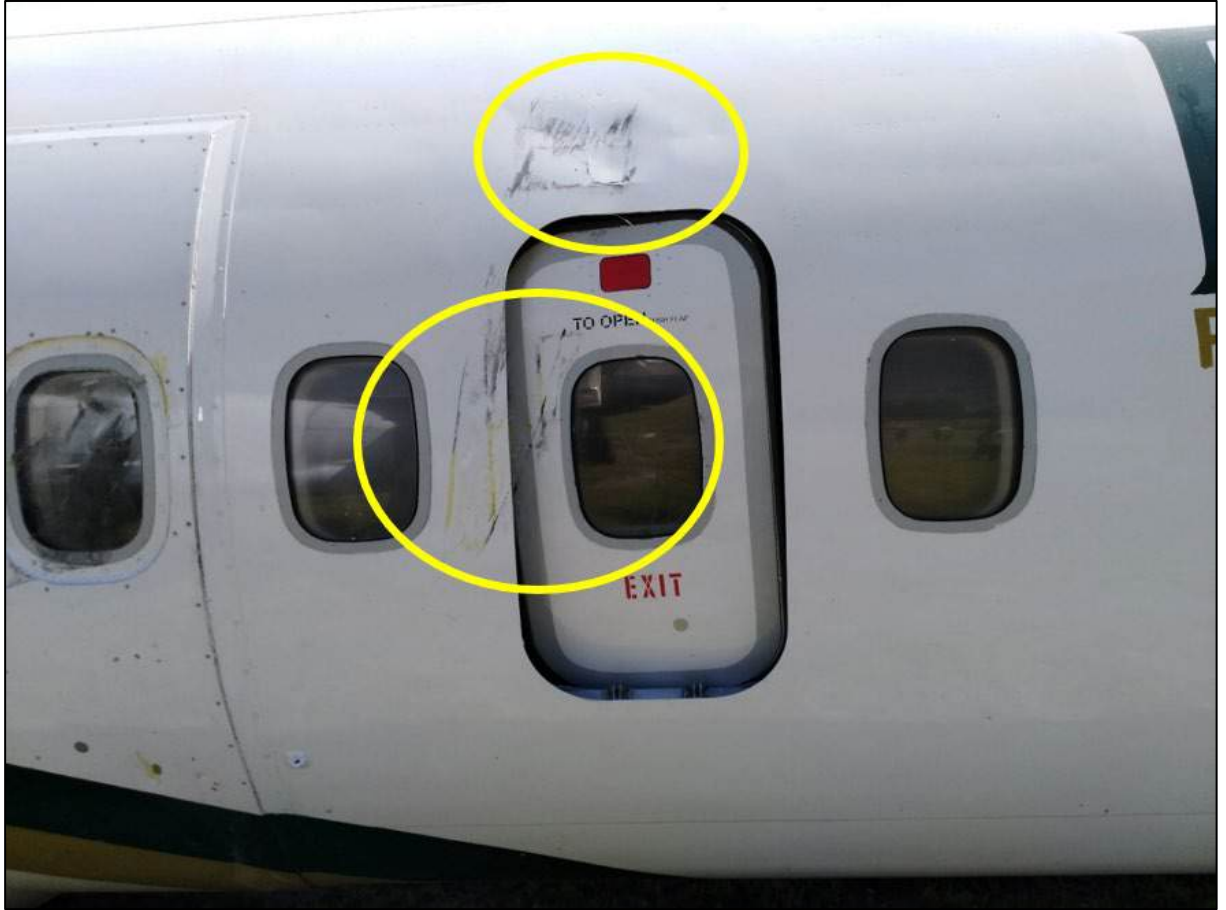
1.3.2. Impact marks on fuselage above emergency door from broken propeller blades' strike.

Figure 3 Impact Marks on Fuselage

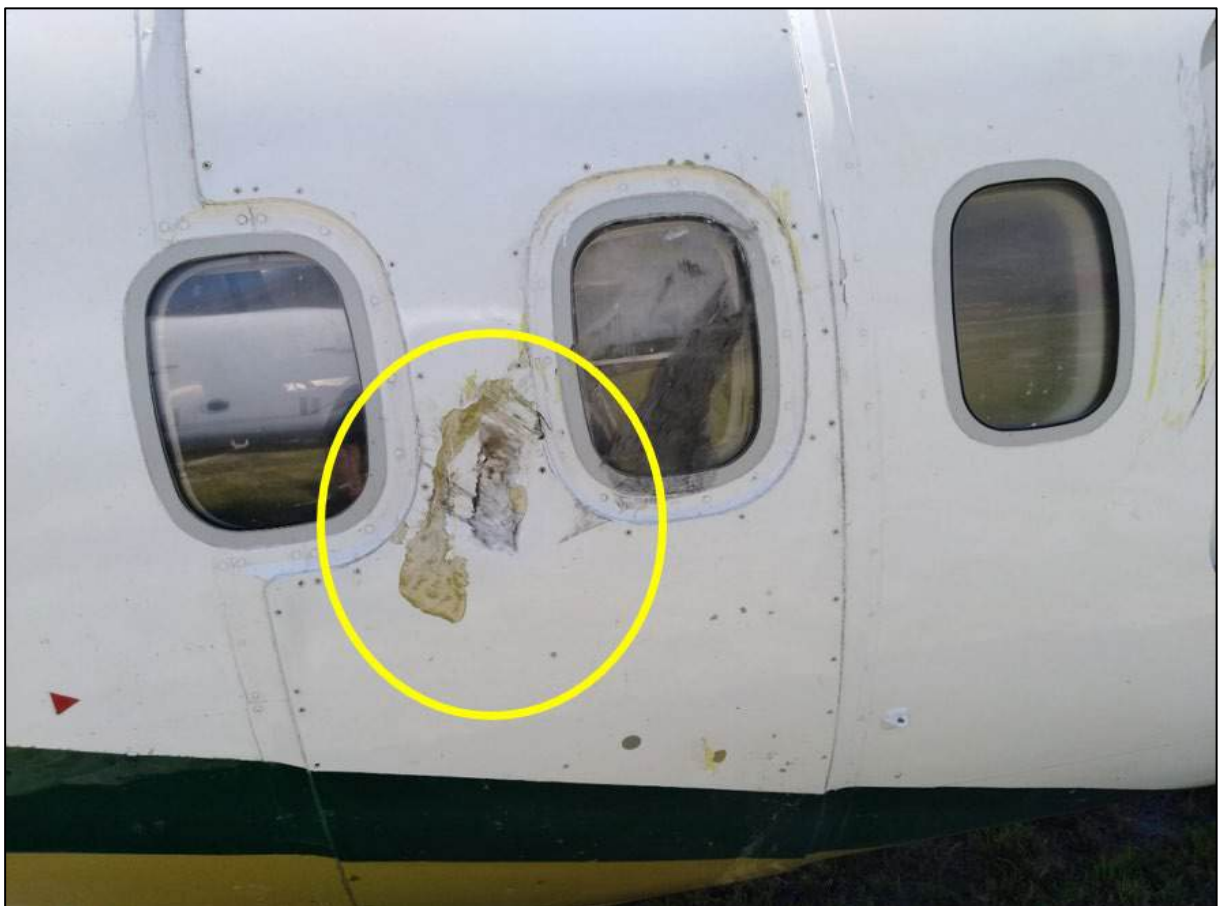
1.3.3. Impact marks on fuselage between windows 4 & 5.

Figure 4 Impact Marks on Fuselage

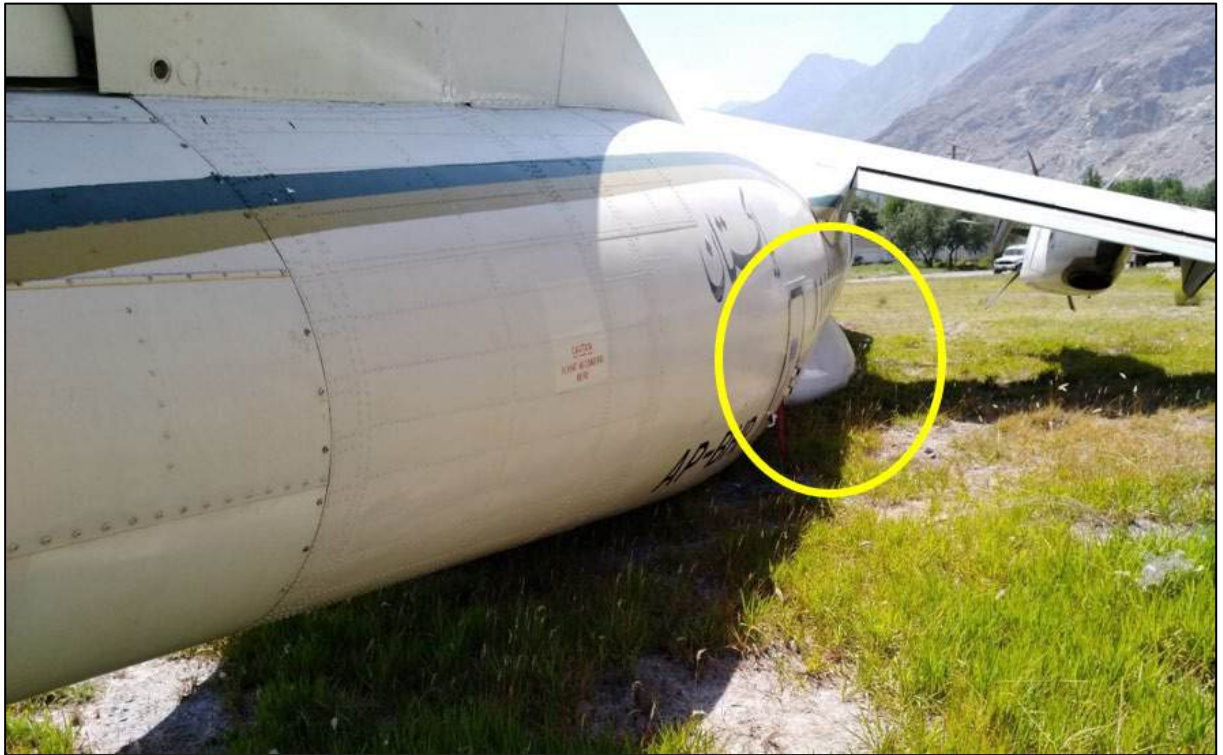
1.3.4. Right Main Landing Gear (MLG) collapsed.

Figure 5 Right MLG Collapsed

- 3.1.48 Due to the collapse of Right MLG, the aircraft suffered major structural damage.
- 3.1.49 At this time, the engines were also running and the right engine suffered major damage once the propeller hit the ground.

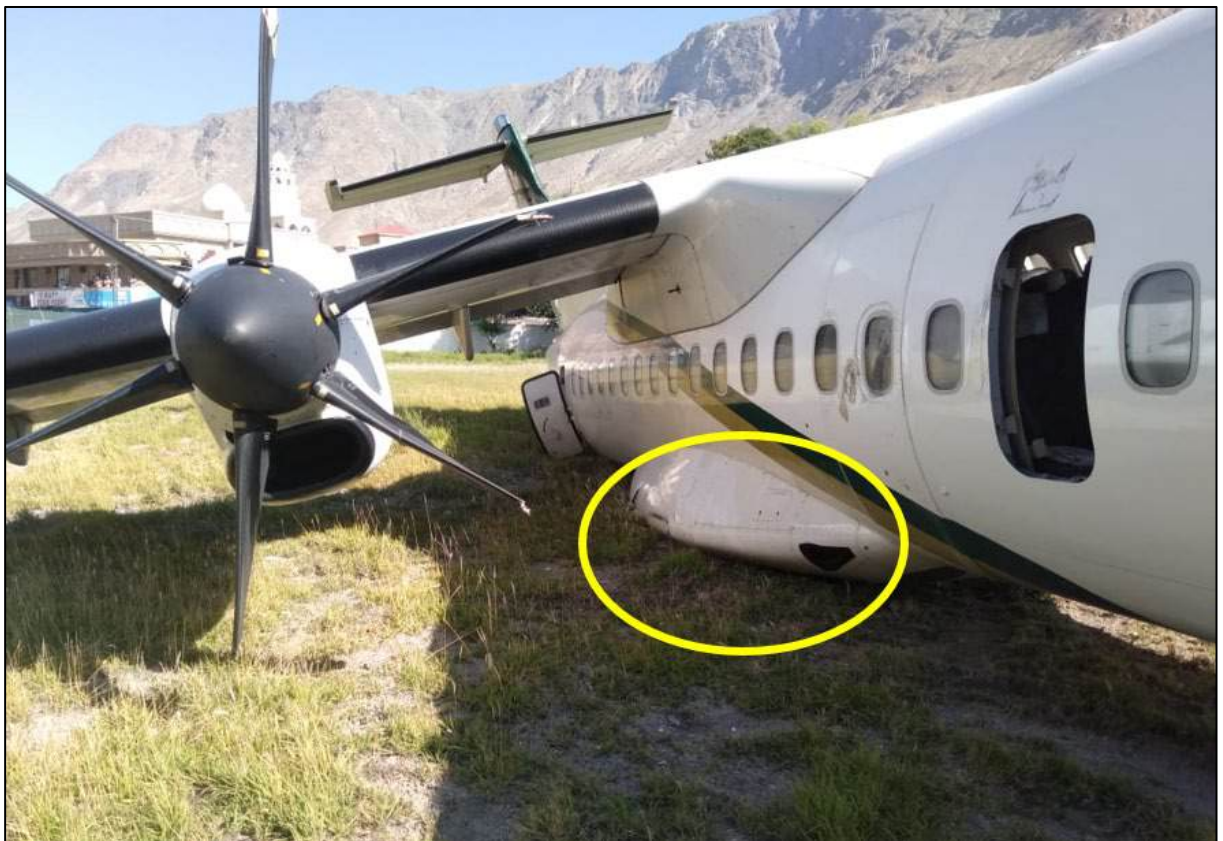
1.3.5. Right MLG fairing area damaged.

Figure 6 Right MLG Fairing Area Damaged

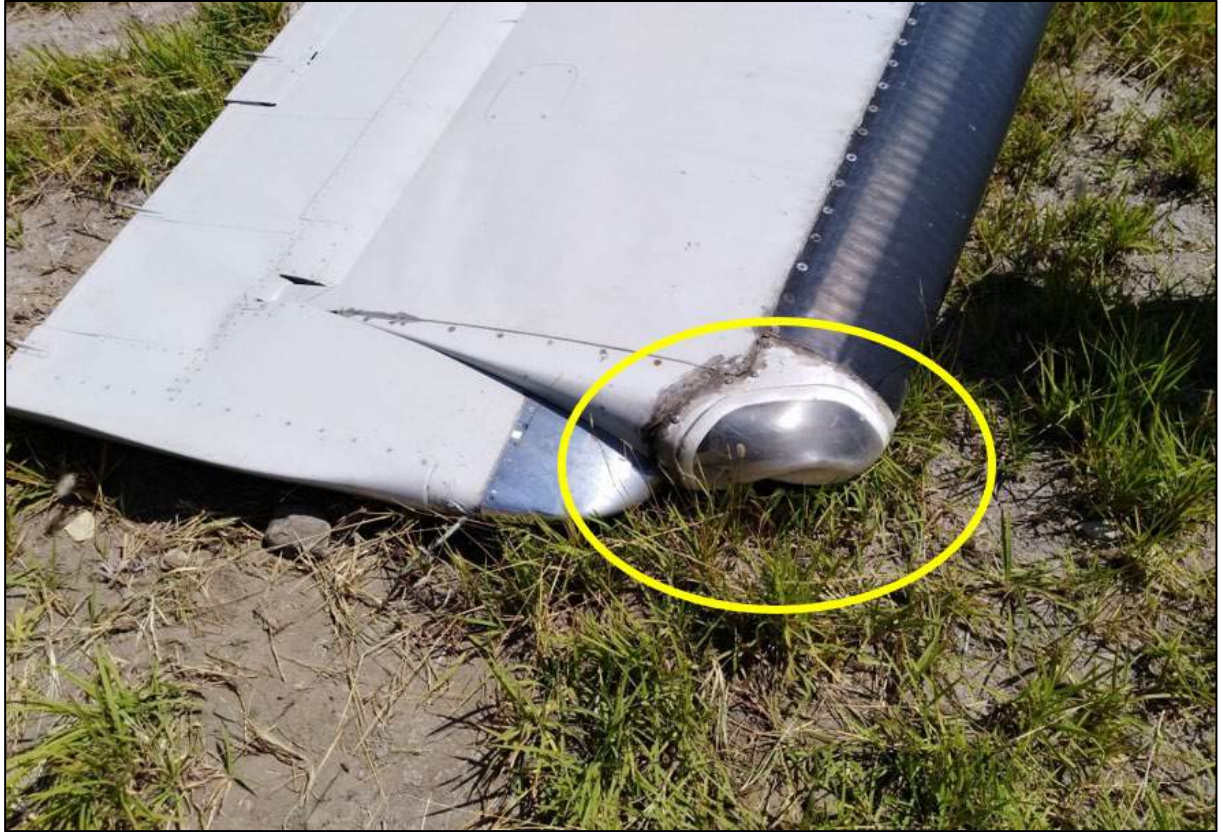
1.3.6. Right wing navigation light damaged.

Figure 7 Right Wing Navigation Light Damaged

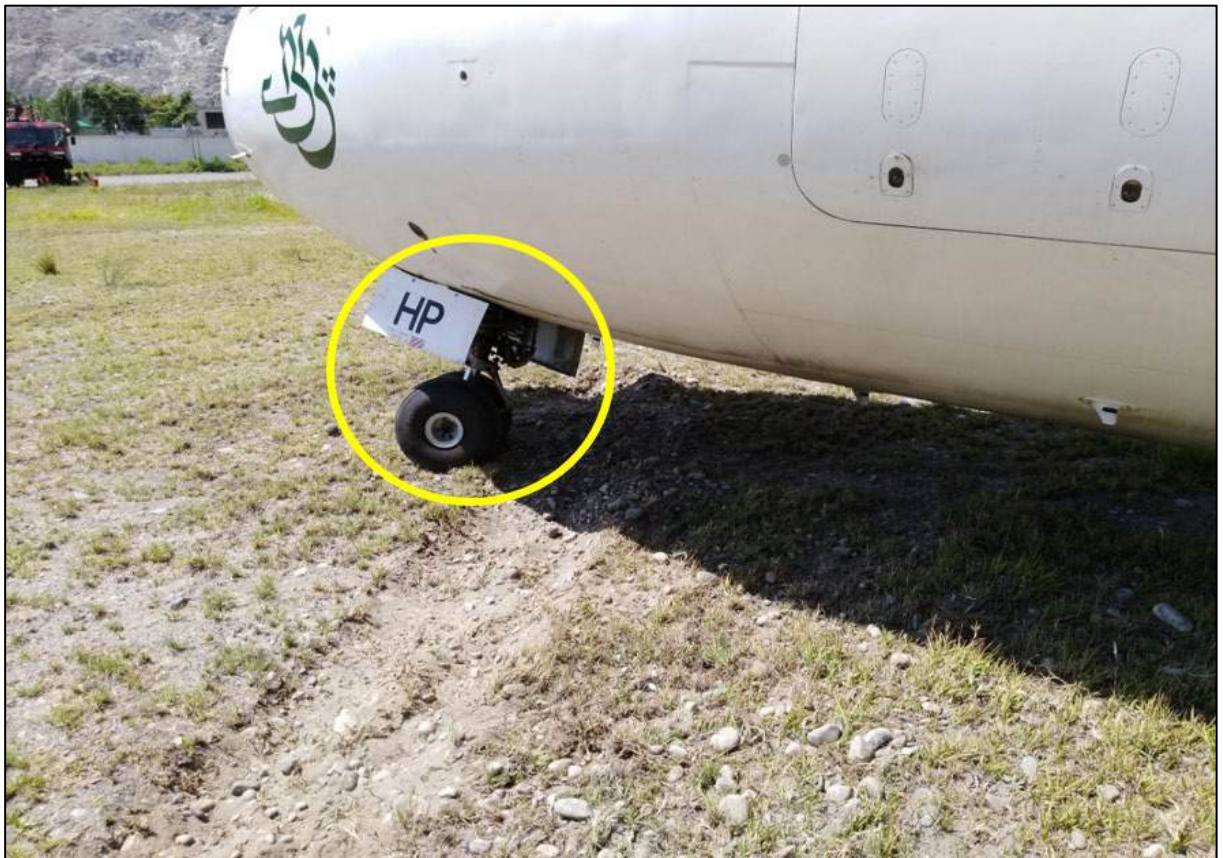
- 1.3.7. Right side ice shield / protection plate slightly damaged.
- 1.3.8. Nose Landing Gear (NLG) right wheel deflated and shock strut bent.

Figure 8 NLG damaged

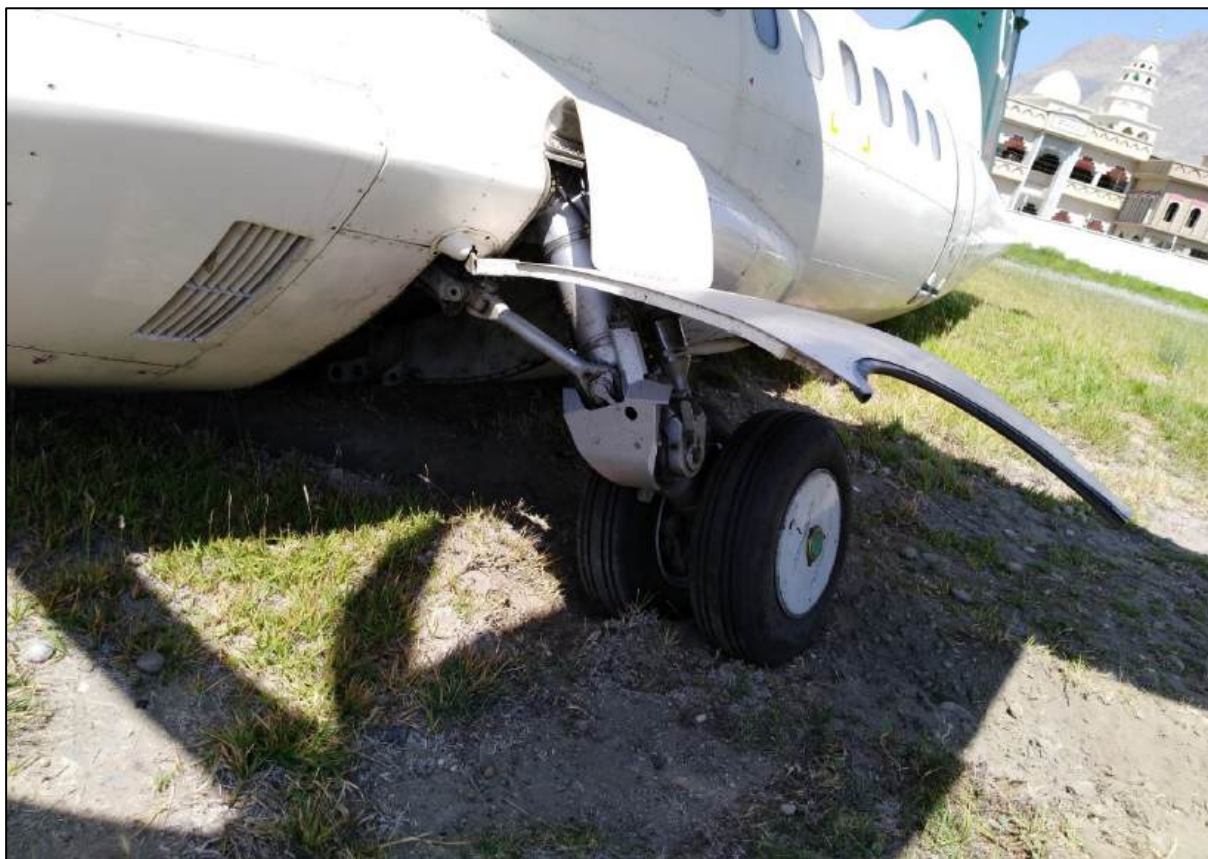
1.3.9. Left MLG tilted outwards.

Figure 9 Left MLG damaged

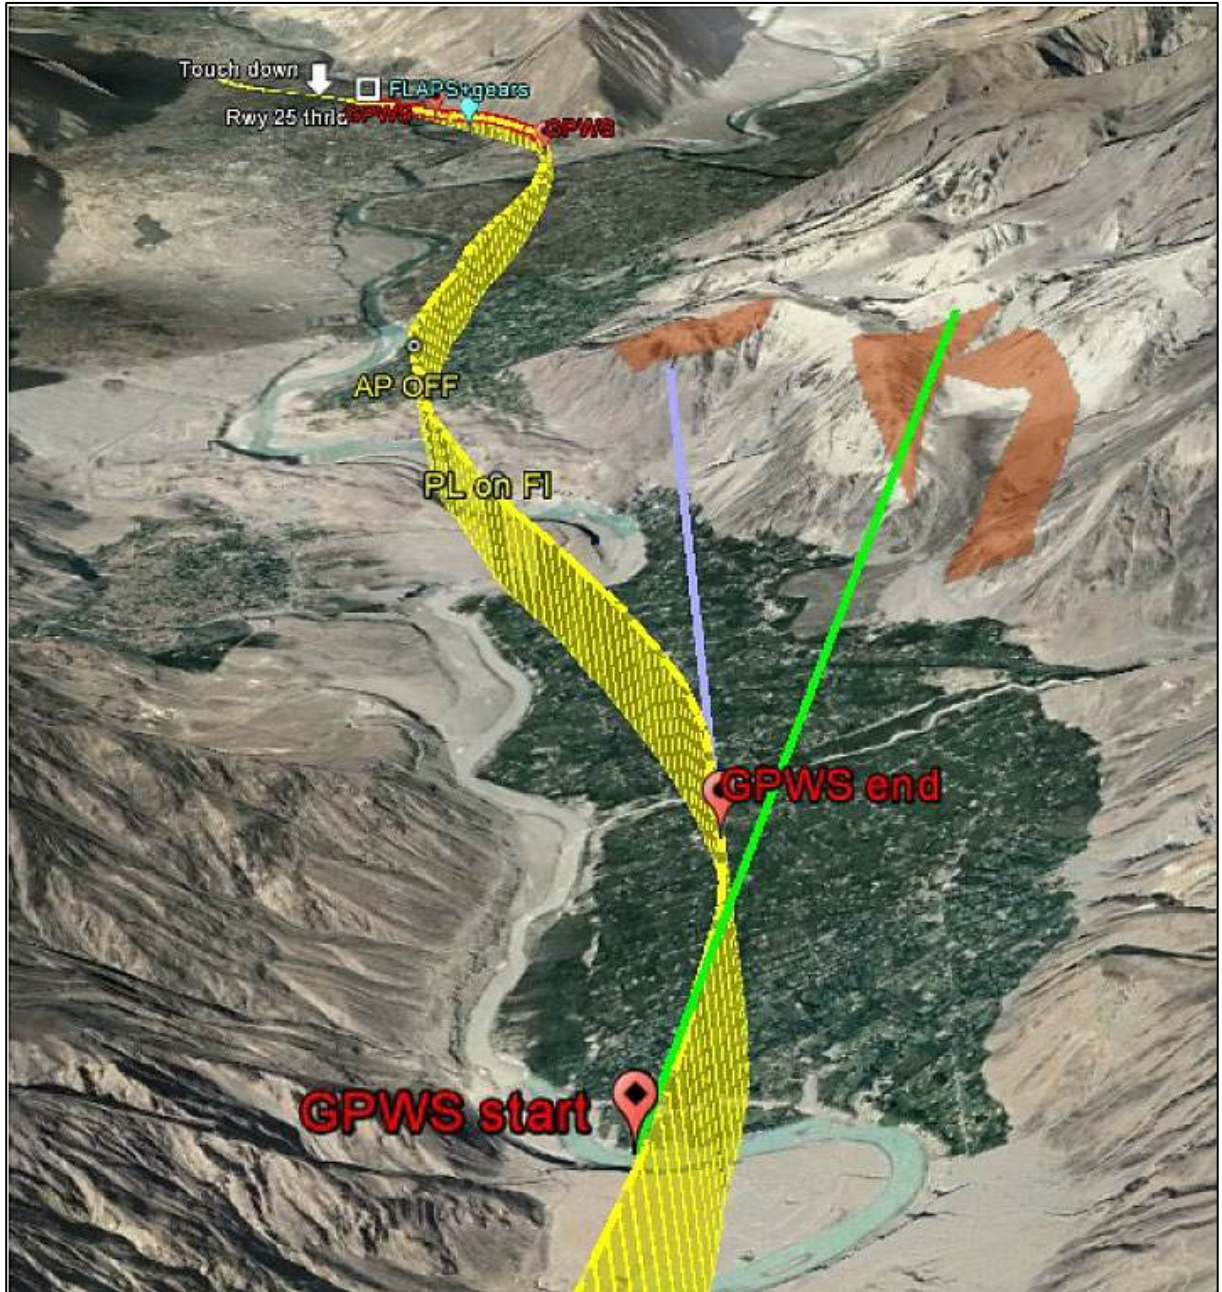
Figure 18 EGPWS Alert Depiction

2.7.4 At 02:45:10 h, the EGPWS triggered an alert for 17 seconds (s). The aircraft position at this time was 10.1 Nautical Miles (NM) from R/W threshold at a height of 7,630 ft AMSL while the RA height varied between 3,000 to 3,500 ft during this alert. In case the speed criteria mentioned in PIA SOPs is adhered to, no EGPWS alerts are

generated as the aircraft is clear of terrain. This warning most likely triggered because of terrain in front of the aircraft which it would have reached in 55 s as per the parameters being maintained; however, if the aircraft had been flying at correct speed, then this alert could have been avoided. The aircraft levelled off at 2,000 ft AGL with AP engaged. The throttles were retarded to Flight Idle (FI) where they remained till touchdown. The speed gradually decreased from 240 kt to 200 kt.

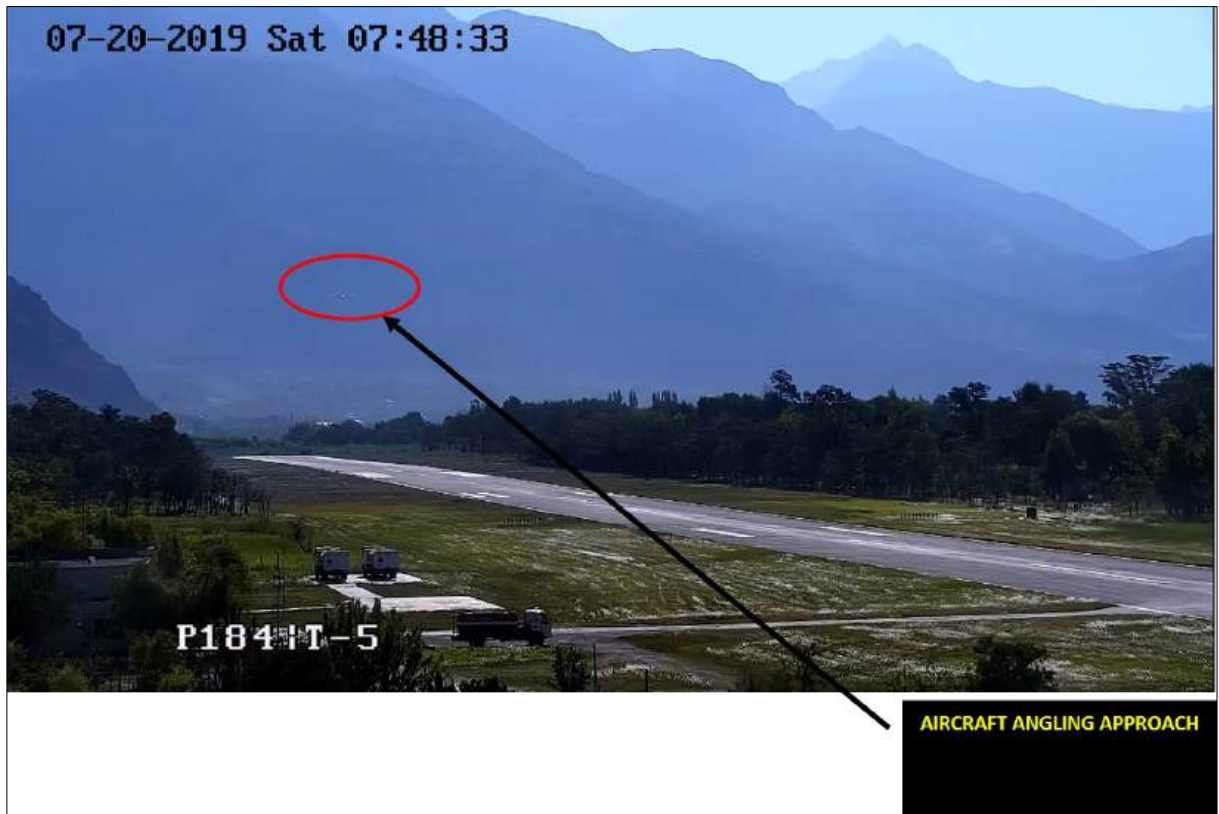
Figure 24 Aircraft Approach Path

2.9.2 Moreover, the Captain did not carry out an academic base turn. Instead, the aircraft approached the R/W at an angle of 10°-15° from final R/W heading by cutting corners and heading directly for the R/W threshold.

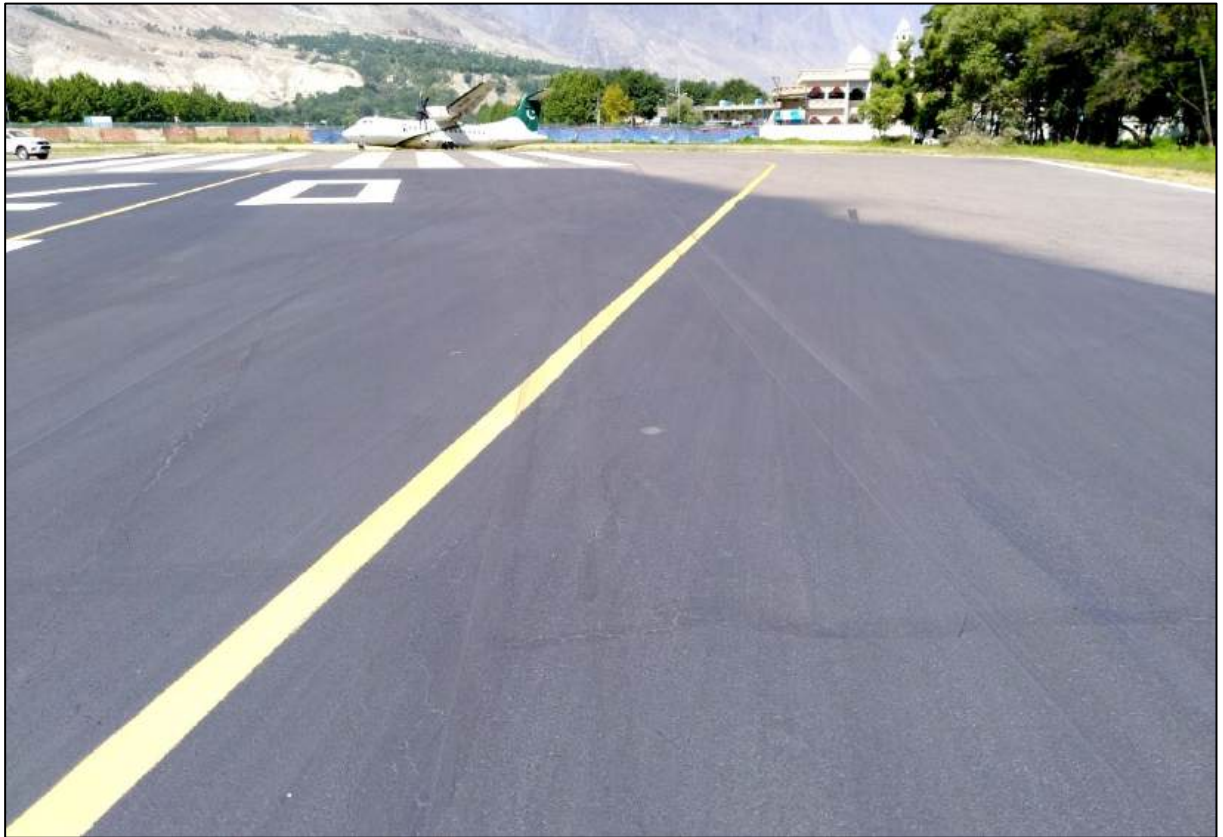
Figure 41 Aircraft Tyre Marks

2.13.1 As the aircraft approached end of R/W, the Captain realized that the aircraft would not be able to slow down sufficiently to stop on the R/W. To avoid going off the R/W, the Captain tried to turn about the aircraft. At 02:47:53 h, the aircraft was veered to the right at 75 kt.

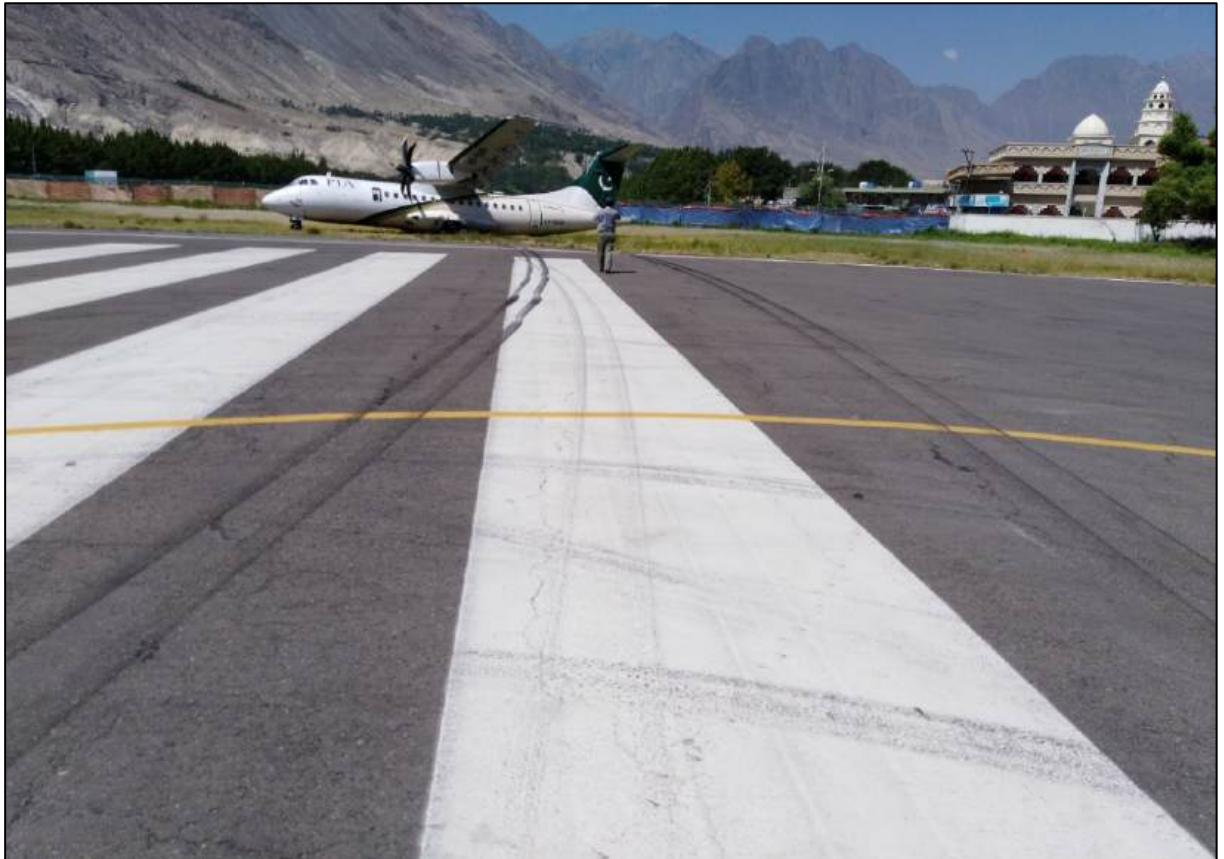
Figure 43 Aircraft Tyre Marks During R/W Excursion

2.13.2 At time 02:47:56 h, the aircraft was turned anti-clockwise at 56 kt while applying brakes. Simultaneously, right throttle was pushed forward for 6 s while left throttle remained at idle. As per ATR 42-500 FCOM Volume 2, pivoting (sharp turns) on L/G with fully braked wheels is prohibited except in emergencies.

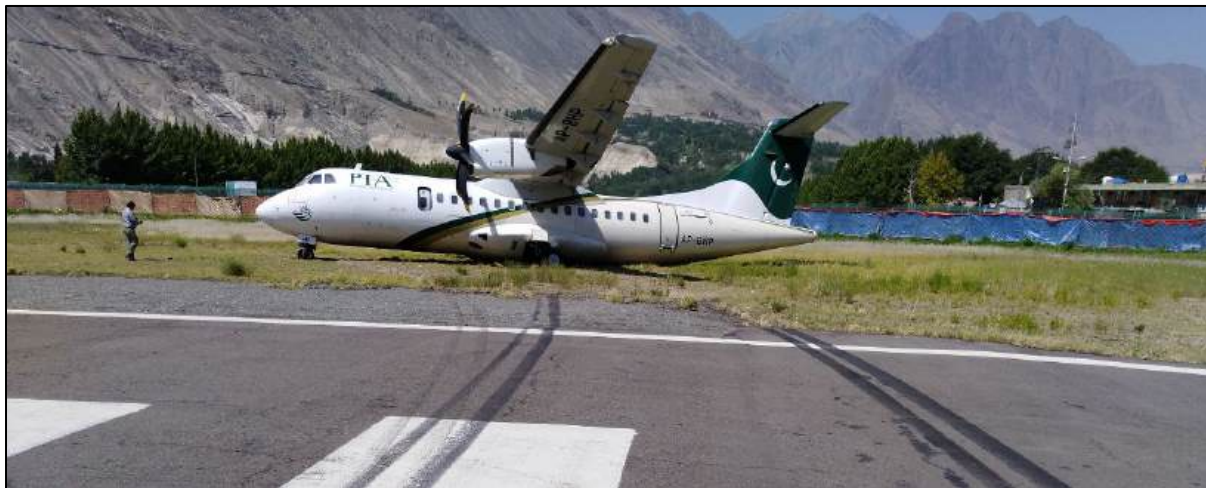
Figure 45 Aircraft Post R/W Excursion

2.13.3 Due to high centrifugal forces resulting from high-speed turn, the aircraft could not be controlled and went off the R/W. As the aircraft departed the R/W, the unpaved ground exerted further stress on the Landing gears. The right MLG, already under strain due centrifugal forces, was unable to withstand the extra force and collapsed. This resulted in damage to the airframe as well as the engine which was running at the time. As the right MLG collapsed and the aircraft came to a stop, the aircrew shut down the engines and other systems.
