Loss of control — Embraer S.A. EMB-120ER Brasilia, VH-ANB

Darwin Airport, Northern Territory | 22 March 2010

ATSB Transport Safety Report
Aviation Occurrence Investigation
AO-2010-019
Final

Report No. AO-2010-019

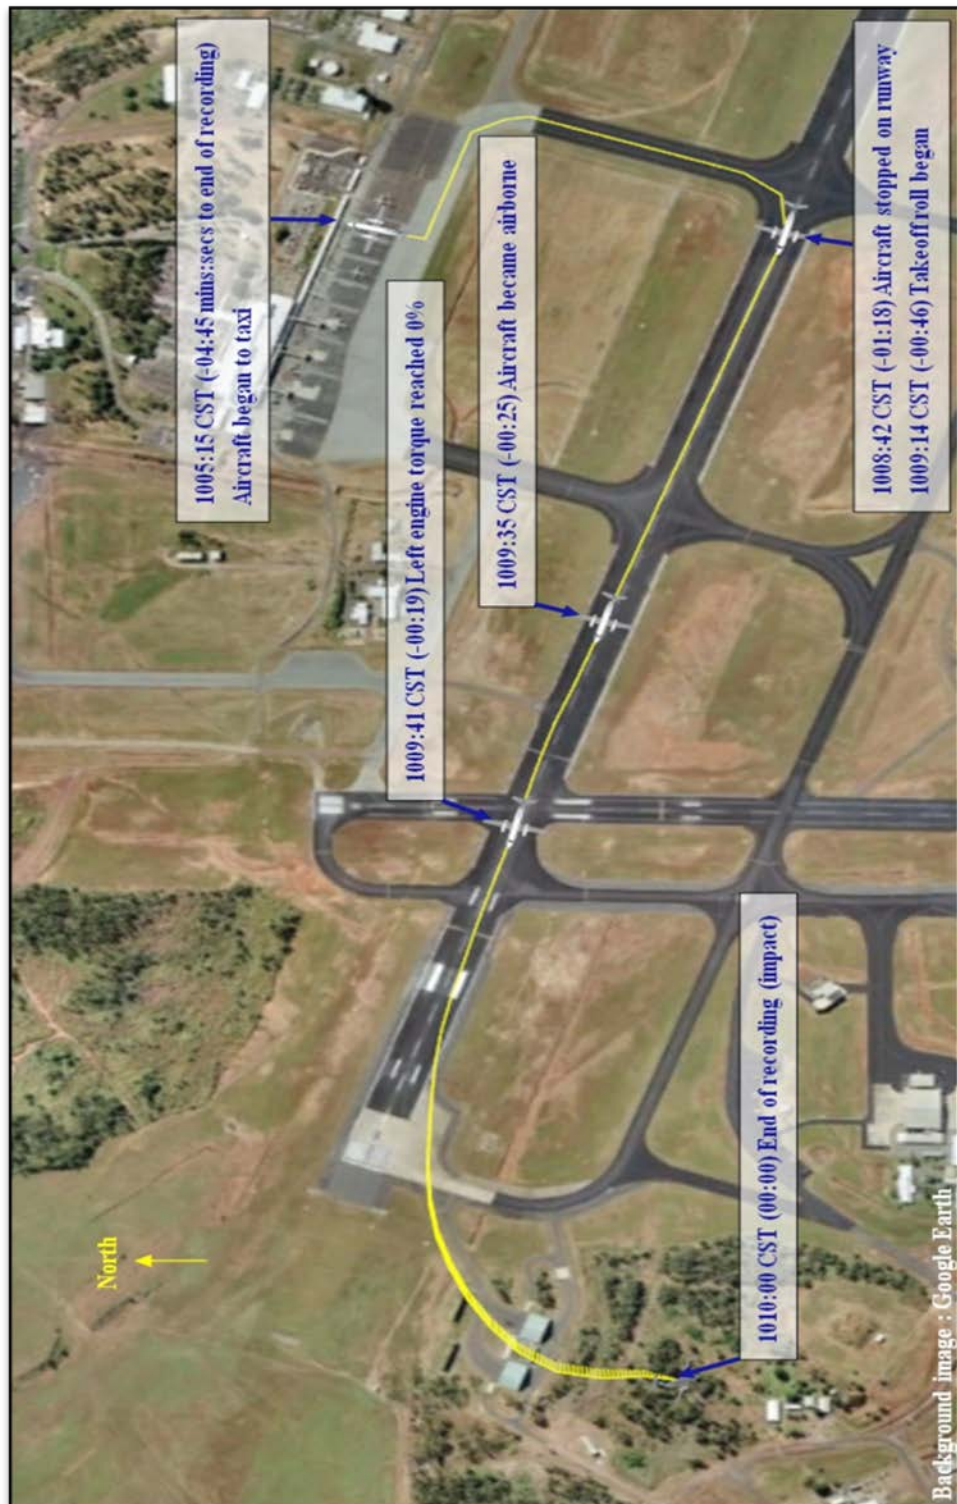
Figure 1: Aircraft's flightpath as reconstructed from the recorded data

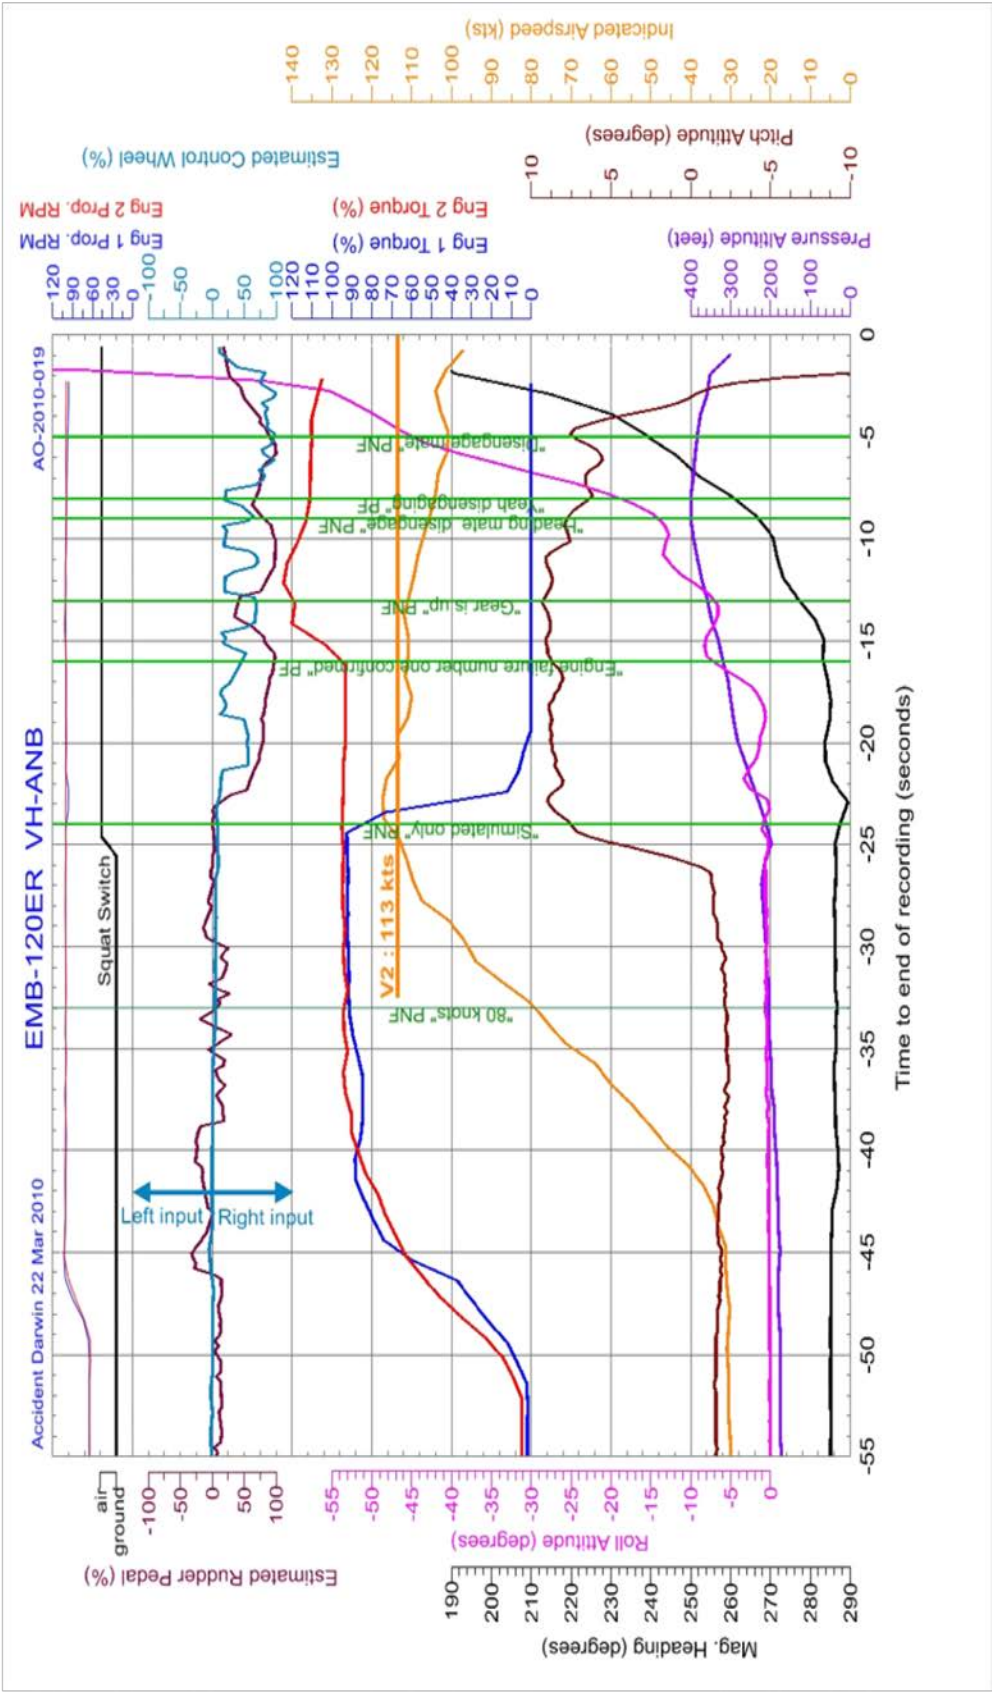
Data from the cockpit voice recorder (CVR) and the flight data recorder (FDR) were used to establish a sequence of events (Table: 1). A graphical representation of the FDR data is at Figure 2.

Figure 2: Flight data parameters and relevant extracts from cockpit voice recorder (superimposed in light green)

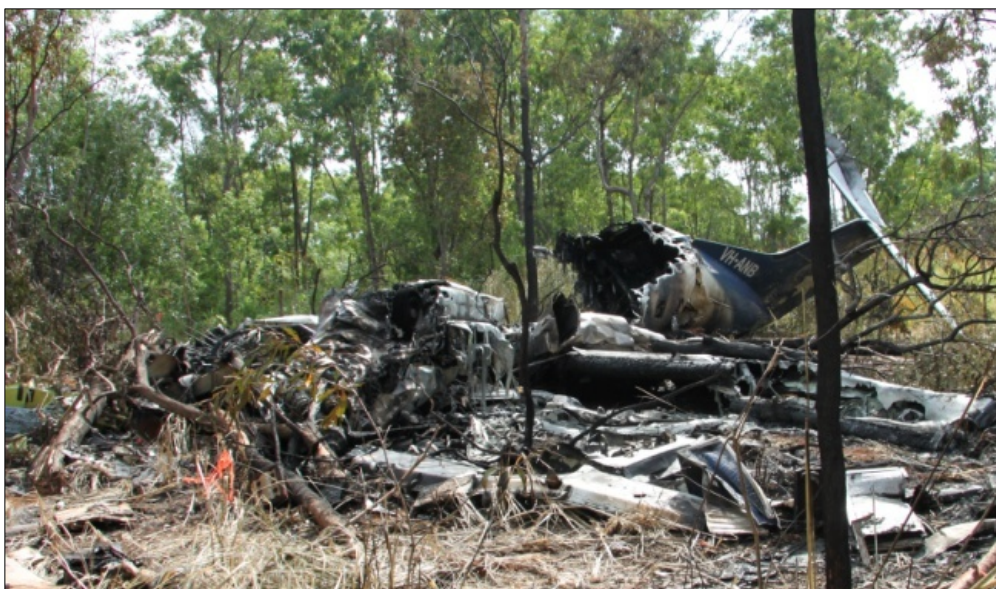
The fuselage forward of the cargo door, the inboard sections of the right wing, and most of the left wing including the engines and propellers were destroyed by impact forces and a post-impact, fuel-fed fire (Figure 12).

Figure 12: Aircraft wreckage, showing the extensive fire damage

The damaged right wing was separated from the main aircraft wreckage and was located on top of the left wing. The leading edge of the right wing had been liberated from the structure following ground impact and was extensively fire damaged. The right aileron and aileron trim tab were fire damaged and the trim position was unable to be determined.

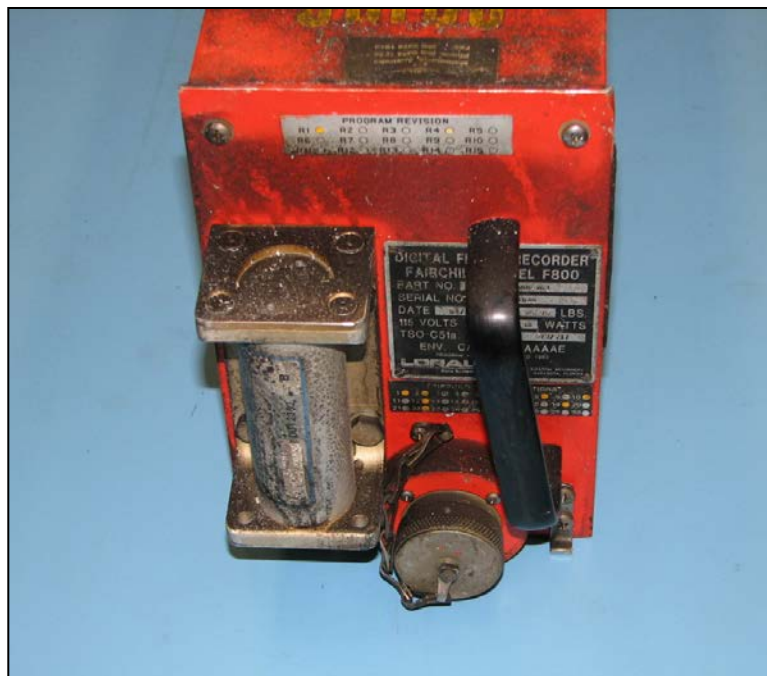
Figure A-1: The FDR as received in Canberra

The FDR was disassembled to expose the magnetic tape (the recording medium) and carefully inspected.

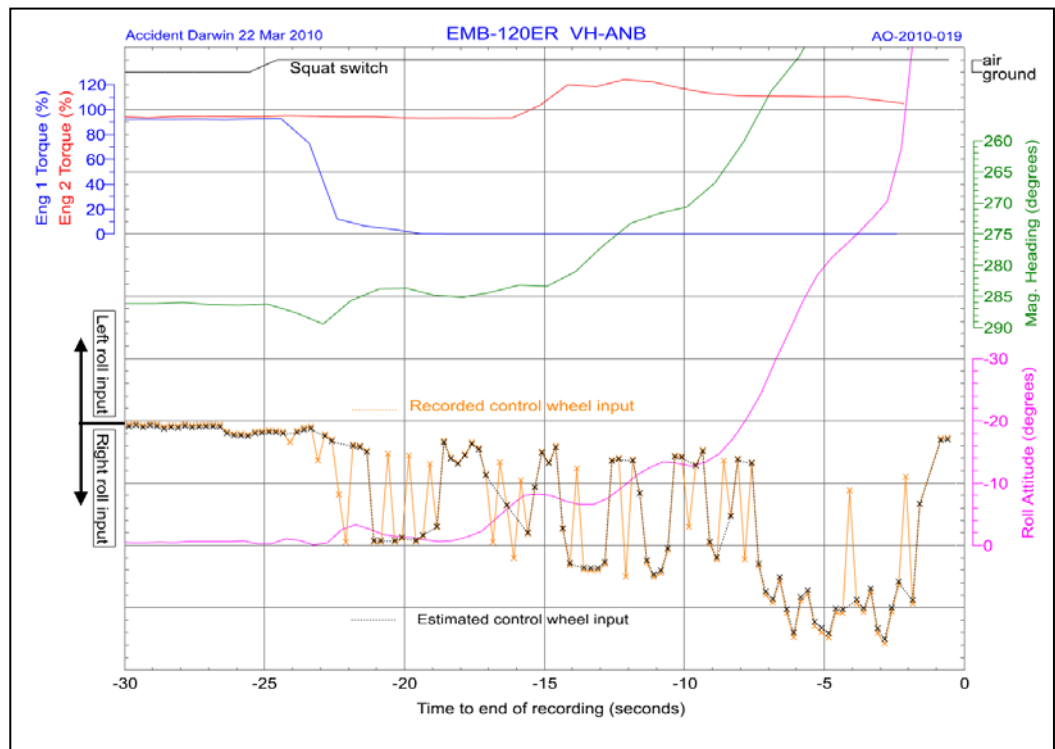
Figure A-2: Estimated control wheel (aileron) input

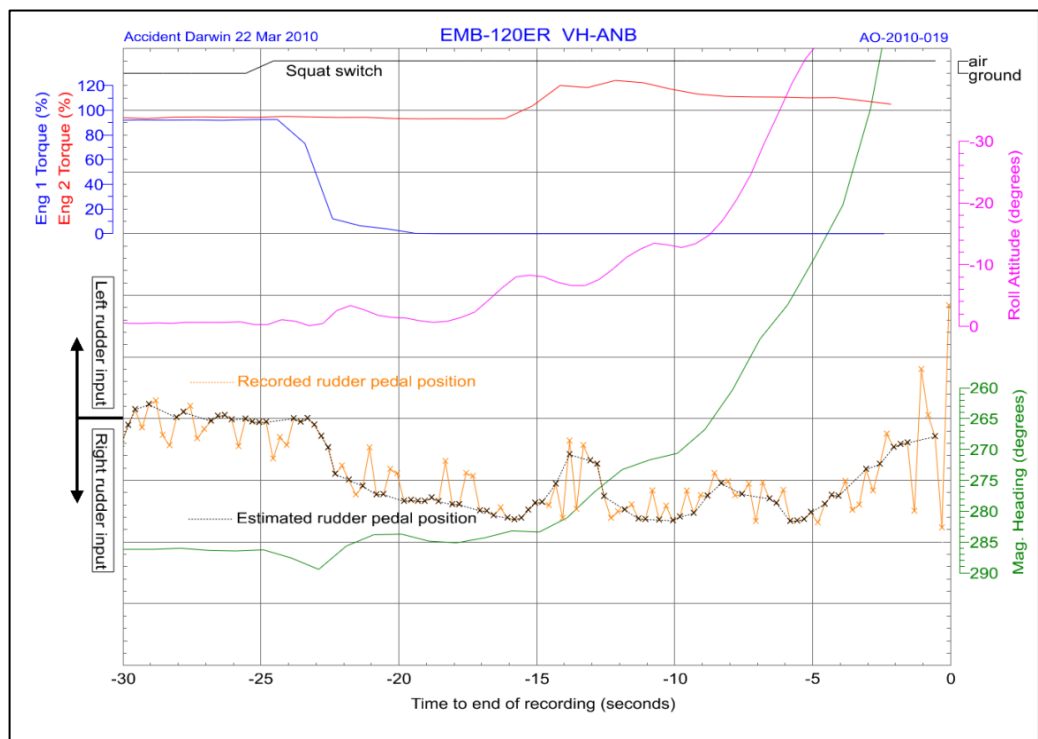
Figure A-3: Estimated rudder pedal input

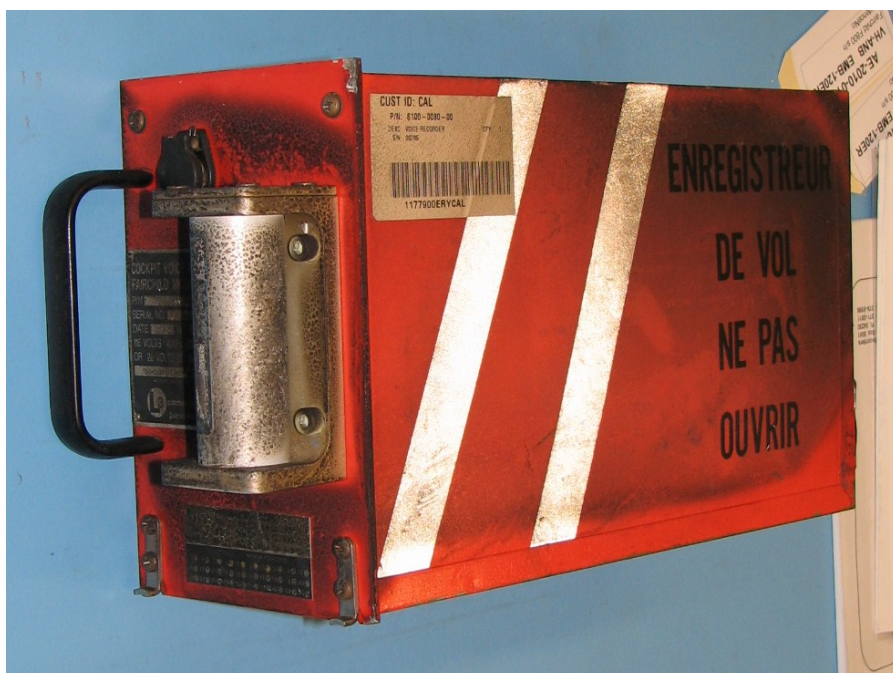
Figure B-1: Cockpit Voice Recorder as received in Canberra

The CVR dust cover was removed to allow access to the download connector and an inspection of the internal circuits and modules did not reveal any damage.

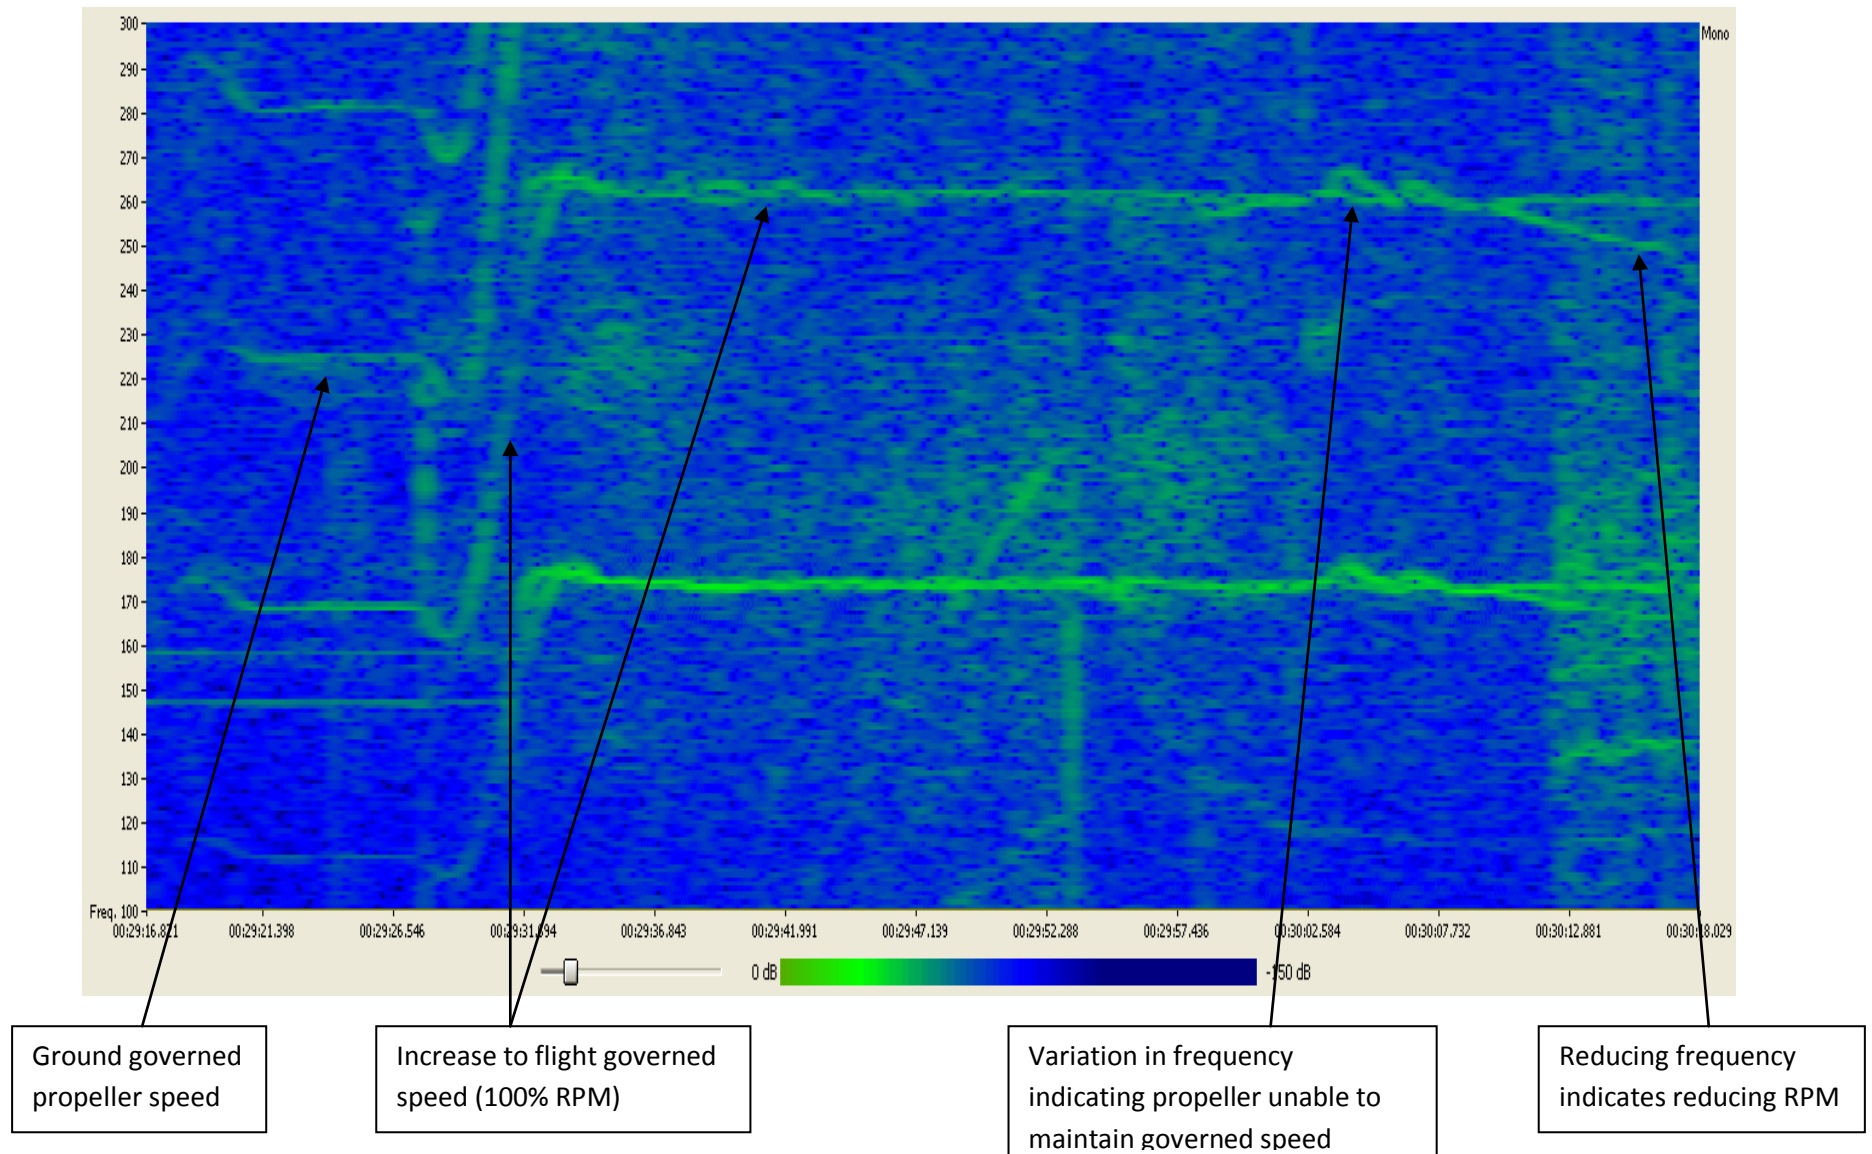
Figure B-2: Spectrograph of cockpit area microphone channel recording of take off showing frequency variation following lift off

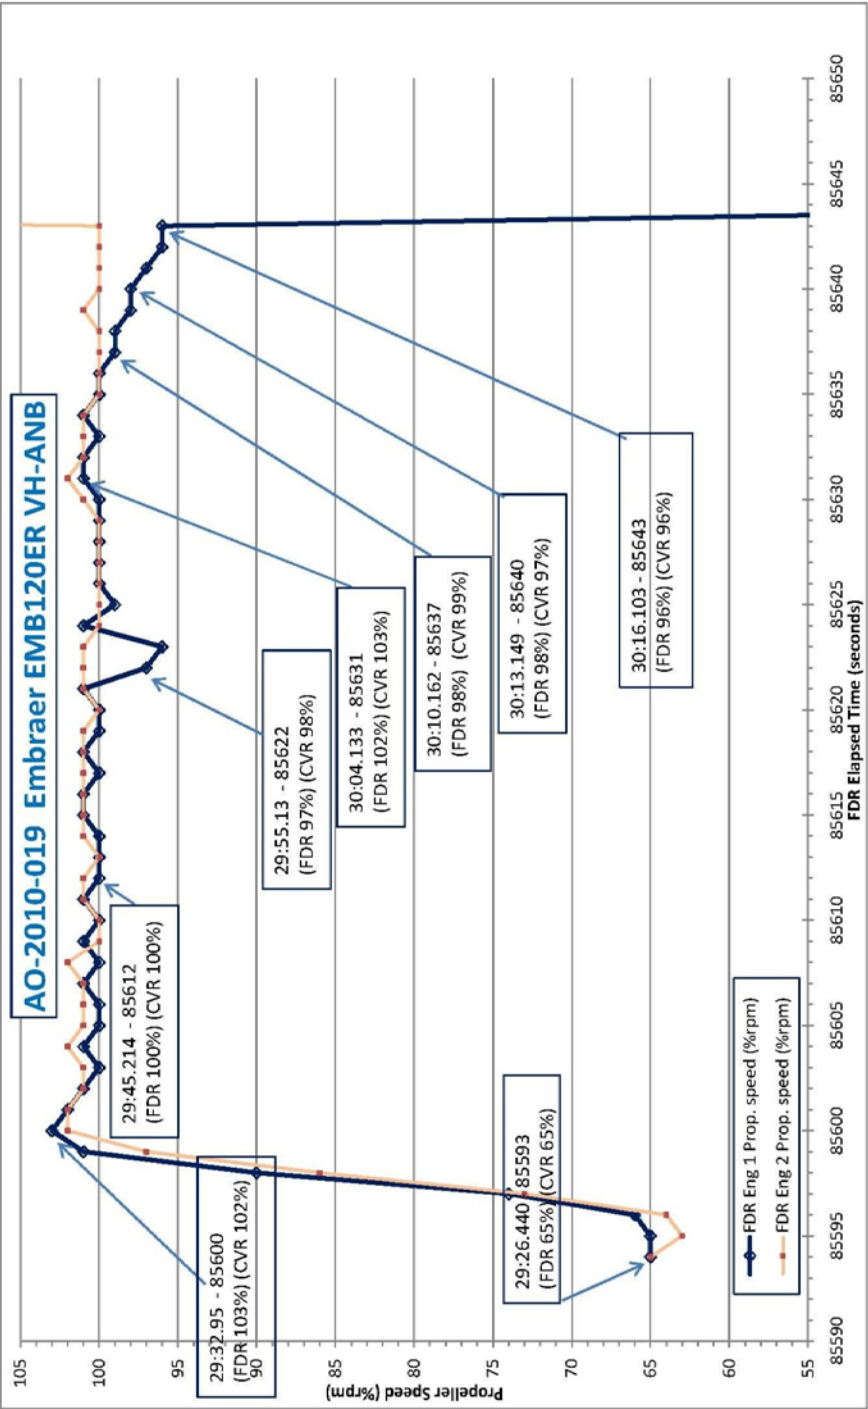
Figure B-3: Plot of propeller speed recorded by the FDR, CVR derived rpm comparison included in text boxes
