# Collision with terrain Piper PA-31P-350 Mojave VH-PGW

6 km north-west of Bankstown Airport, New South Wales | 15 June 2010

**ATSB Transport Safety Report**  
Aviation Occurrence Investigation  
AO-2010-043  
Final

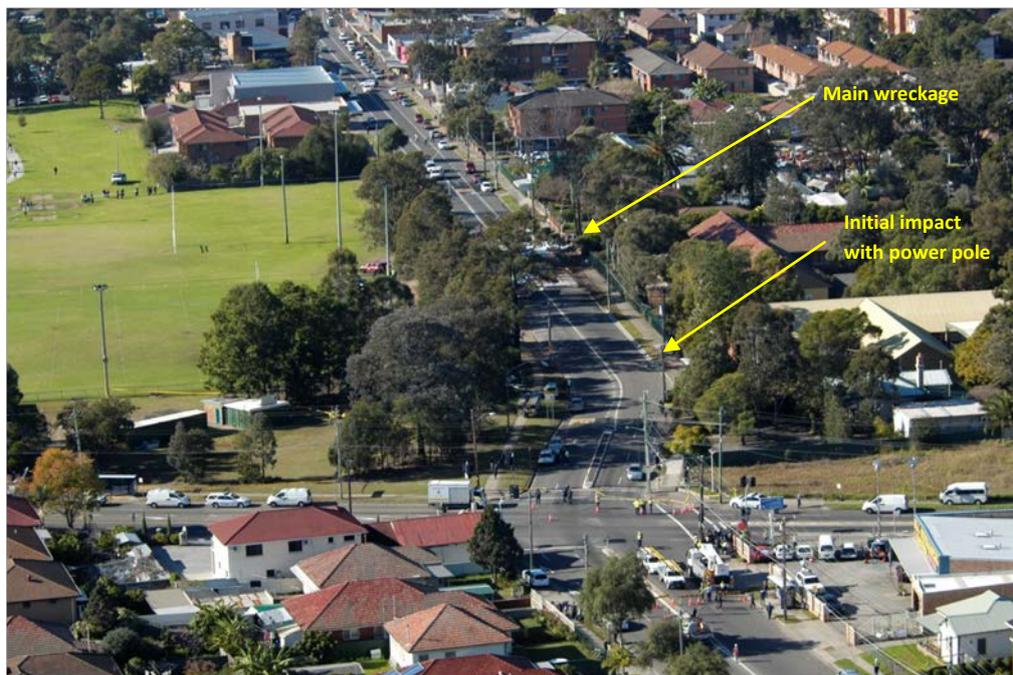
**Figure 3: Accident site**

There were no reported injuries to any person on the ground. Damage was sustained by the powerline infrastructure, the front fence of a dwelling, several motor vehicles and the road tarmac.

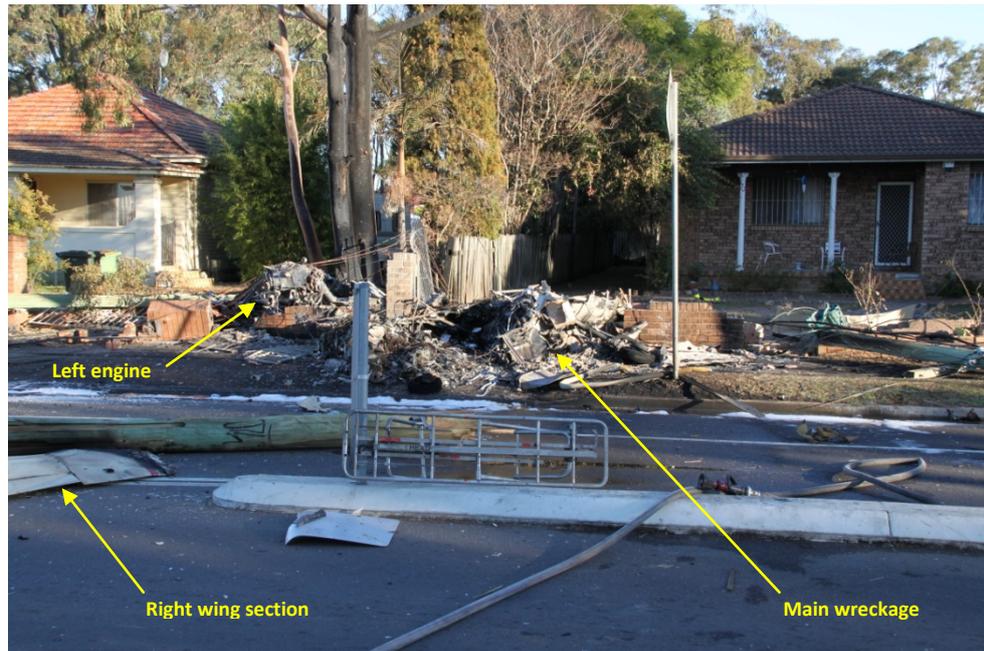
**Figure 4: Main wreckage**

The fuselage, inboard sections of the left and right wings and the engines and propellers were destroyed by the impact forces and post-impact, fuel-fed fire. The structural damage to the aircraft was consistent with the application of excessive structural loads during the impact sequence, and the effects of the subsequent fire. No pre-existing structural defects likely to have contributed to the accident were found. All aircraft control surfaces were located at the site. The flaps were retracted and the landing gear was probably extended at impact.

Evidence from the accident site indicated that the right wing fuel tank was breached early in the impact sequence, most likely at the initial impact with the top of the powerline support pole. There was scorching damage to trees after this point. Witnesses also reported that they felt heat from a fire as the aircraft passed above them. Following impact with the ground, an intense, fuel-fed fire caused significant damage to the aircraft and its systems.
