**AVIATION INVESTIGATION REPORT
A11W0048**

LOSS OF CONTROL – IN-FLIGHT BREAKUP

**BLACK SHEEP AVIATION & CATTLE CO. LTD.
DE HAVILLAND DHC-3 OTTER C-GMCW
MAYO, YUKON, 38 NM NE
31 MARCH 2011**

Report Number A11W0048

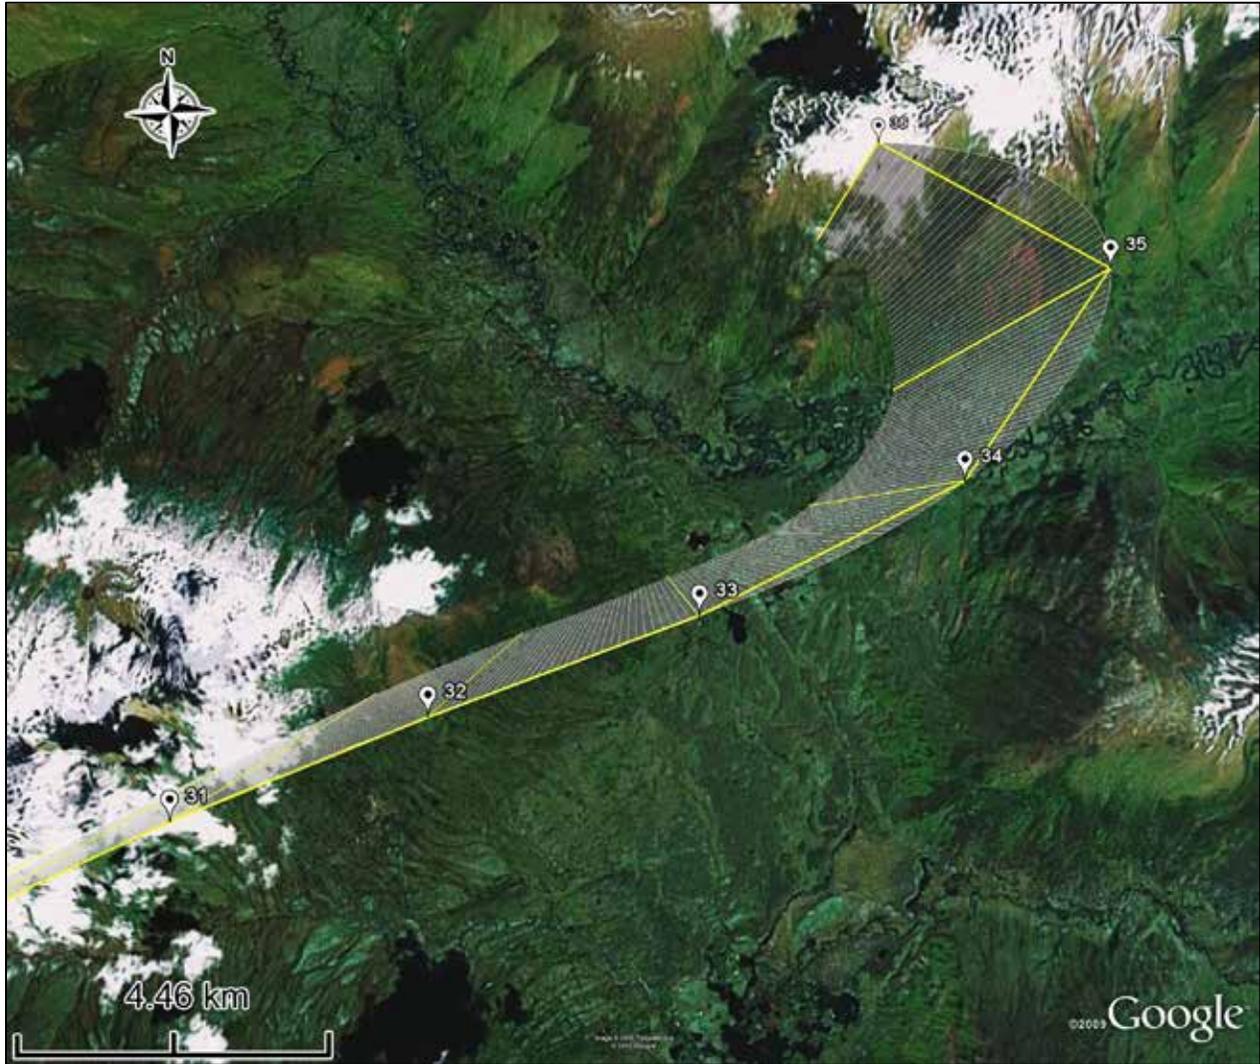
Figure 1. Aircraft final track based on GPS data

Based on these data, it was determined that the aircraft had reached an altitude of approximately 11 500 feet asl about 13.5 minutes after take-off on the accident flight. The aircraft had remained on track to Rackla at that altitude for approximately 2 minutes, and had then commenced a descent at a slightly increased speed. Over the final 2 minutes of the flight, the aircraft entered a shallow left turn, and the track changed from 66°T through 360°T to 286°T, over a total distance of approximately 4.4 sm. The GPS data did not indicate that the aircraft had entered a spiral dive. Between the last two 30-second data points, the GPS altitude decreased by 2392 feet and the GPS speed through space increased from 177 to 241 mph calibrated airspeed (CAS), indicating a loss of control. Due to the capability of the GPS, the GPS data were insufficient to determine the aircraft attitudes and movements leading up to the apparent loss of control, the pilot's actions, and the functioning of the aircraft systems (Appendix E).

Data point	GPS track (°M)	GPS altitude (feet asl)	Calibrated airspeed (mph)
31	64.7	11 337	150
32	71.1	11 342	147
33	66.1	11 177	153
34	58	10 984	154
35	9.1	10 652	152
36	286	8 262	203

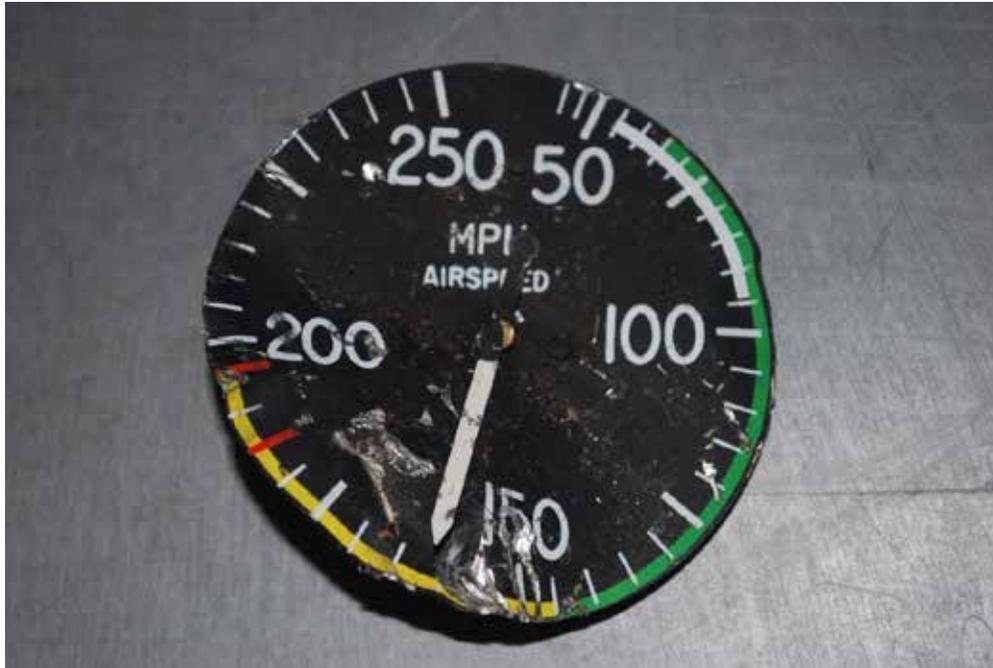
Figure 2. ASI dial removed from accident aircraft

flight and atmospheric conditions, turbulence in particular. That speed range was marked by the standardized yellow arc on the airspeed indicator (Appendix F). Based on the results of the Texas Turbine Conversions STC flight test program, no changes were made to any of the airspeed limits that applied to the original piston-engine DHC-3 Otter.

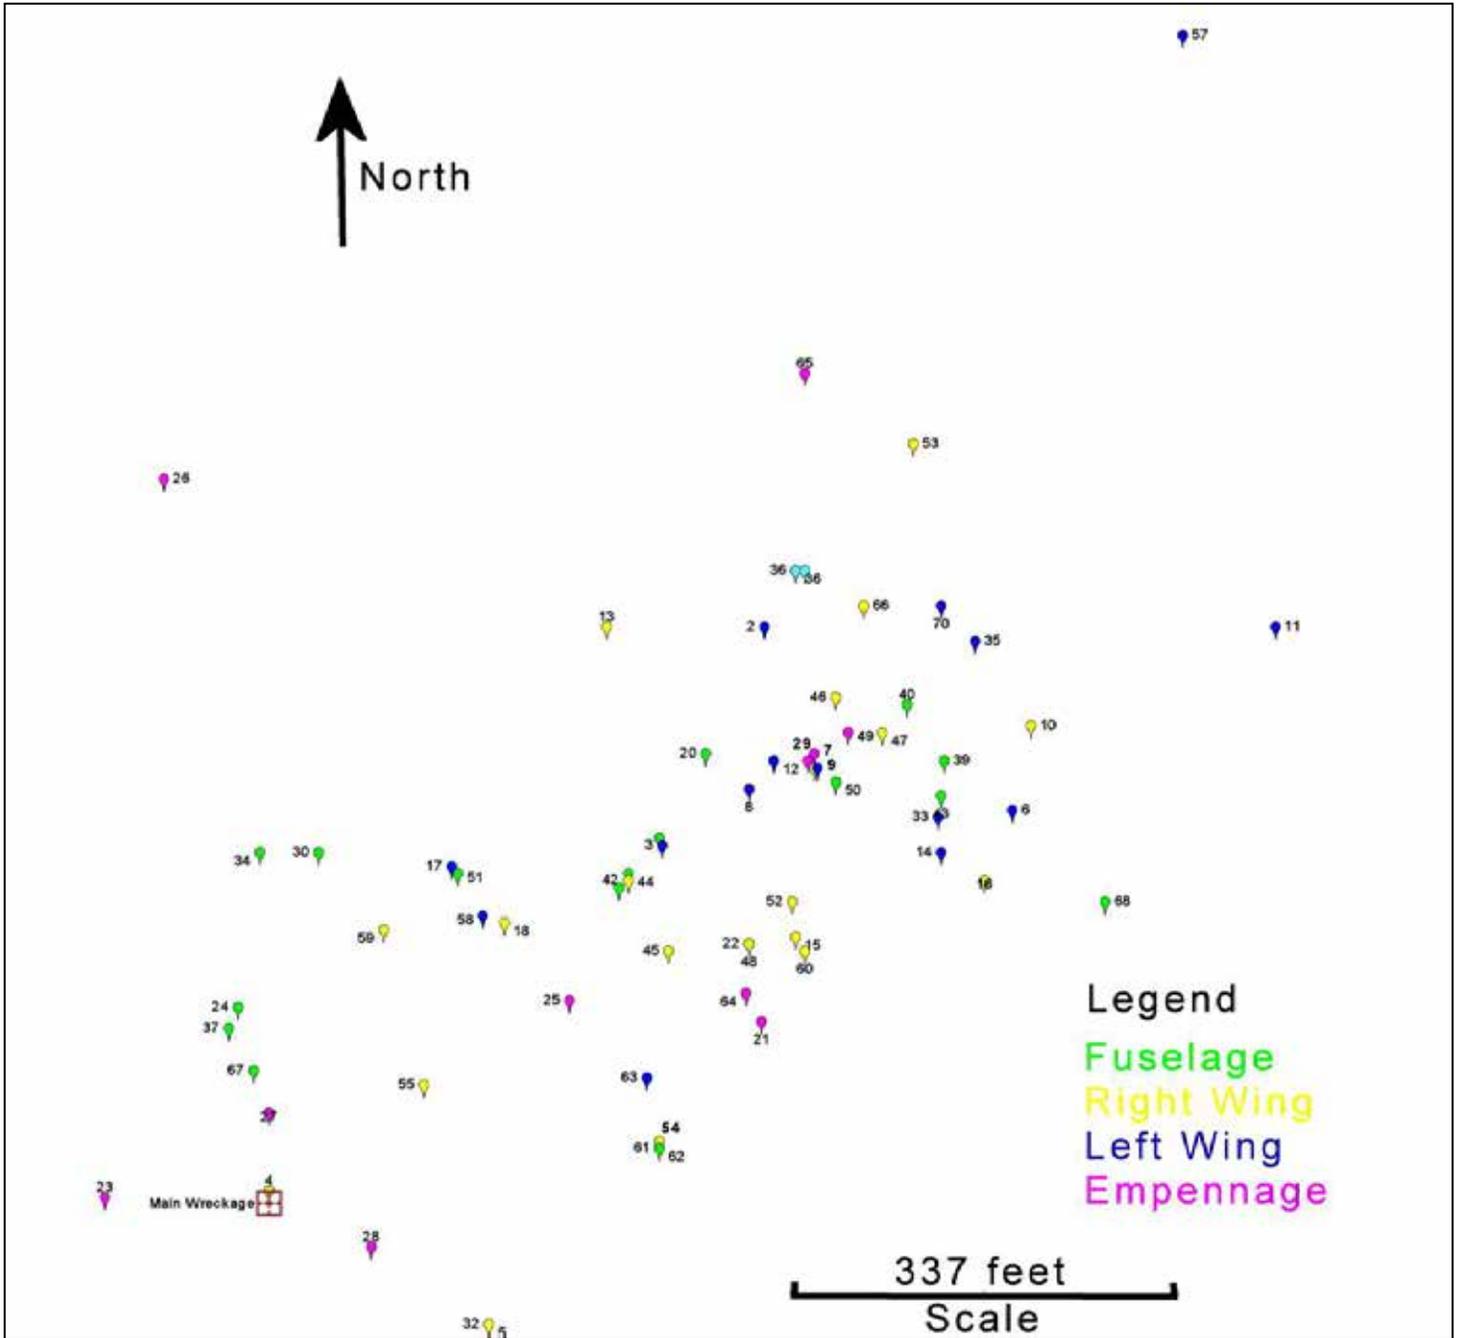
Appendix H – Wreckage Distribution

The wreckage was spread over a debris field approximately 800 feet wide and 1300 feet long (Appendix H) at between 4200 and 4600 feet asl on a remote treed hillside in the central Yukon. Ground scars and damage to trees suggested that the wreckage, including the fuselage, had no significant horizontal velocity at impact. The engine remained attached to the firewall following impact.

Scale drawing of the contents of the debris trail produced from the on-site GPS survey of the debris trail (key to numbered items is on next page)
