ACCIDENT

Aircraft Type and Registration:	Piper PA-31-325 Navajo C/R, G-BWHF	
No & Type of Engines:	1 Lycoming TIO-540-F2BD piston engine 1 Lycoming LTIO-540-F2BD piston engine	
Year of Manufacture:	1976	
Date & Time (UTC):	18 January 2012 at 1117 hrs	
Location:	Long Mountain near Welshpool Airport, Powys	
Type of Flight:	Private	
Persons on Board:	Crew - 2	Passengers - None
Injuries:	Crew - 2 (Fatal)	Passengers - N/A
Nature of Damage:	Aircraft destroyed	
Commander's Licence:	Airline Transport Pilot's Licence	
Commander's Age:	55 years	
Commander's Flying Experience:	11,164 hours (of which 375 were on type) Last 90 days - 3.0 hours Last 28 days - 2.0 hours	
Information Source:	AAIB Field Investigation

Synopsis

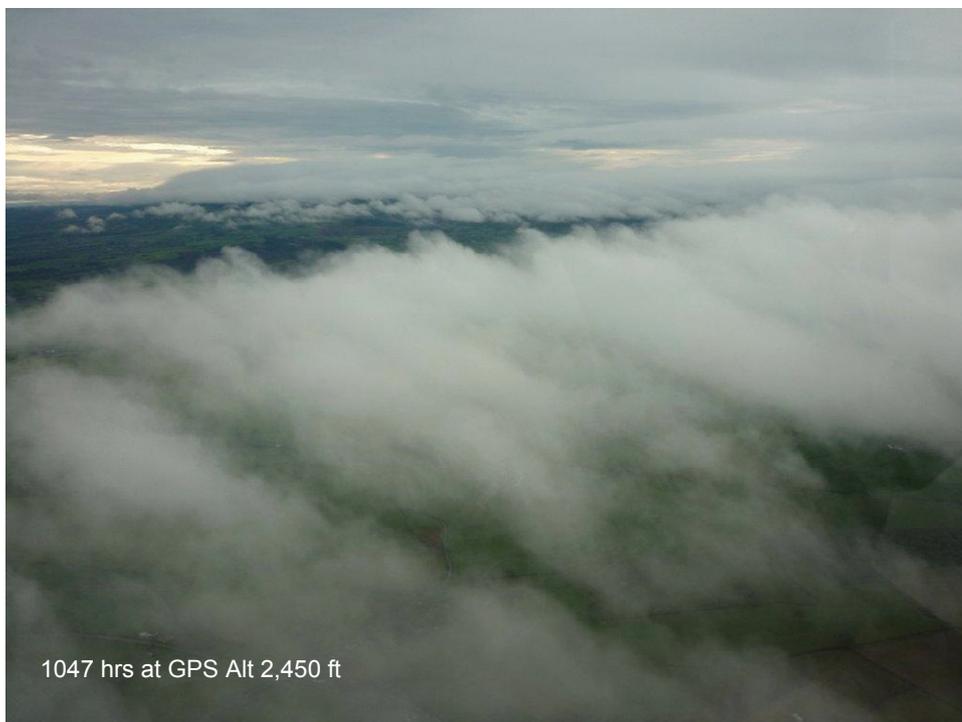
Figure 1

noted that the top of Long Mountain was in cloud and his passenger took a photograph of the Long Mountain area which is shown at Figure 1.

Photograph taken by the R22 passenger showing the area of Long Mountain, covered in cloud in the upper part of the picture, approximately 30 minutes before the accident

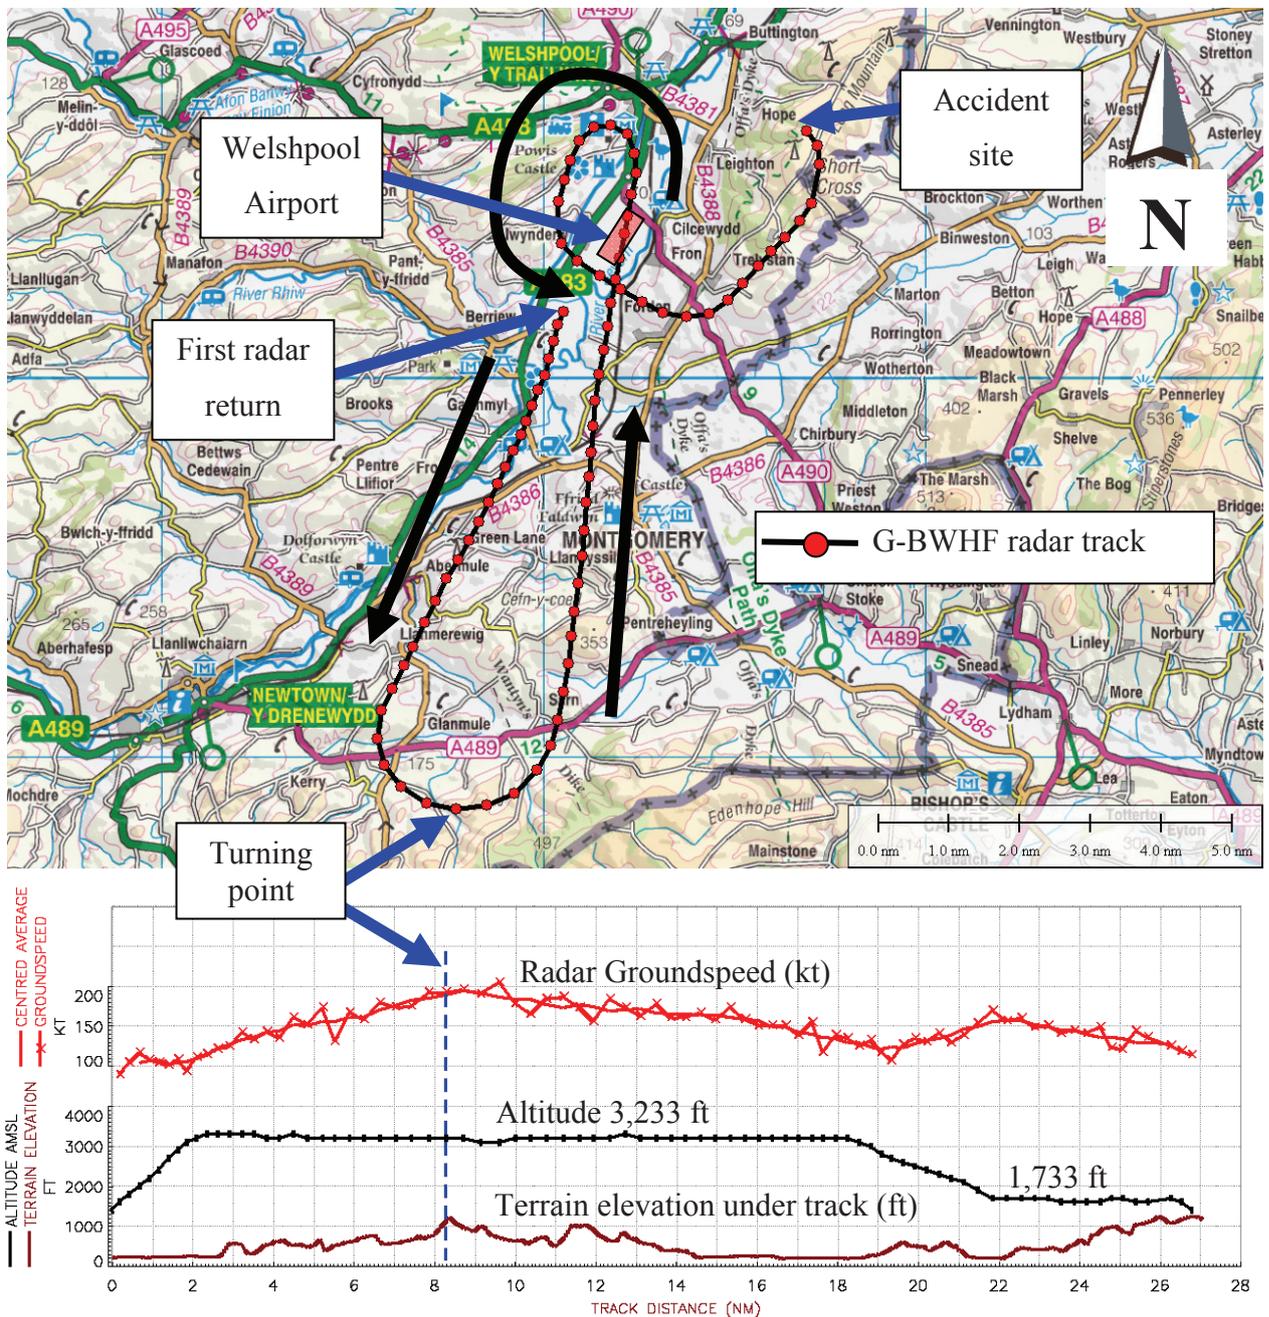
Figure 2

The PA-31 track is shown at Figure 2. After passing overhead Welshpool, it made a descending left circuit, becoming established on a left hand, downwind leg for Runway 22.

over 1 nm from the end of Runway 22, at an altitude of 1,433 ft amsl. The aircraft climbed to 3,223 ft amsl, tracking to the south of the aerodrome before turning in the opposite direction (Figure 2).

G-BWHF radar track (Map terrain elevations are shown in metres)
 © Crown copyright. All rights reserved Department for Transport 100039241 2012

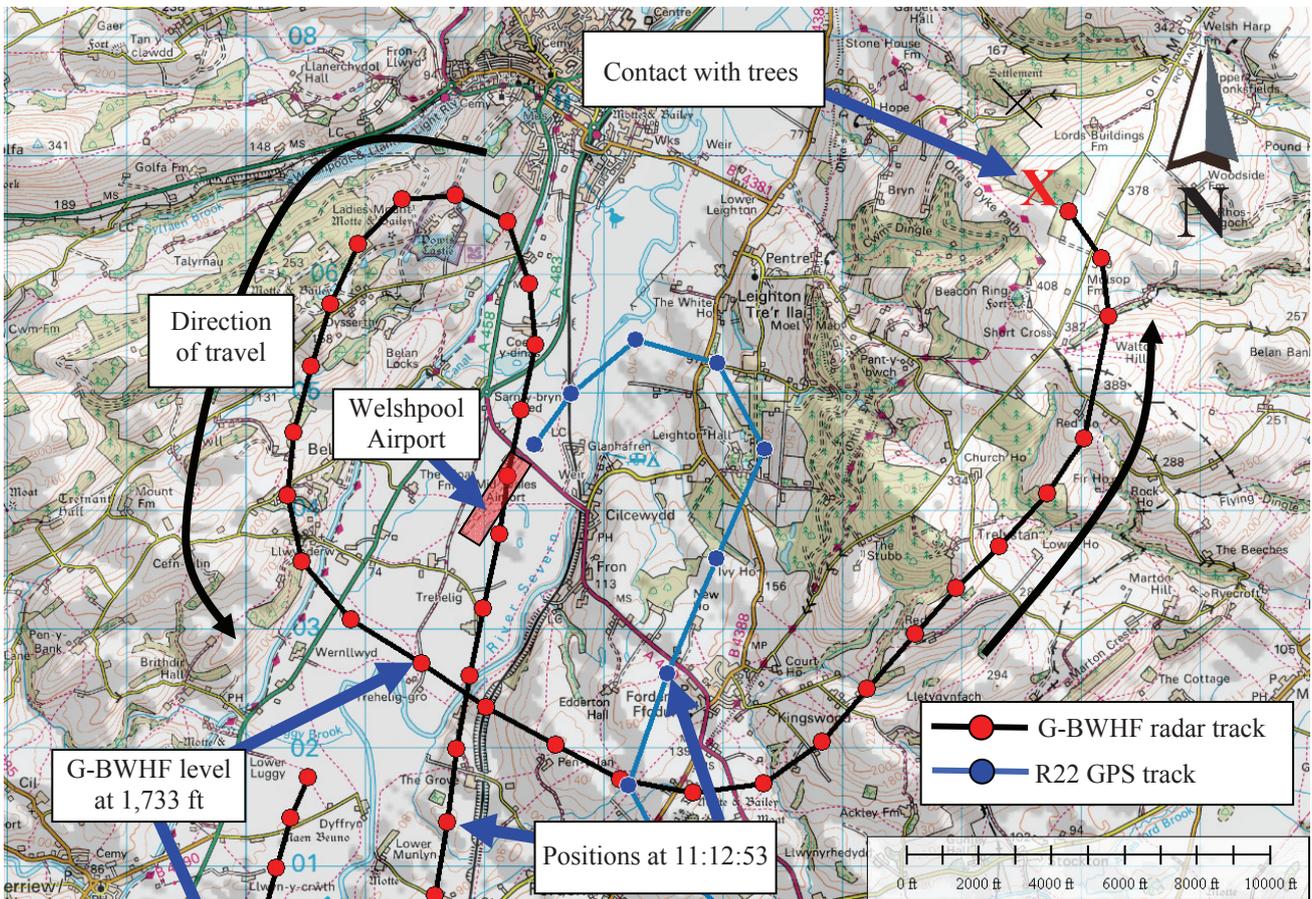
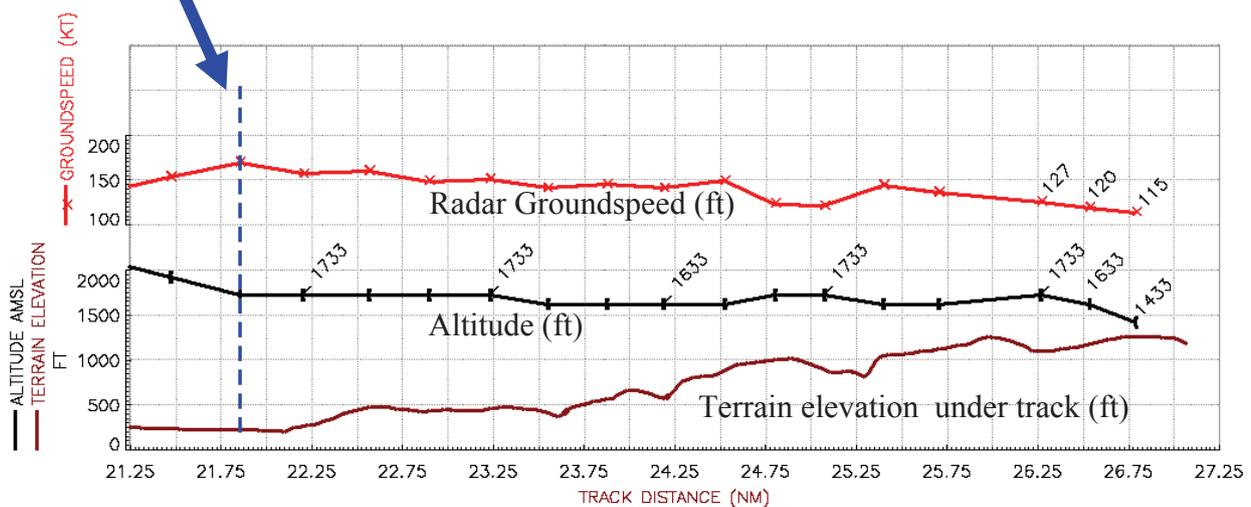
Figure 3

on the downwind leg of its approach to Runway 22 at approximately 1,000 ft amsl. At the same time, G-BWHF was positioned 1.3 nm south of the aerodrome at 3,233 ft amsl (Figure 3). Ninety seconds later, the R22 turned onto the base leg, at which time G-BWHF

G-BWHF radar track and R22 GPS track
