AIRCRAFT ACCIDENT REPORT AND EXECUTIVE SUMMARY

Reference:	CA18/2/3/8959	
Aircraft Registrations	ZS-NJX AND ZU-MMI	Date of Accident	14 August 2011		Time of Accident	±0830Z
Type of Aircrafts	Piaggio P166 Albatrosses		Type of Operation	Private		
Pilot-in-command Licence Types		Commercial and Private	Ages	61 and 57	Licences Valid	Yes
Pilot-in-command Flying Experience		Total Flying Hours	Approximately 4286 and 2893 respectively		Hours on Type	Unknown
Last point of departure		Tzaneen Aerodrome (FATZ) - Limpopo				
Next point of intended landing		Rand Airport (FAGM) - Gauteng				
Location of the accident site with reference to easily defined geographical points (GPS readings if possible)						
On a mountain, approx 500m south-east of Tzaneen, – GPS positions: S24°05,107', E030°11,230' and S24°05,107', E030°11,185; Elev = 5030 ft AMSL						
Meteorological Information		Wind: 160°03 knots ; Temperature: 14 °C;				
Number of people on board	1+5; and 1+6	No. of people injured	0	No. of people killed	13

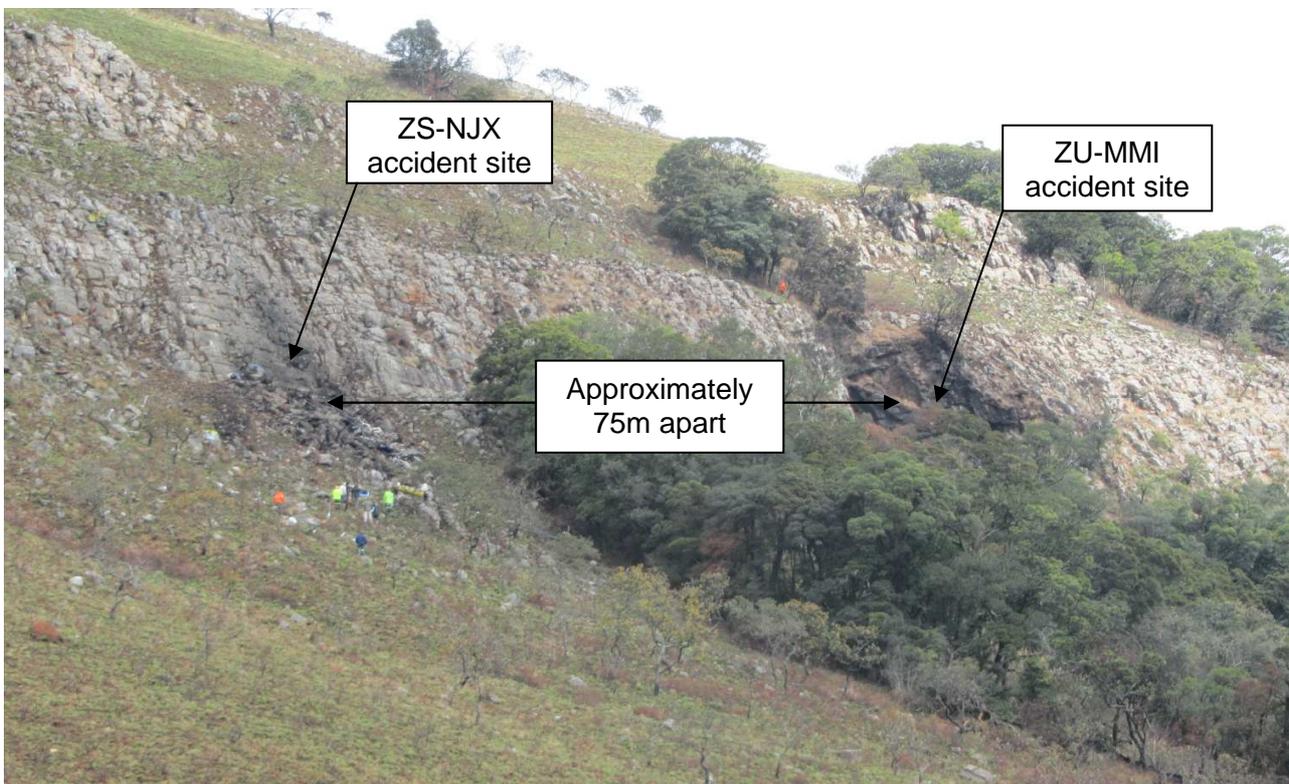
Photo 1: Showing the accident sites of the two aircrafts.

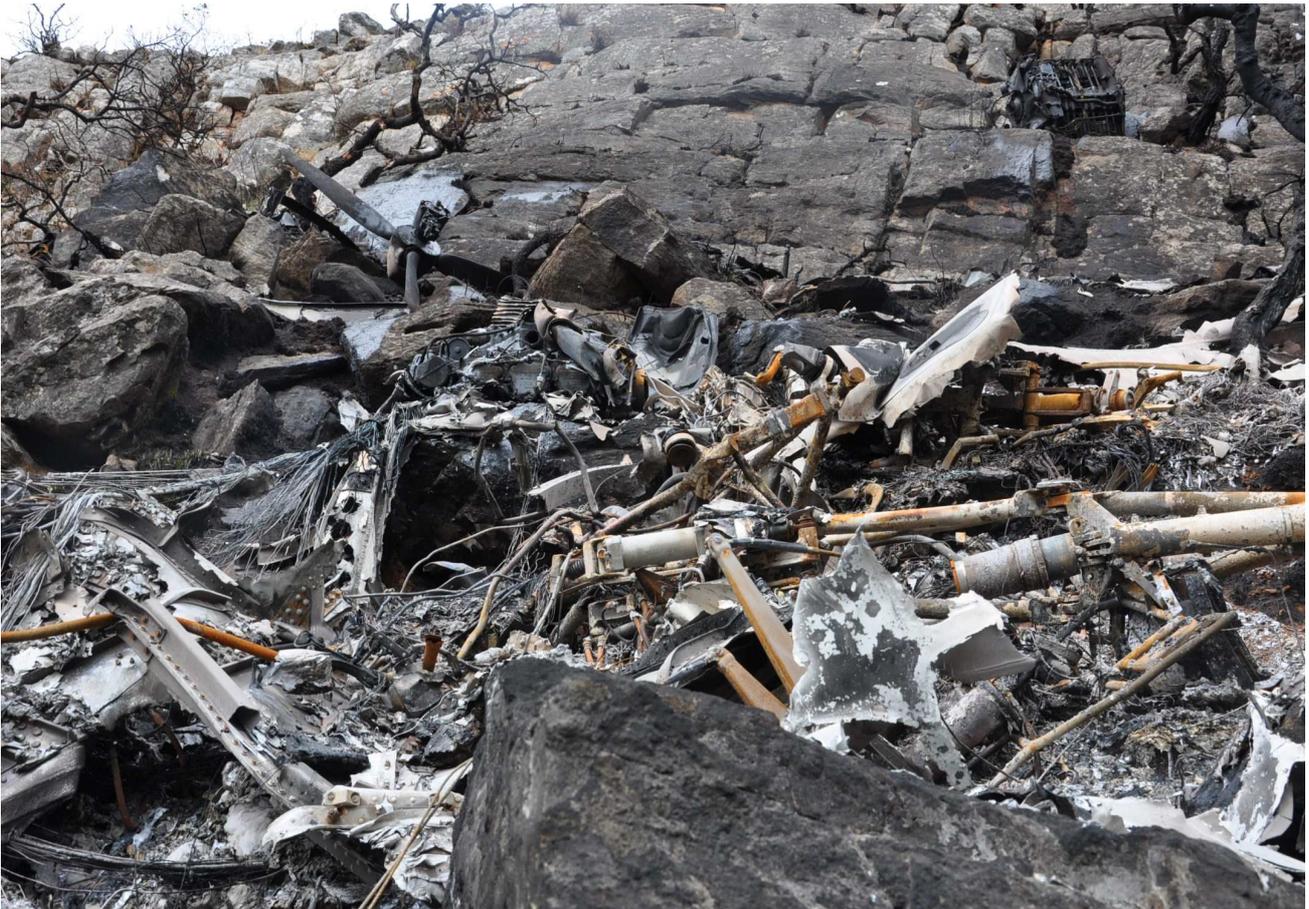
1.3.1. Both aircraft were destroyed during the accident sequence.

Photo 2: Showing damage to ZS-NJX

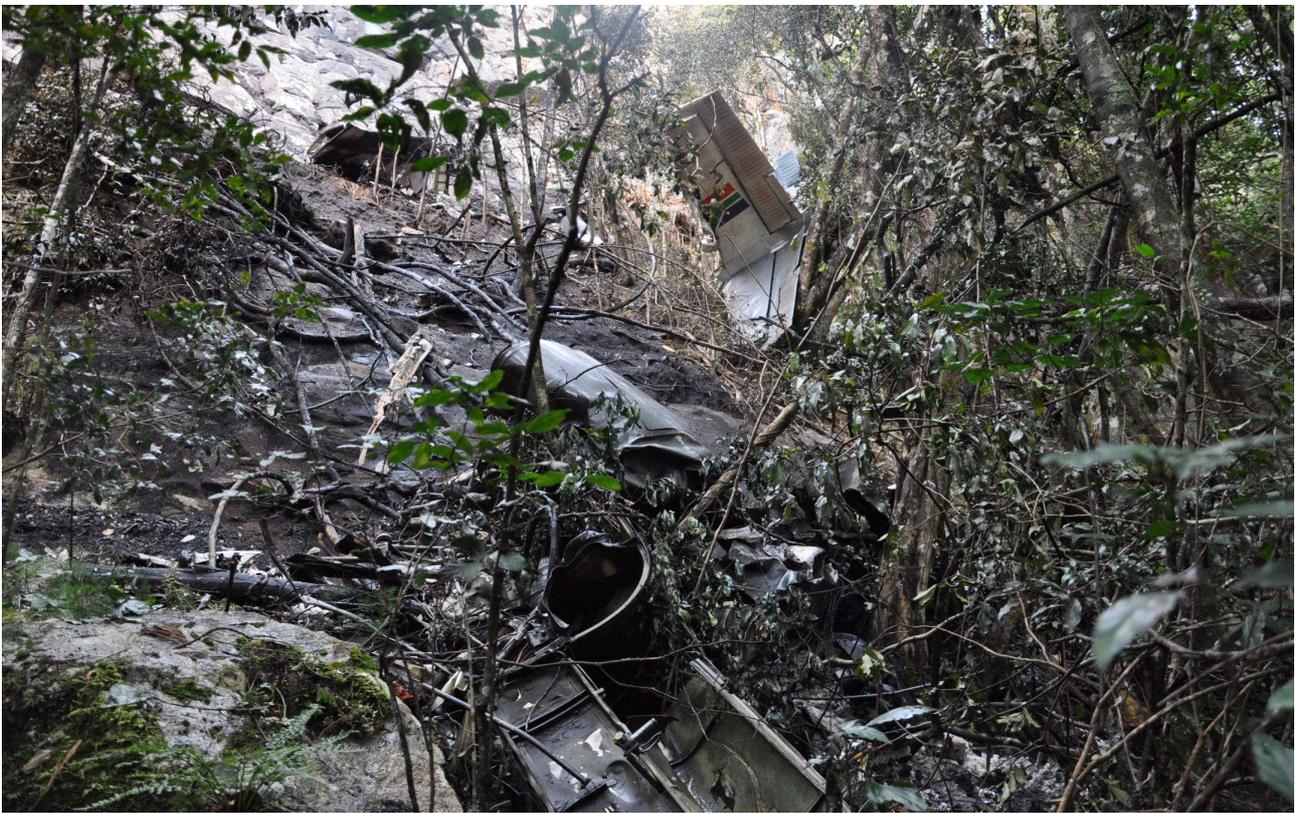
Photo 3: Showing damage to ZU-MMI

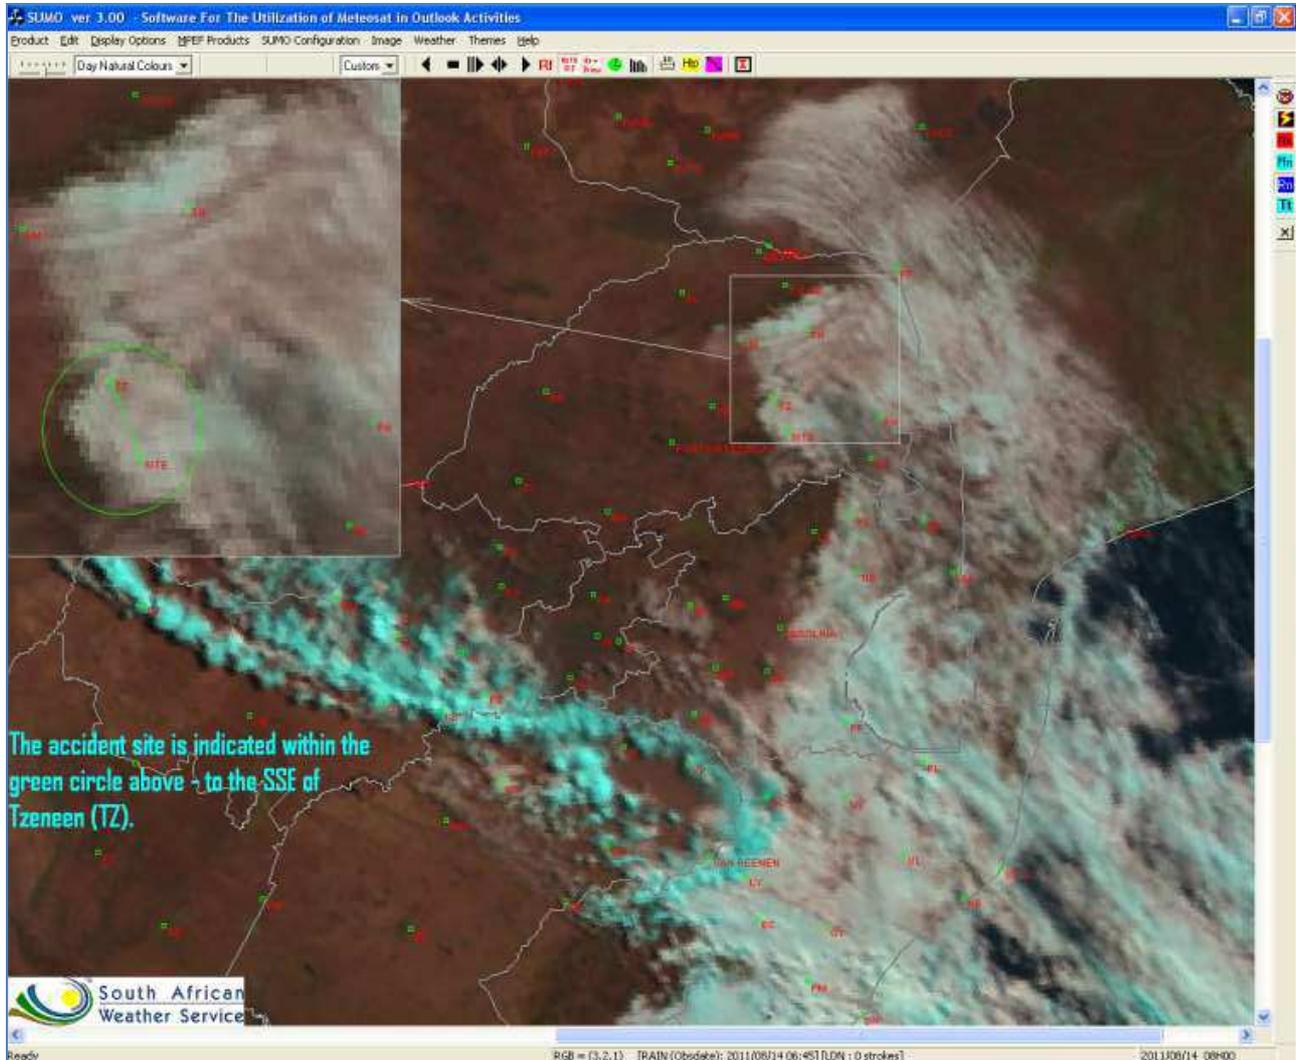
1.7.2. SATELLITE IMAGE (0800Z 14 AUGUST 2011)

The satellite image below shows a uniform layer (overcast) of low level clouds (stratiform) over the eastern and north-eastern parts of the country, which extend from the coast up to the escarpment areas. The brown colour indicates the ground (earth surface) while the light (whitish/creamy) shades depict low clouds. Mid-level clouds over the central interior are indicated by the light-blue colour within which convective cells can be identified as the cellular structures within this mid-level cloud band.

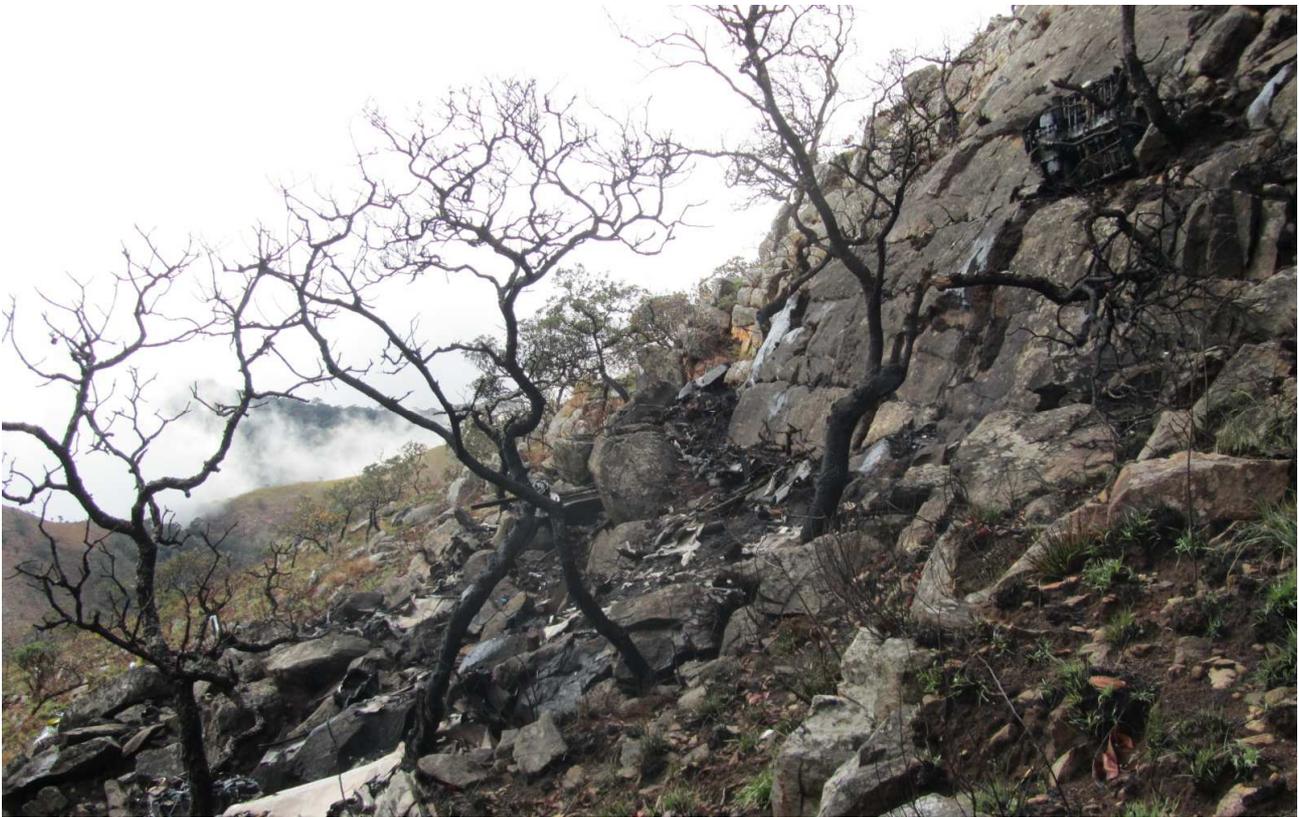
1.12.2.1. The terrain where the aircraft was found was a steep slope of approximately 60 degrees, with a lot of outcropped rocks and several trees and bushes in the vicinity, but no pre-impact skid or scratch marks were observed on any of the trees, bushes or rocks in the vicinity of the wreckage site.

1.12.2.2. The aircraft's point of impact with the mountain was at a rocky wall with an approximate 90 degree slope, approximately 20 meters below the top of the mountain, before sliding down the mountain a further 10 to 15 meters.

Photo 4: Showing the slope, terrain and impact point of ZS-NJX

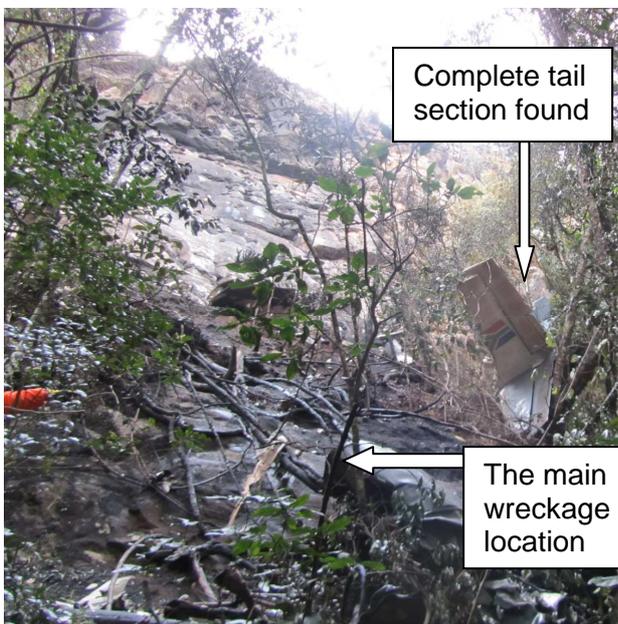
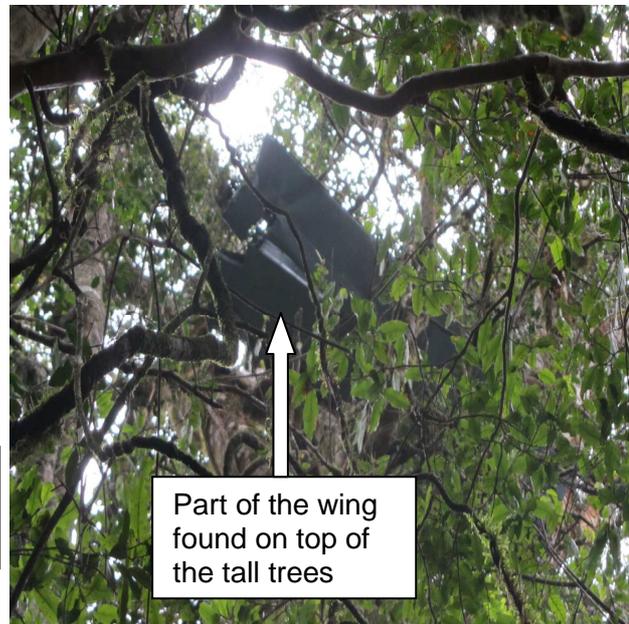
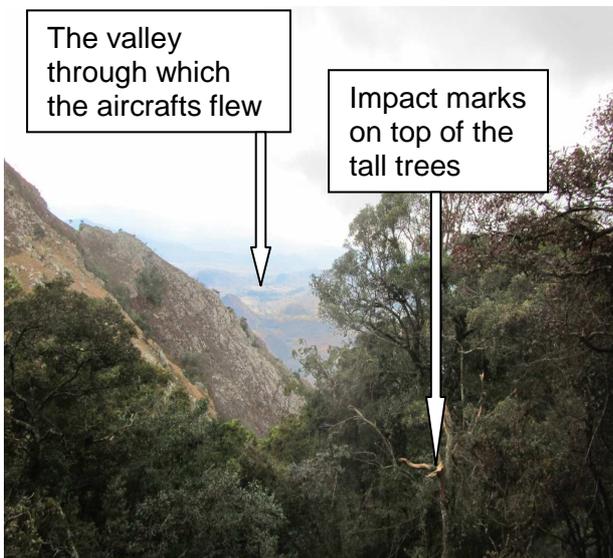
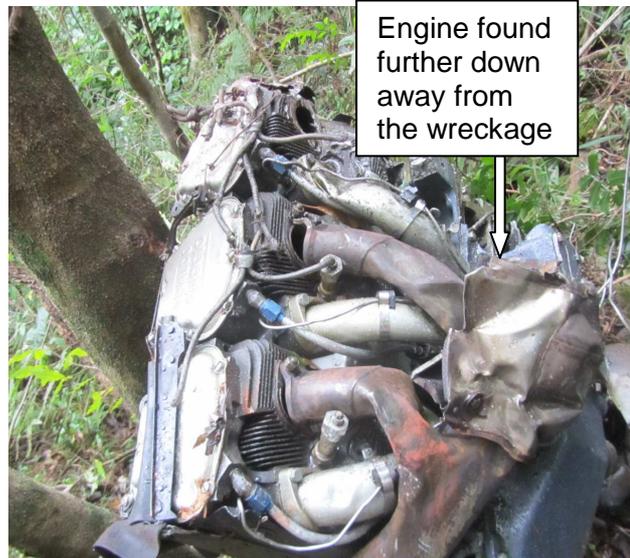
1.12.3.1. The terrain where the aircraft was found was a steep, wet and slippery slope of approximately 80 degrees, with a lot of huge, outcropped rocks, and a lot of tall trees. A lot of pre-impact marks were observed on top of the tall trees, and part of the left wing structure was found stuck on top of the tall trees.

1.12.2.3.A post impact fire ensued which destroyed most of the aircraft structure. The tail section was found in a relatively complete condition close to the main wreckage, with one of the engines found approximately a further 30 meters from wreckage down the slope, in between the trees.

Below are different pictures showing a number of components found at the wreckage of ZU-MMI as described above, and the trees hit by the aircraft in the valley through which the aircraft were flying:
