FINAL
KNKT.12.04.08.04

Aircraft Accident Investigation Report

**PT. ASI Pudjiastuti Aviation
Pilatus Porter PC-6 ; PK-VVQ
Melak Area , East of Kalimantan
East of Kalimantan
Republic of Indonesia**

25 April 2012

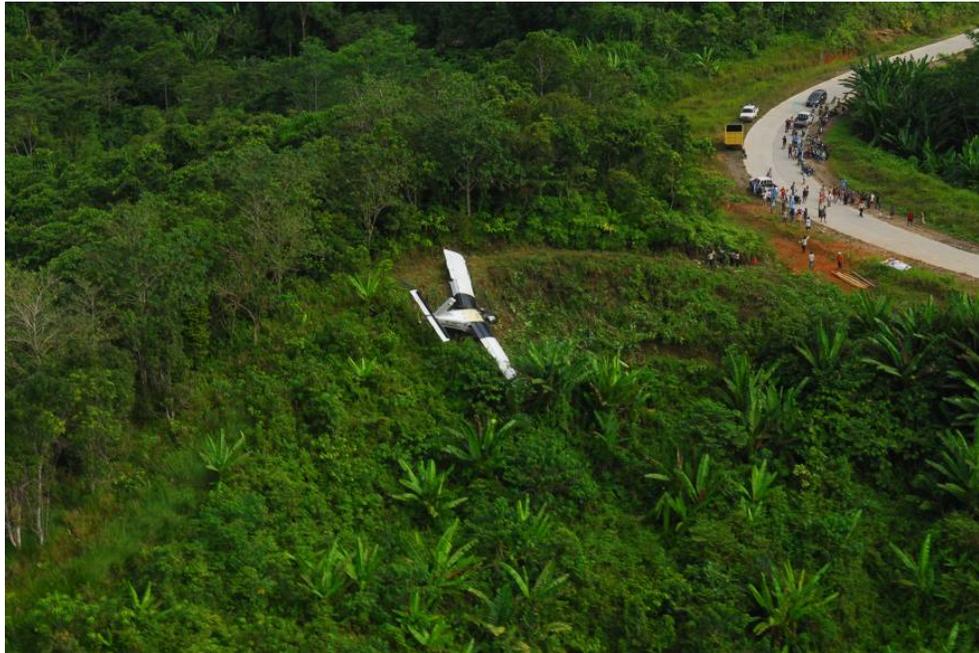
Figure 1: The accident site

The accident site is located about fifty meters from the local mining road (Figure 1 and 2).

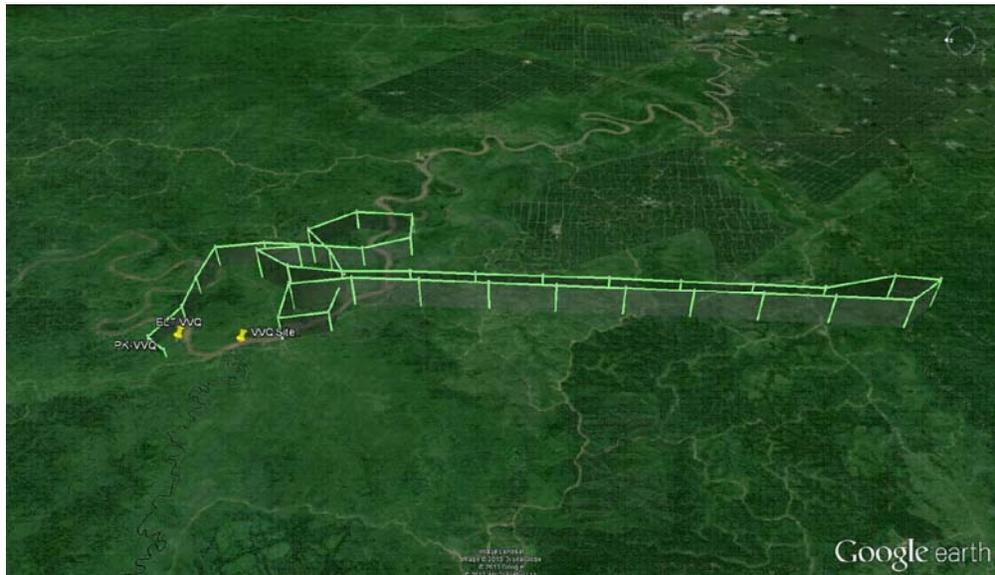
Figure 2: Accident Location Data from Flight Following Monitor

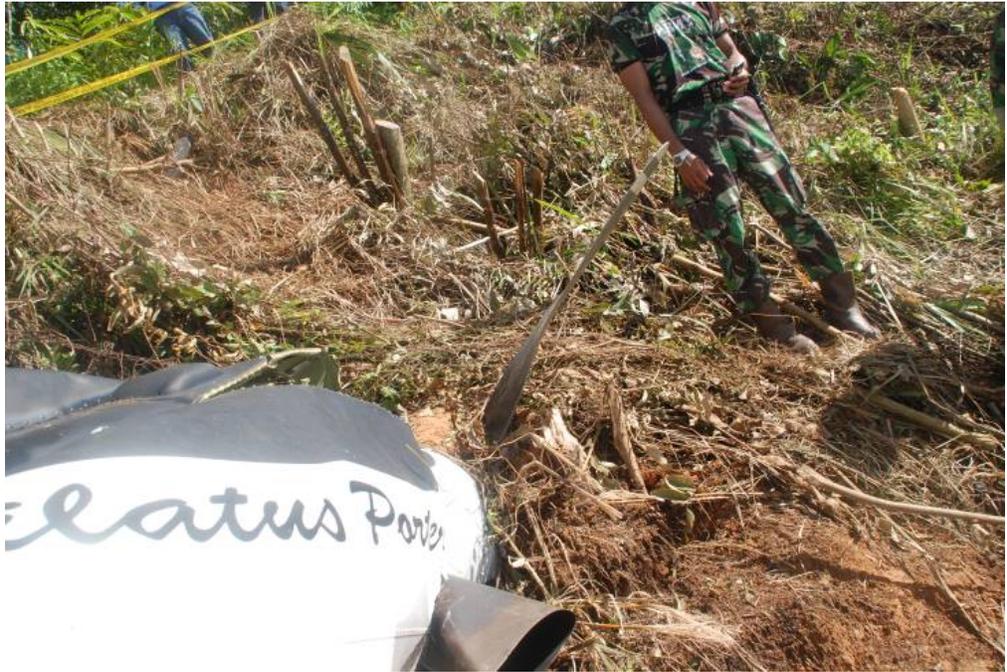
The engine was reported flamed out during flight, the propeller was feathered and with no evidence of rotation at impact

Figure 3: Propeller was on feather

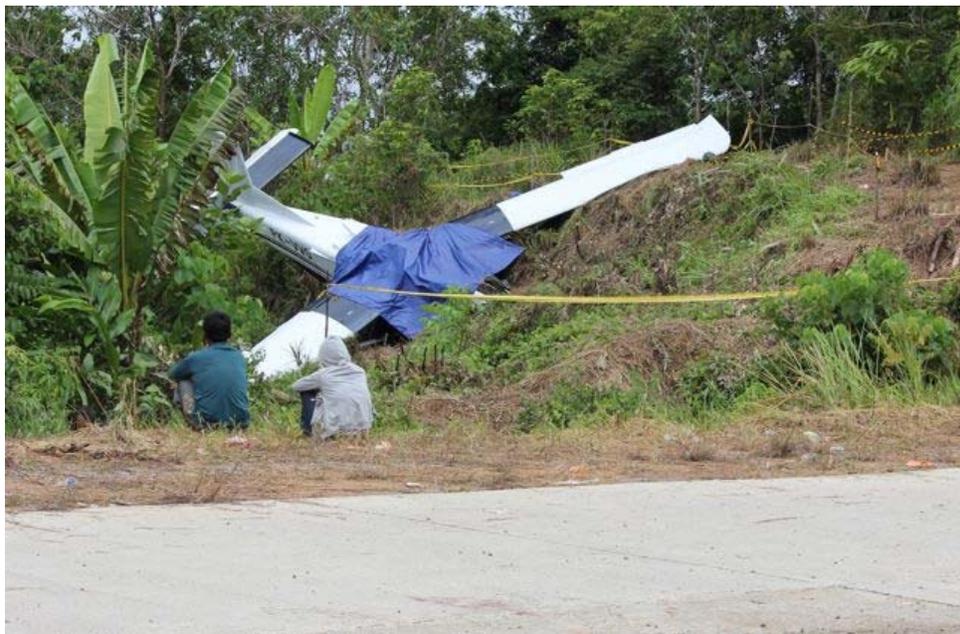
At impact, the aircraft was in a descending right turn. The impact site had a slope of about 40 degrees. The aircraft impacted with an approximately 25 degrees nose down attitude, resulting in a impact angle of 65 degrees relative to the ground (Figure 4). There was no evidence of continued forward motion of the aircraft after the initial impact.

Figure 4: The aircraft impacted with an approximately 25 degrees

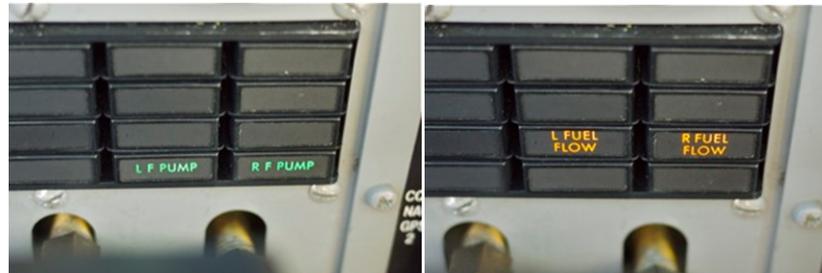
Figure 6: There were no fuel low levels warning lights or annunciators installed on the aircraft.

It is recommended to develop a low fuel warning system for all PC6 aircraft that can be installed on new aircraft and retrofitted to existing aircraft.

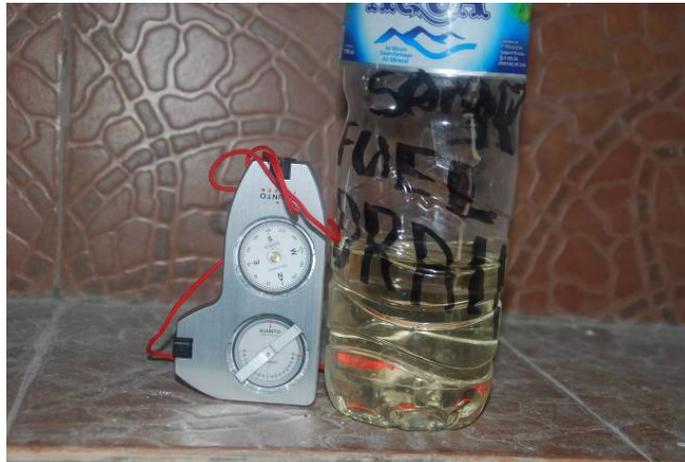
The remaining fuel at the collector tank was clear fuel (non-contaminated (Fig 7), and the engine fuel filter element was clean see (Fig 8), the fuel pump drive gear was normal. see (Fig 9),

Figure 7: Remaining fuel at collector tank

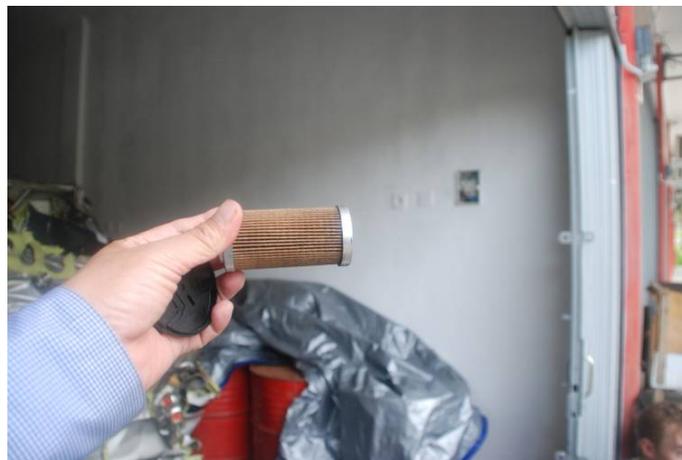
Figure 8: Engine fuel Filter.

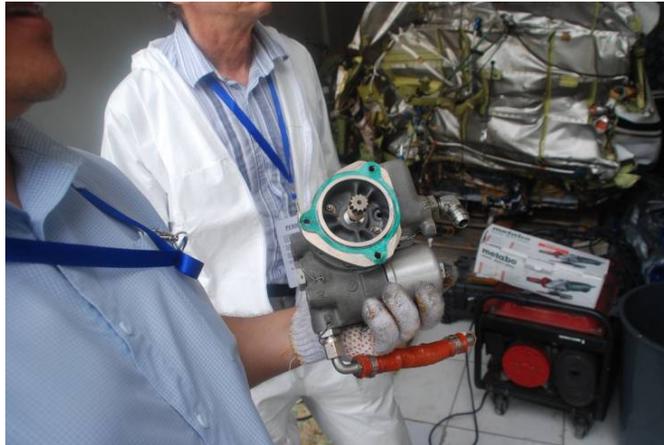
Figure 9: Spline Gear shaft

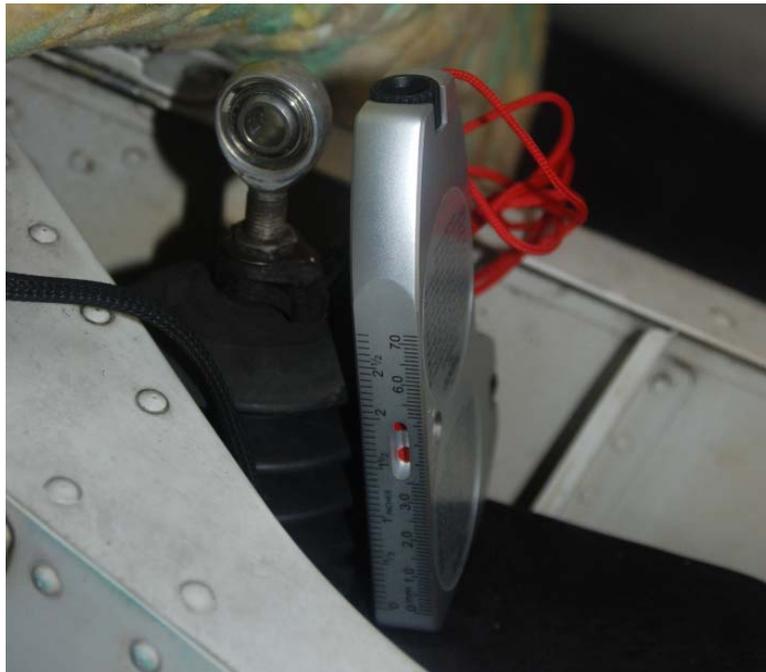
Figure 10: Actuator Horizontal Trim Tab

The Aircraft Manufacturer expert determined that the pitch trim was set to the nearly full nose-up position (see Figure 10) and that the flaps were about half extended ($16^{\circ} - 18^{\circ}$ versus 38°). (See Figure 11)
