File No. 2143-43

REPORT OF THE CIVIL AERONAUTICS BOARD

On the Investigation of an accident,
involving aircraft of United States
registry NC 17603, in the Tagus River,
Lisbon, Portugal, on February 22, 1943.

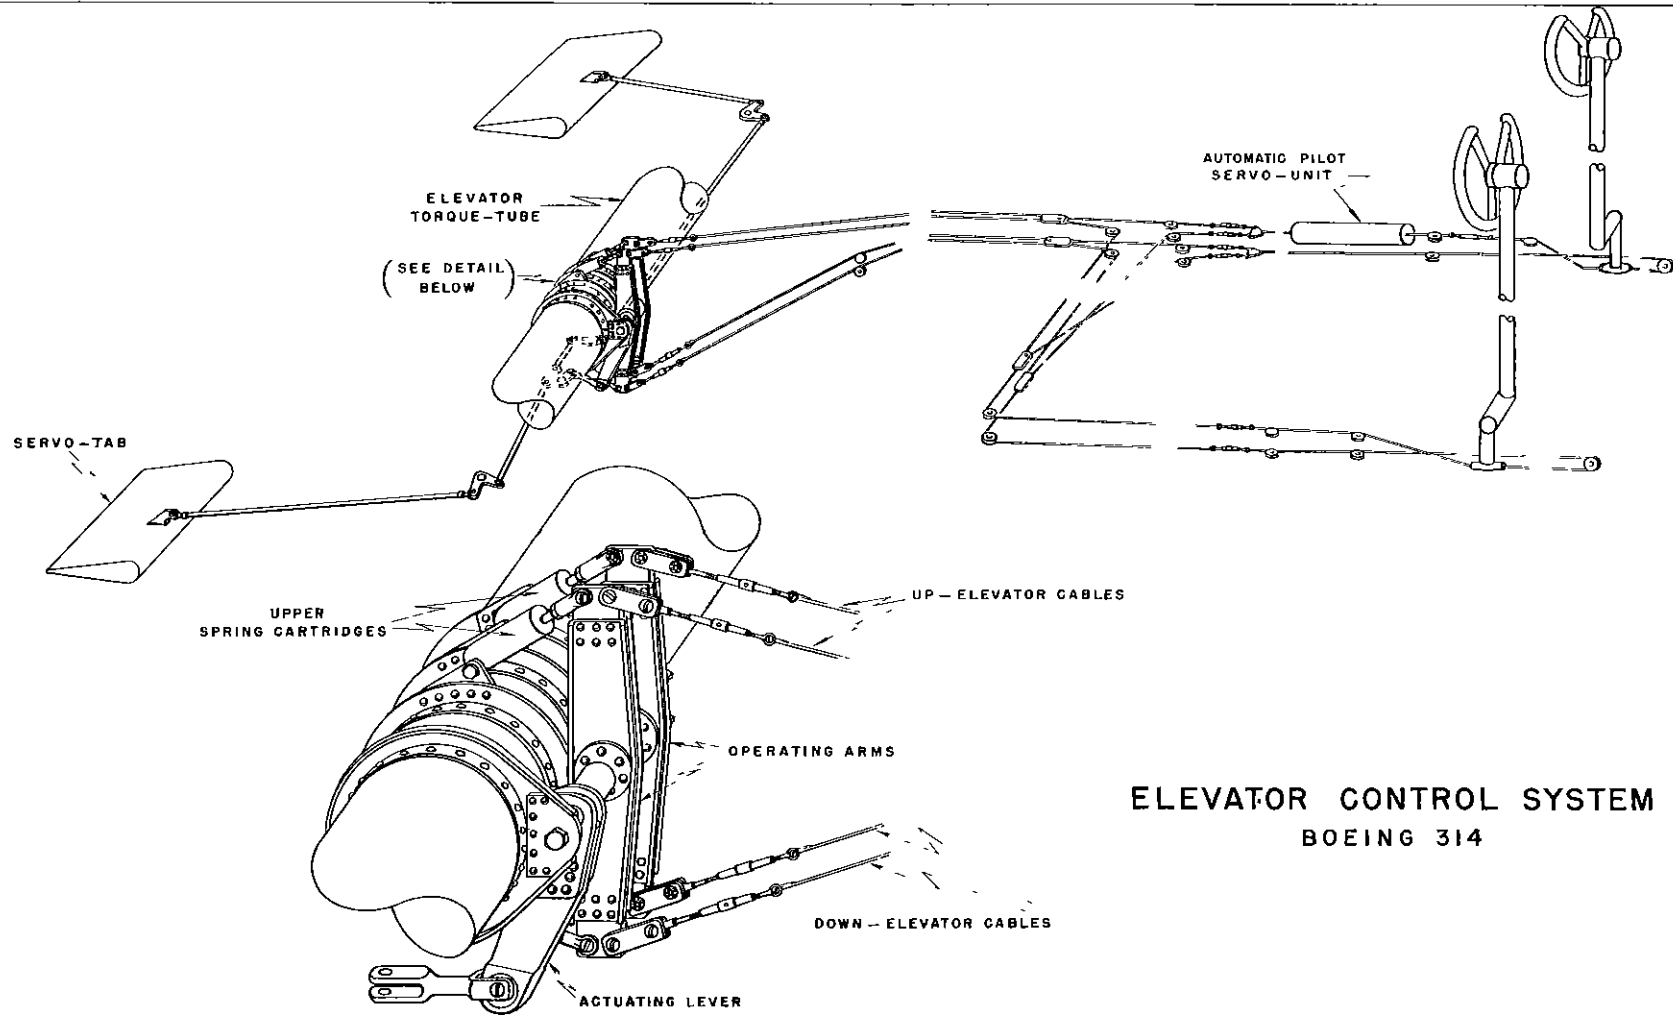
**ELEVATOR CONTROL SYSTEM
BOEING 314**

The elevator control system of the Boeing 314 consists of two sets of cables which permit operation of the elevator through an initial range of approximately 20° either side of the position of zero hinge moment by means of servo-tabs.^{4/} An additional 5° motion in either direction is attained by direct operation of the elevator through the torque-tube. The four ends of the operating arms are also connected to the torque-tube by means of four independent spring-cartridges. The purpose of these cartridges is to permit the operation of the elevators through the normal operating range by means of the servo-tabs, while still permitting direct operation of the elevators

The only individual failures in the cable control system which could render the elevators inoperative are the two cable connecting links which were recovered from the wreckage undamaged and intact.

The dual set of cables enables either the captain or first officer, or both, to operate the system in case any one cable fails. If one of the servo-tab systems should become inoperative, the other set would operate the elevators sufficiently for control. Even the failure of the hinge bolt supporting the operating arms, or the failure of the actuating lever, would not deprive the airplane completely of elevator control. The failure of one, or even all four of the cartridges would not influence the operation of the elevator through the first 20° of surface movement.

Sufficient parts of the elevator control system were recovered to permit detailed examination and study and to establish beyond reasonable doubt that the system was functioning prior to impact. The only element found to have been broken was the rod of the lower starboard spring cartridge. This break had the appearance of having occurred sometime prior to the accident. However this finding is not considered to be relevant in establishing the cause of the accident, inasmuch as even had this cartridge been broken, it would have had no effect on the operation of the airplane. Although this conclusion seemed quite apparent from a study of the design of the elevator control system, nevertheless the Board arranged with PanAm for specific tests to clarify this matter beyond a doubt. During these tests, one or more of the cartridges were disconnected and the operation of the elevator control system was found to remain normal.
