AIR SAFETY BOARD
REPORT

Accident involving aircraft NX 19901

of the Boeing Aircraft Company, near

Alder, Washington, March 18, 1939.

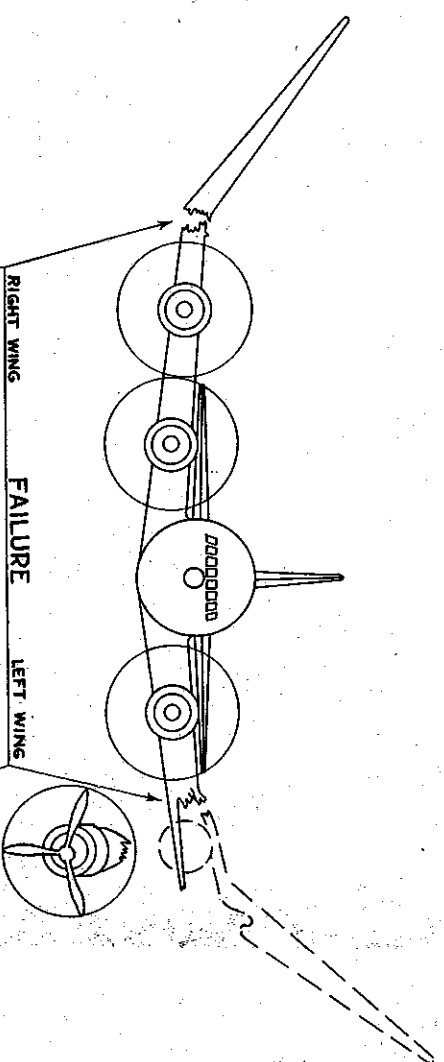
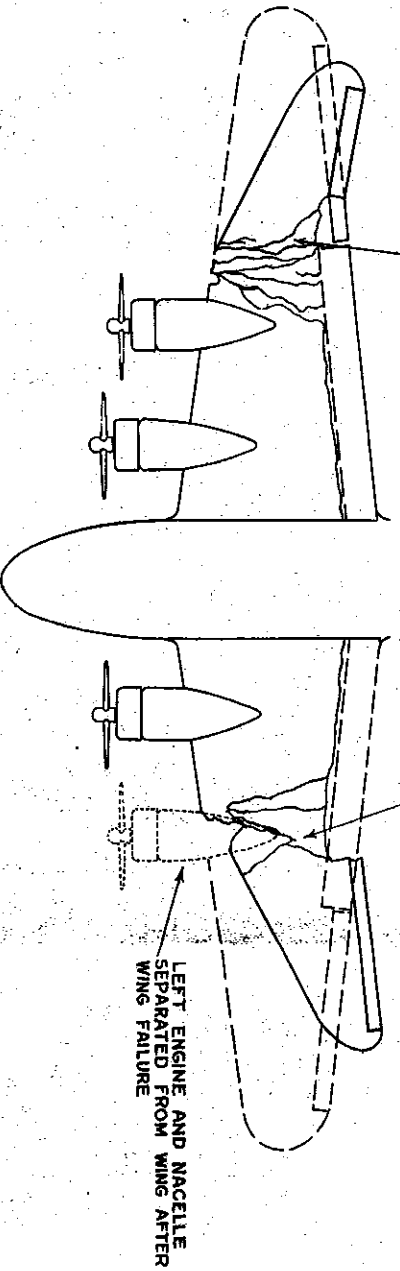
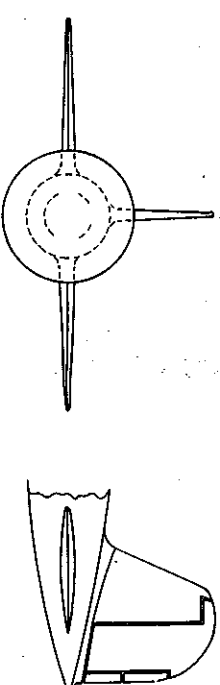
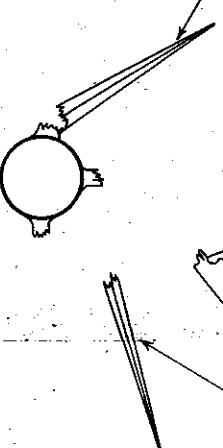
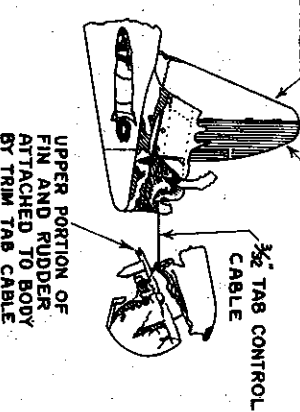
EXHIBIT C
FAILURES IN DESCENT

OUTER PORTION LEFT ELEVATOR DETACHED —
INNER PORTION LEFT ELEVATOR REMAINED
ATTACHED FOR A SHORT TIME —

RIGHT STABILIZER AND ELEVATOR
REMAINED ATTACHED TO BODY AFTER
FAILURE. HELD TO BODY BY UPPER
FAIRING AND $\frac{1}{2}$ TRIM TAB CABLE

LEFT STABILIZER SEPARATED, BROKEN
FROM BODY, FELL FREE AND WITHOUT
ELEVATOR PARTS

Both the stabilizers and elevators failed upward, and, as was indicated by the symmetry of the failures on both sides of those surfaces, both as to type and location of the failures, these tail surfaces were apparently symmetrically loaded at the time of such failures. The failures in the stabilizer front spar upper chords consisted of the rivets attaching the hinge fittings to the spar chords being sheared by loads acting inward. The upper spar chords made deep symmetrical dents in the body on their respective sides. The lower front stabilizer spar chords failed in tension, the one on the left failing in the steel hinge terminal, and the one on the right failing in the spar chord just outboard of the steel hinge terminal. The failures in the rear spars were similar to the failures in the bottom chords in the front spars.

The left elevator was broken into two pieces, the outboard failure occurring in the nose section of the elevator formed by the elevator channel section spar and the leading edge skin just outboard of the point where the heavy torque tube ends within the elevator. The failure was due to torsion and bending, with bending predominating. As the stabilizers and elevators were deflected upward under the action of the upward acting loads, the elevators moved out-

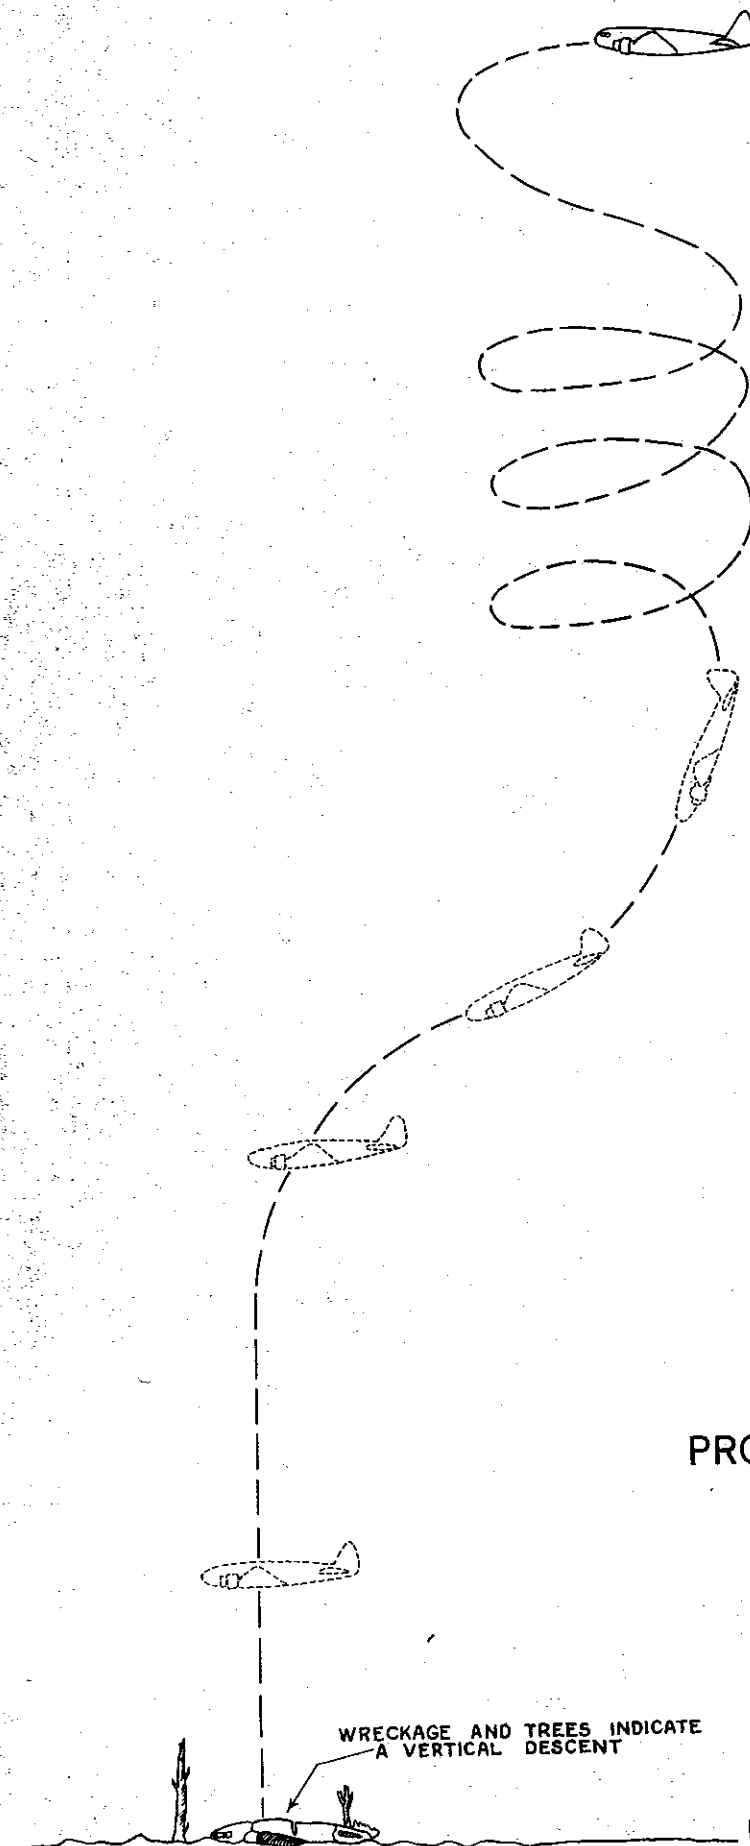
EXHIBIT A
PROBABLE FLIGHT PATH

vicinity of Alder, Washington, the aircraft stalled and began to spin in a nose down attitude. After completing two or three turns in the spin, during which power was applied, it recovered from the spin and began to dive. The aircraft partially recovered from the dive at an altitude of approximately 3,000 feet above sea level, during which recovery it began to disintegrate. Outboard sections of the left and right wings failed upward and broke entirely loose from the aircraft. Major portions of the vertical fin and portions of the rudder were carried away by the wing wreckage. The outboard section of the left elevator separated from the stabilizer and both fell to the ground detached. The right horizontal tail surface, being held on by the fairing along the top surface and also by the elevator trim tab cables, remained with the fuselage. The No. 1 engine nacelle also broke loose from the aircraft and fell to the ground separately. The main body of the aircraft settled vertically and struck the ground in an almost level attitude both longitudinally and laterally at a point approximately 1,200 feet above sea level. Watches and clocks aboard the aircraft, which were broken by force of the impact, indicated the time of the accident as approximately 1:17 p.m. (PST).

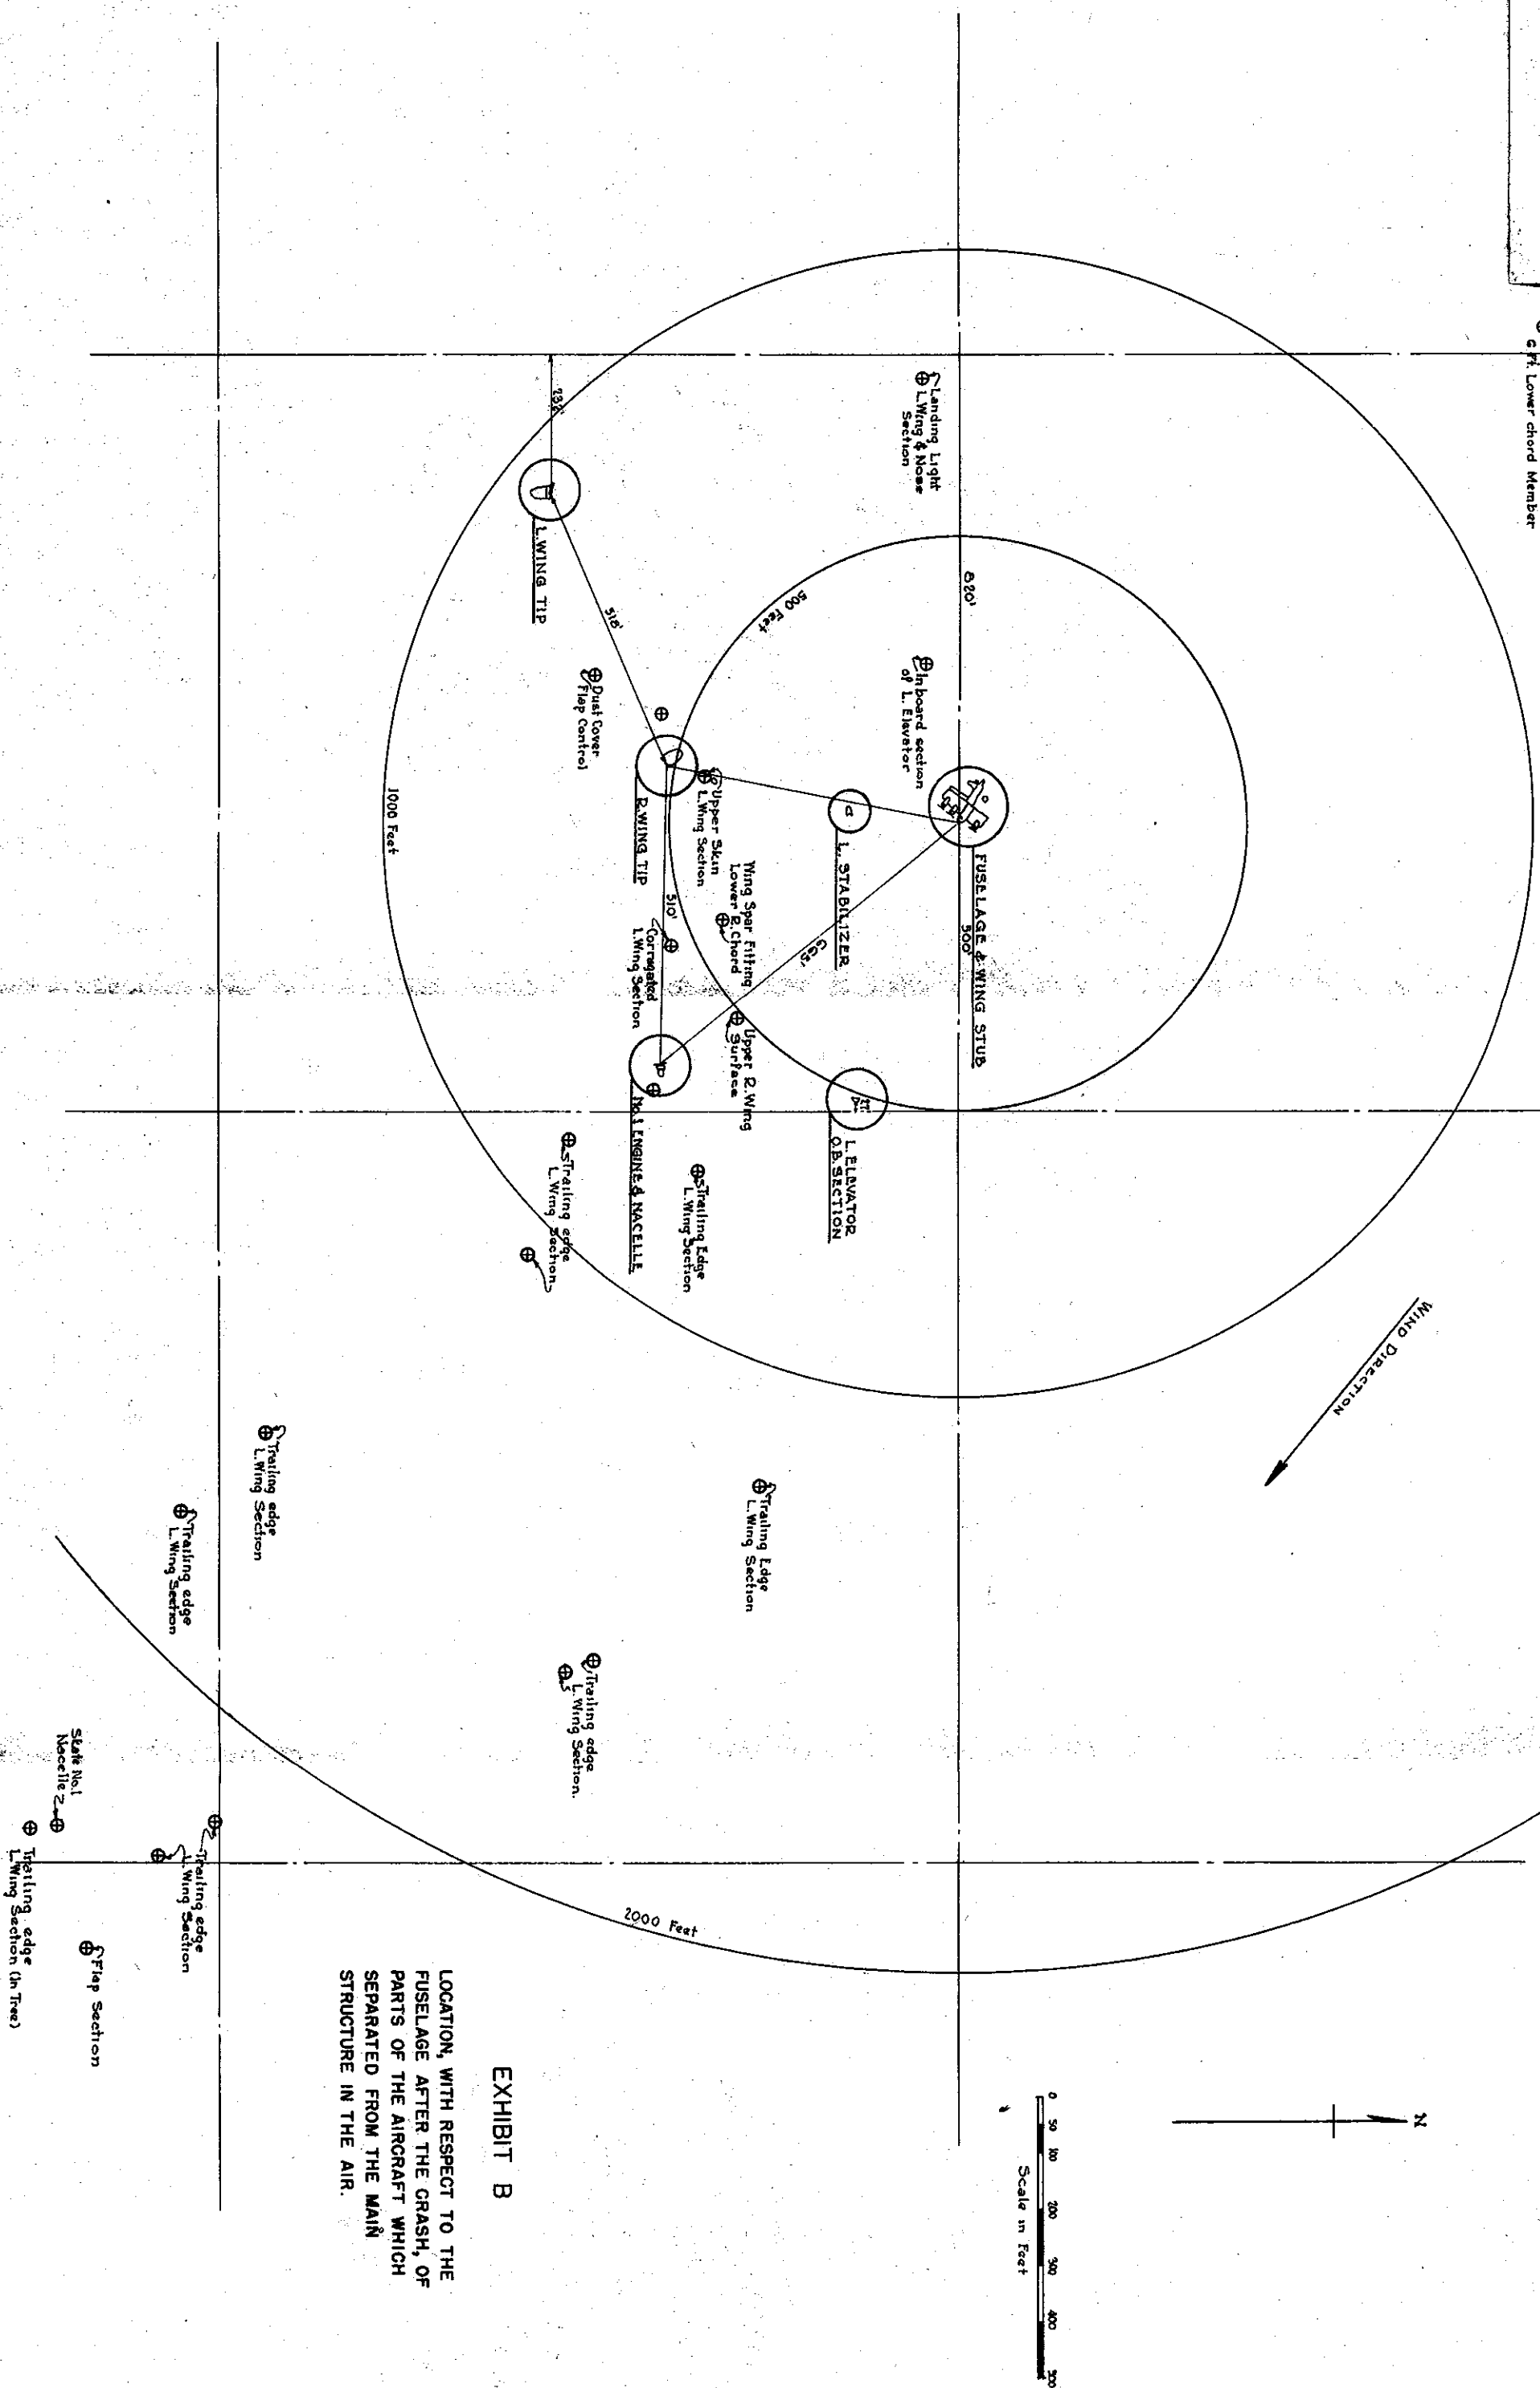
EXHIBIT B
LOCATION, WITH RESPECT TO THE
FUSELAGE AFTER THE CRASH, OF
PARTS OF THE AIRCRAFT WHICH
SEPARATED FROM THE MAIN
STRUCTURE IN THE AIR.

Left outer wing panel, about 1,000 feet in a southwesterly direction; right outer wing panel, about 530 feet in a southerly direction; left outboard engine nacelle, about 660 feet in a southeasterly direction; left horizontal stabilizer, about 200 feet in a southerly direction; and the left elevator outboard portion, about 500 ft. in a southeasterly direction. The great majority of small parts were found within the distance encompassed by the location of the larger pieces from the fuselage, though a few parts were found at a distance of 2,500 feet in a southeasterly direction.
