ACCIDENT

Aircraft Type and Registration:	Saab-Scania SF340B, G-LGNL	
No & Type of Engines:	2 General Electric CT7-9B turboprop engines	
Year of Manufacture:	1991 (Serial no: 340B-246)	
Date & Time (UTC):	2 January 2015 at 0833 hrs	
Location:	Stornoway Airport, Isle of Lewis	
Type of Flight:	Commercial Air Transport (Passenger)	
Persons on Board:	Crew - 3	Passengers - 26
Injuries:	Crew - None	Passengers - None
Nature of Damage:	Extensive damage to the nose landing gear, powerplants and underside of the aircraft	
Commander's Licence:	Air Transport Pilot's Licence	
Commander's Age:	46 years	
Commander's Flying Experience:	3,880 hours (of which 3,599 were on type) Last 90 days - 98 hours Last 28 days - 28 hours	
Information Source:	AAIB Field Investigation

Synopsis

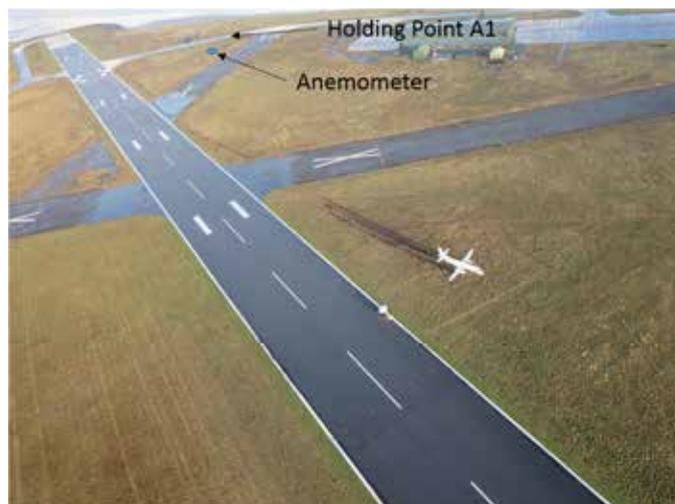
Figure 1

Marks from all six tyres were visible on the runway from about 200 m after the taxiway where the aircraft entered Runway 18. These tracks diverged to the left and then departed the paved surface after another 100 m. The tracks remained visible on the unpaved surface beside the runway until the point where the aircraft came to rest, a further 250 m, but were not visible for the period when the aircraft crossed a disused paved runway (Figure 1).

General view of accident site

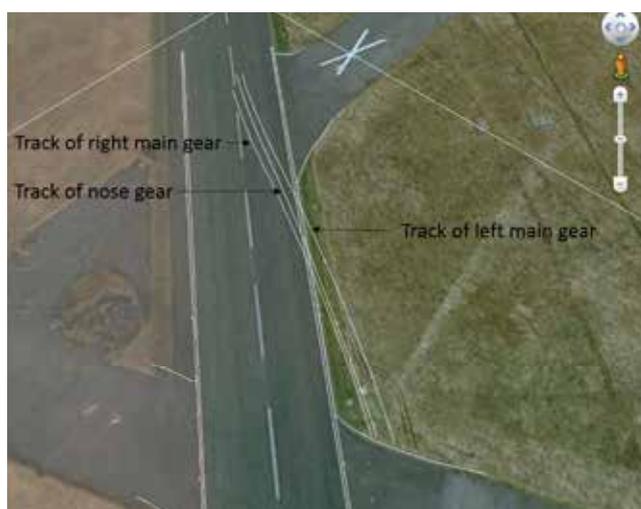
The rubber marks left by the tyres indicated that the tyres were not rolling straight ahead and, as the aircraft approached the side of the runway, the geometry of the marks indicated that the aircraft was progressively yawing to the right of its direction of travel (Figure 2). Calculations indicated that this yaw angle reached a maximum of approximately 14° just after the aircraft entered the grass beside the runway and it remained fairly constant until the aircraft reached the disused runway. There were no tyre marks across the disused runway but when they reappeared in the grass on the far side the aircraft was no longer yawed. Shortly after this point the ground markings indicated where the nose landing gear collapsed.

Tracks of the aircraft landing gear (Police Scotland)

As the aircraft moved towards the edge of the runway, the pilot applied right rudder in an attempt to return to the runway centreline. Figure 2 shows that, with the aircraft still on the runway, the nose of the aircraft began to turn right in response to the rudder input but the main landing gear maintained their track towards the runway edge. The track of the nose landing gear moved towards that of the right landing gear, indicating that the aircraft was skidding left as it departed the paved surface.

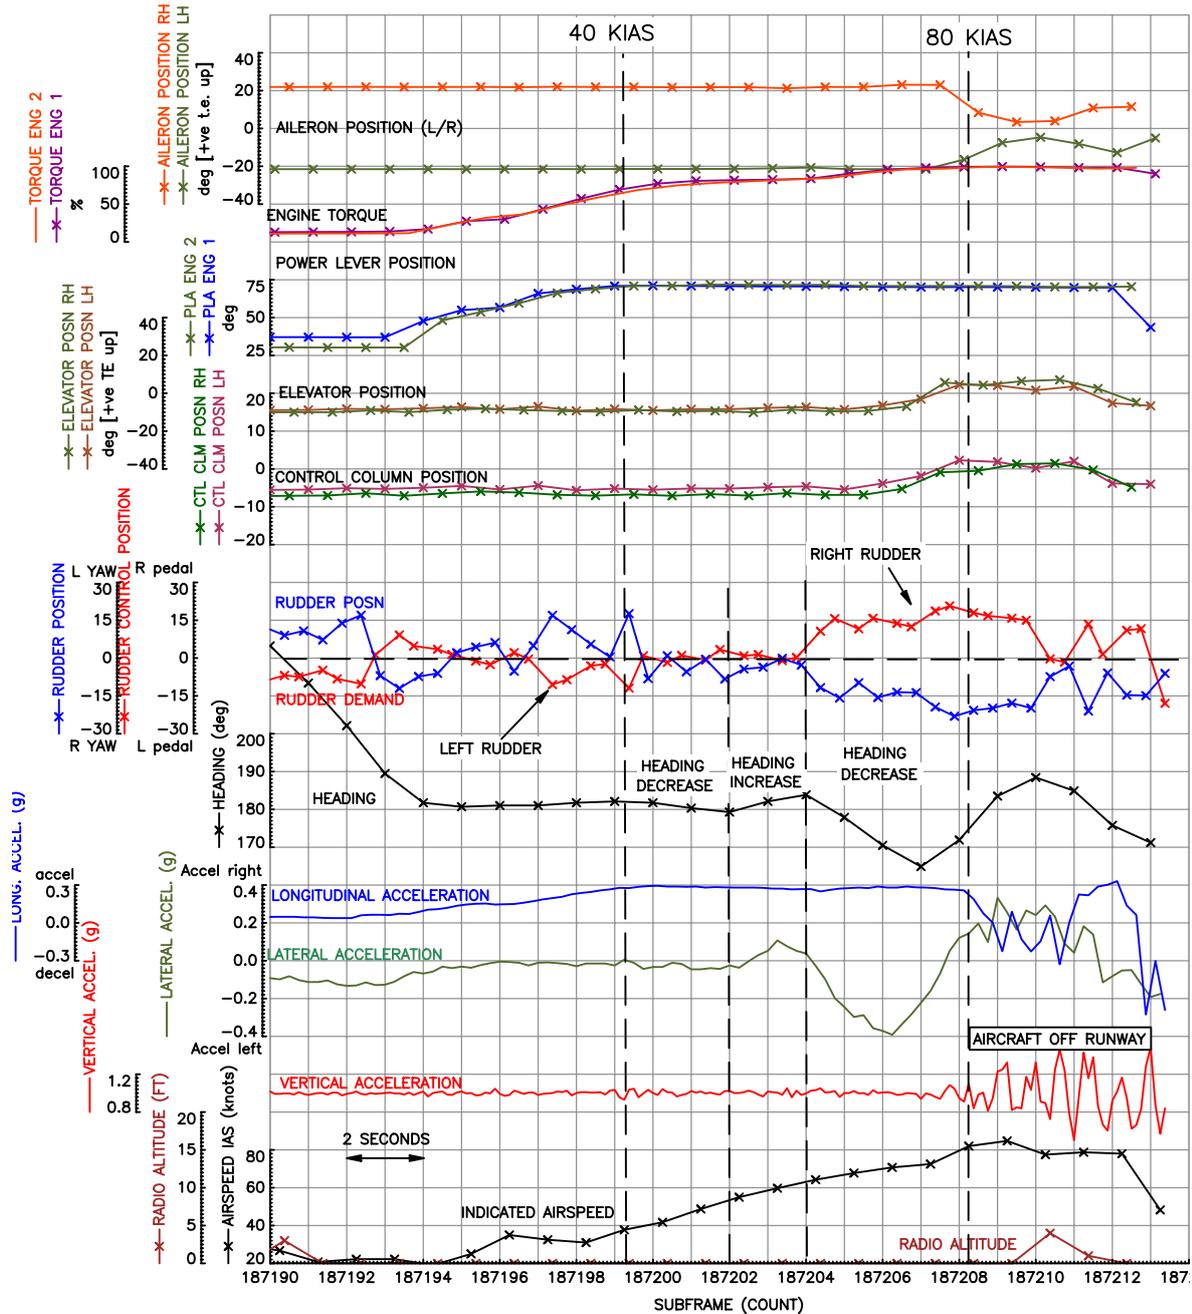
Figure 3
G-LGNL FDR data⁷

As the aircraft turned on to the runway heading, the power levers were slowly advanced, reaching full travel five seconds later, with engine speed and torque increasing symmetrically on both engines. During this period, left rudder was applied until the aircraft reached a recorded airspeed of approximately 40 kt (Figure 3). Over the next three seconds, the heading decreased from 182.1° to 179.3° followed by a reversal in direction to the right to a heading of 183.9° over the following two seconds. At this time, the aircraft was accelerating through approximately 65 kt with the rudder approximately centralised and right aileron still applied.

Over the next three seconds, the aircraft heading decreased to the left to 164.9° . As the aircraft began to turn, right rudder was commanded which increased the heading to 188° as the aircraft accelerated through 80 kt. During this heading change, fluctuations in the normal and longitudinal accelerations suggest that the aircraft had left the paved surface at an indicated airspeed of approximately 80 kt. Despite the heading indicating a turn to the right, the ground marks confirmed the aircraft departed the left side of the runway, yawing to the right. Right rudder was applied continuously throughout.

During the attempted takeoff, the rudder was central from 40 kt and remained so until approximately 65 kt. Between approximately 52 and 65 kt, the aircraft turned right slightly before it turned left sharply at approximately 65 kt (Figure 3). Given that the rudder was central, this change of direction might have been caused by one, or a combination of the following factors:
