Interim Report

Type of Occurrence:	Accident
Date:	30 September 2015
Location:	Saarbrücken
Aircraft:	Airplane
Manufacturer / Model:	Bombardier Inc./ DHC-8-402
Injuries to Persons:	None
Damage:	Aircraft severely damaged
Other Damage:	None
Information Source:	Investigation by BFU
State File Number:	BFU 15-1354-AX
Published:	December 2015

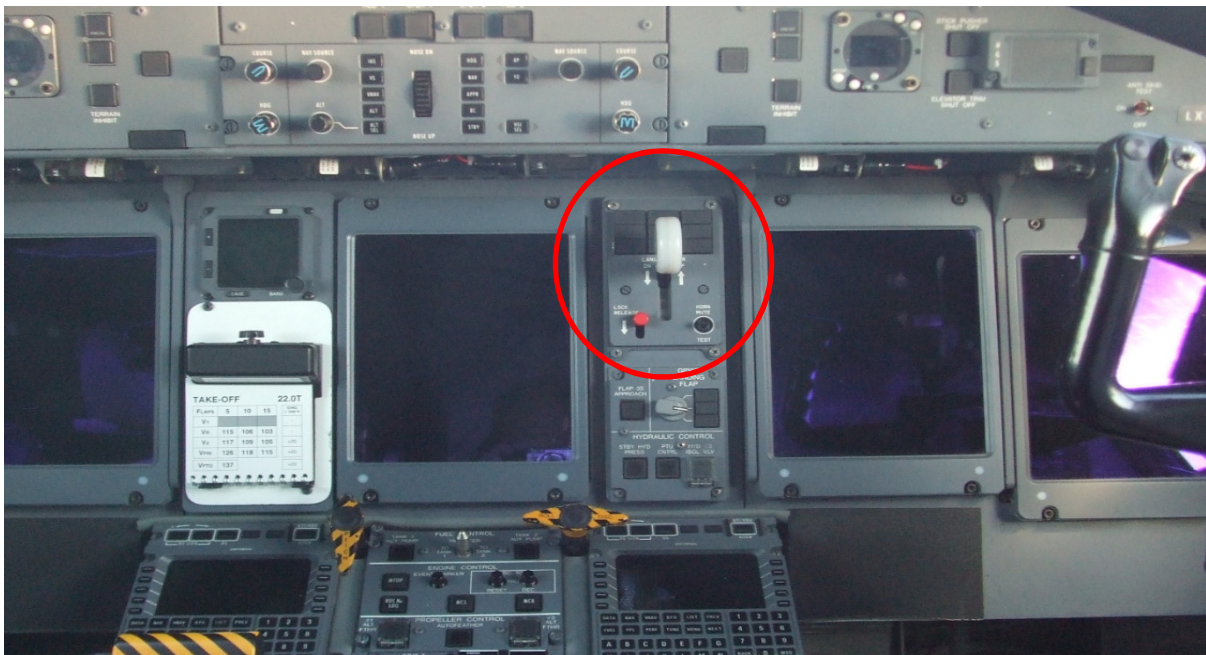
Position landing gear lever, Lock Release and indication lights in the cockpit

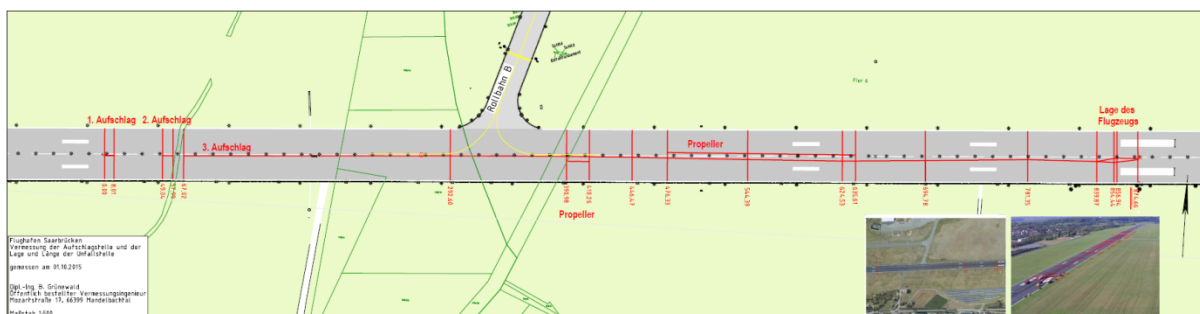
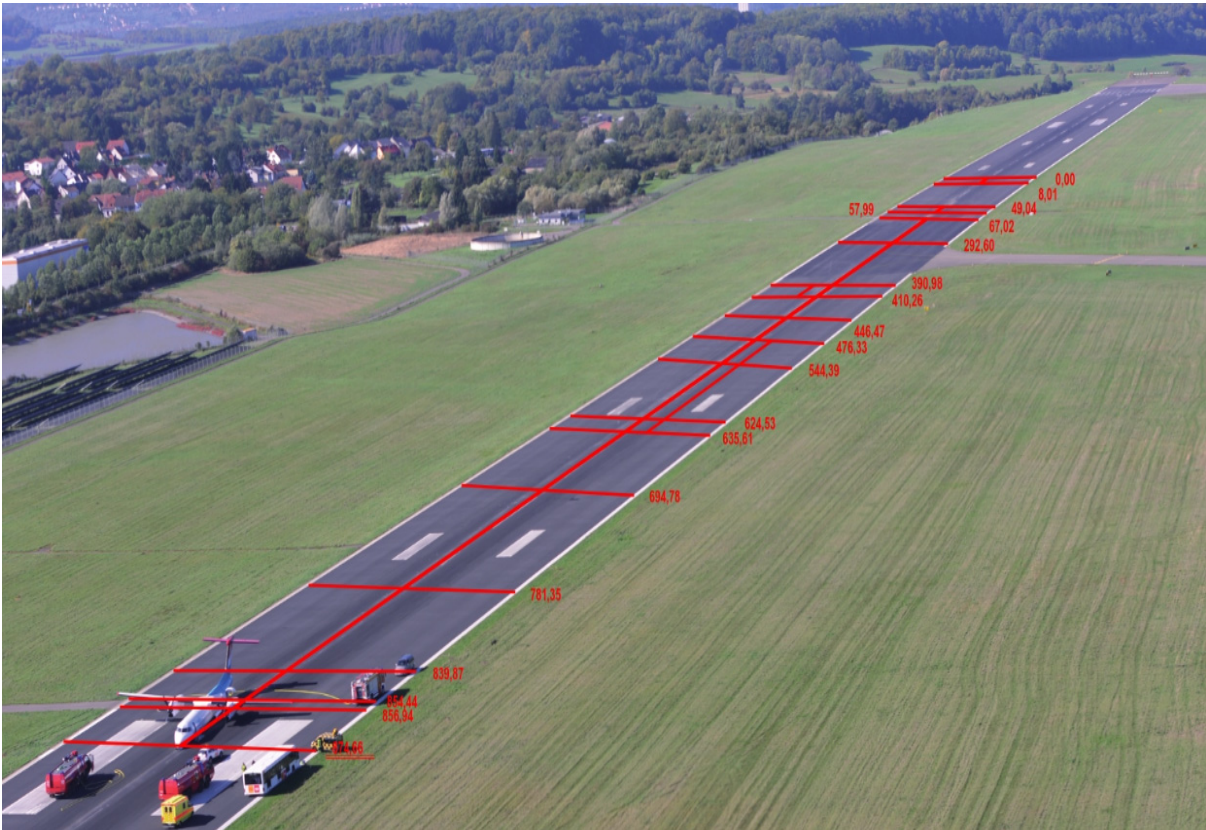
The airplane bounced three times and skidded for a distance of approximately 807 m. It then came to rest abreast the PAPI of runway 27 approximately in the centre of the runway.

Overview skid marks and final position of the airplane

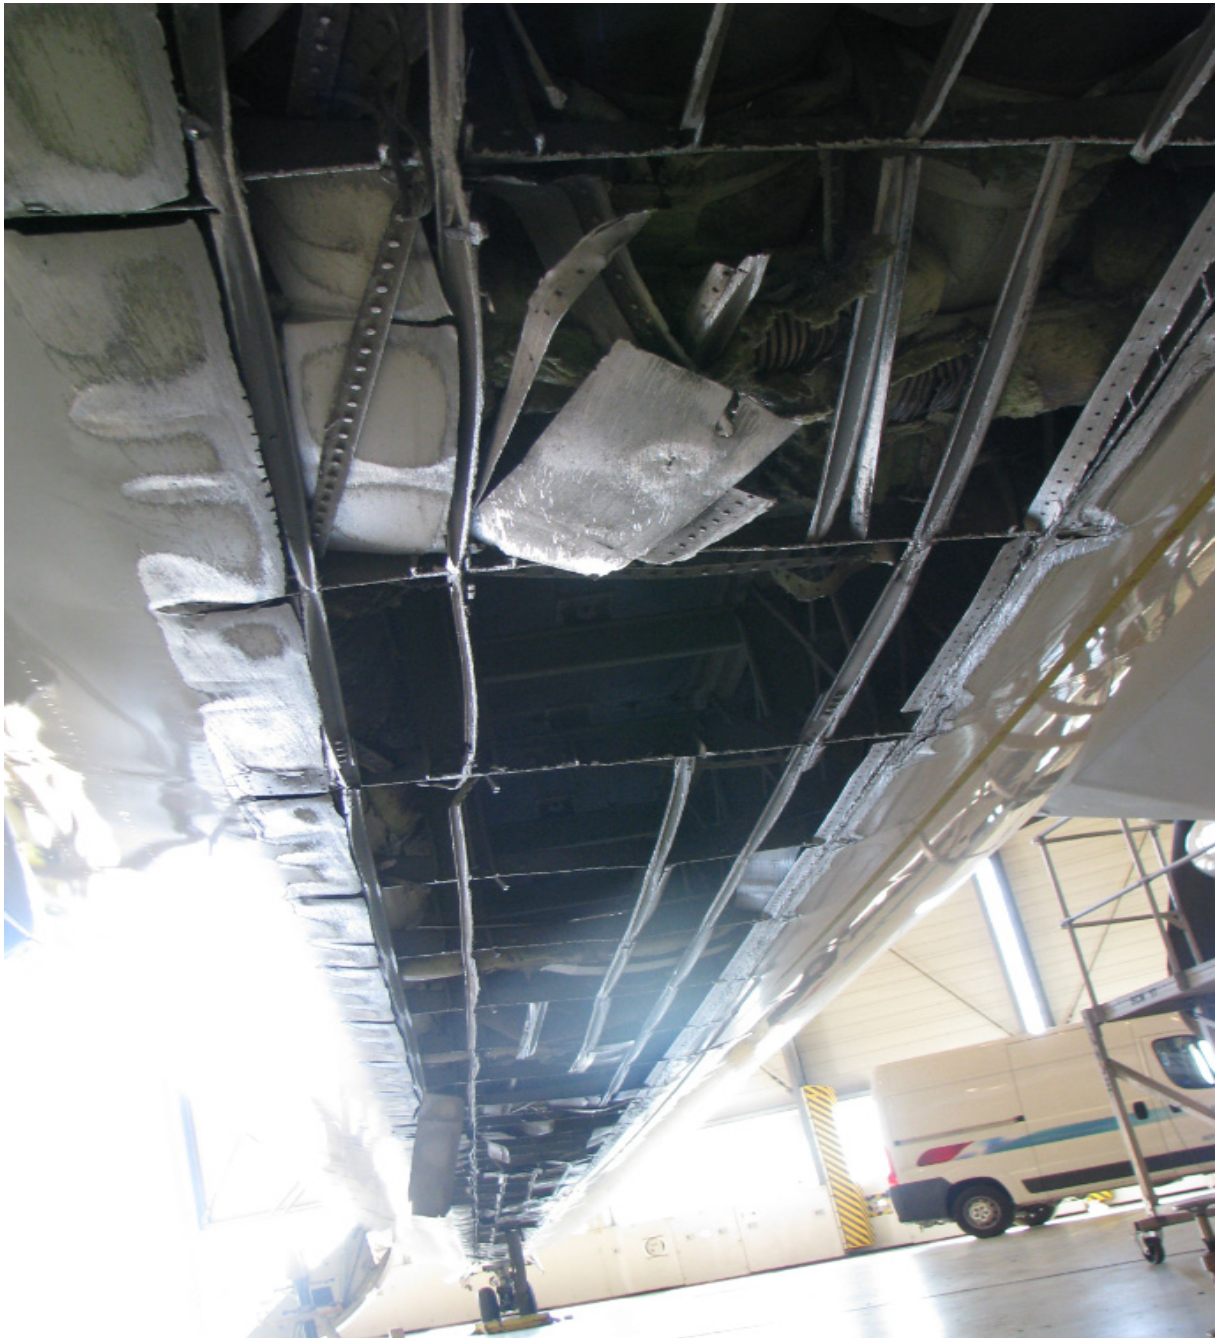
The airplane rested upright on the fuselage. The main landing gear was completely retracted and the wheel well doors at the engine cowlings closed. The nose landing gear was retracted. The front nose landing gear doors were open and damaged. The landing gear selector lever in the cockpit was in the position “Up”, i.e. retracted. The propeller blades of the left propeller were shortened by approximately 40 cm and the ones of the right by about 1 cm. Commensurate propeller impact marks were found on the runway. The left lateral fin below the fuselage was abraded by about 3 cm on the entire length. The fuselage’s bottom surface was scratched, dented and completely abraded, respectively, from about 2 m aft of the nose landing gear until the aft baggage compartment.

Damage on the fuselage's bottom surface (in flight direction)

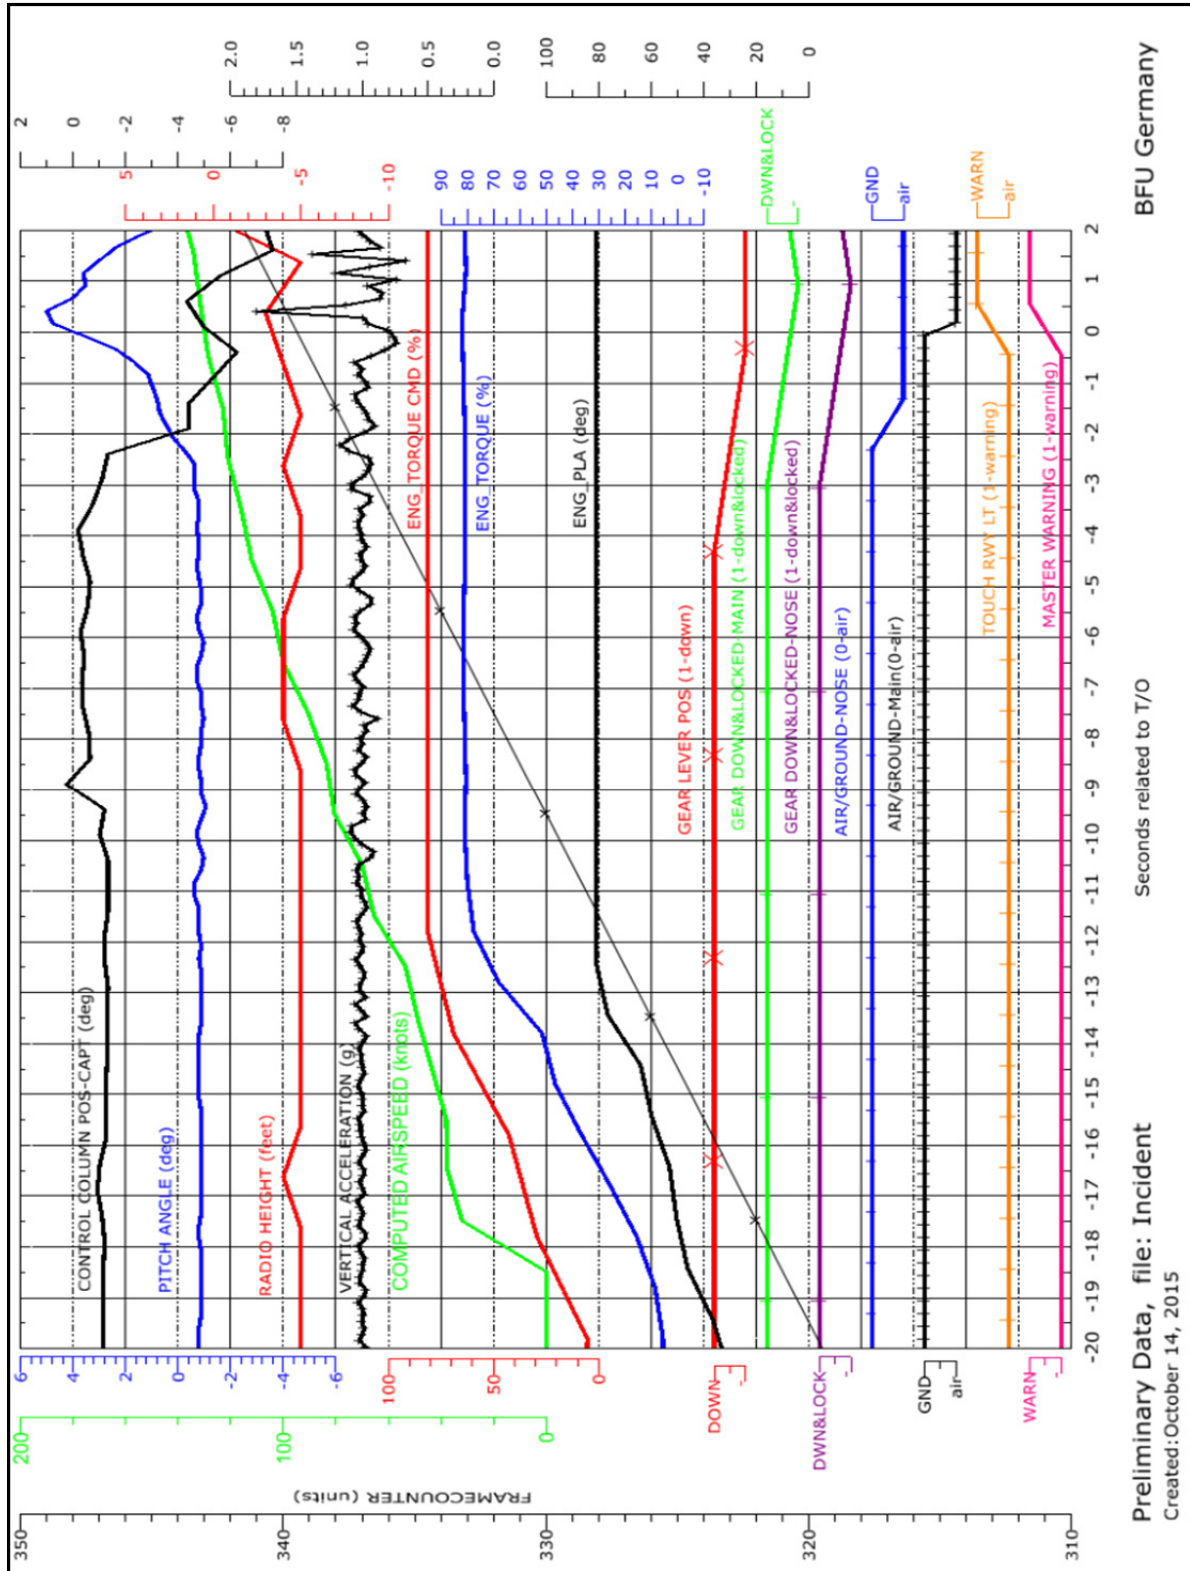
FDR data of the take-off run

During the rotation phase with approximately 127 KIAS and a nose-up attitude of approximately 5°, the landing gear retracted. At 1016:44 hrs the airplane's tail had the first ground contact (tailstrike). The tailstrike warning light illuminated. Approximately 875 m after the initial ground contact the airplane came to a stop after it had bounced three times and skidded on the fuselage.
