No. 10

SABENA (Société Anonyme Belge d'Exploitation de la Navigation Aérienne),
DC-6 aircraft, OO-SDB, crashed at Costone dell'Acquasanta,
Reatini Mountains, on 13 February 1955.
Report by Ministero Difesa Aeronautica, Italy.

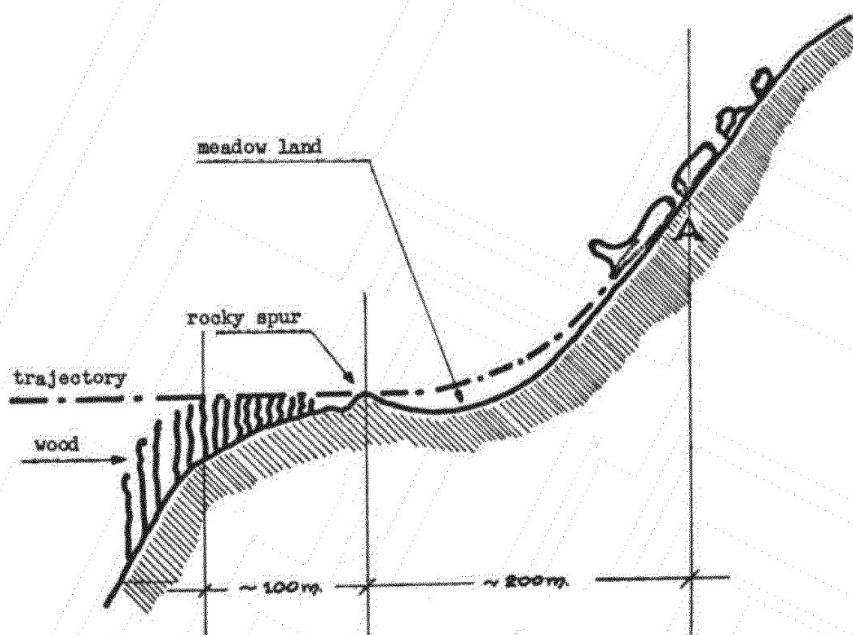
Figure 7

A large part of the wreckage was discovered in the vicinity of Point A in Figure 7. Many parts and fragments were found near the rocky spur (see Figure 7) and in the meadow, not far from the precipitous slope to the right of the fuselage (viewed from the rear).

Diagram of territory in which SABENA DC-6 aircraft crashed.
Reatini Mountains

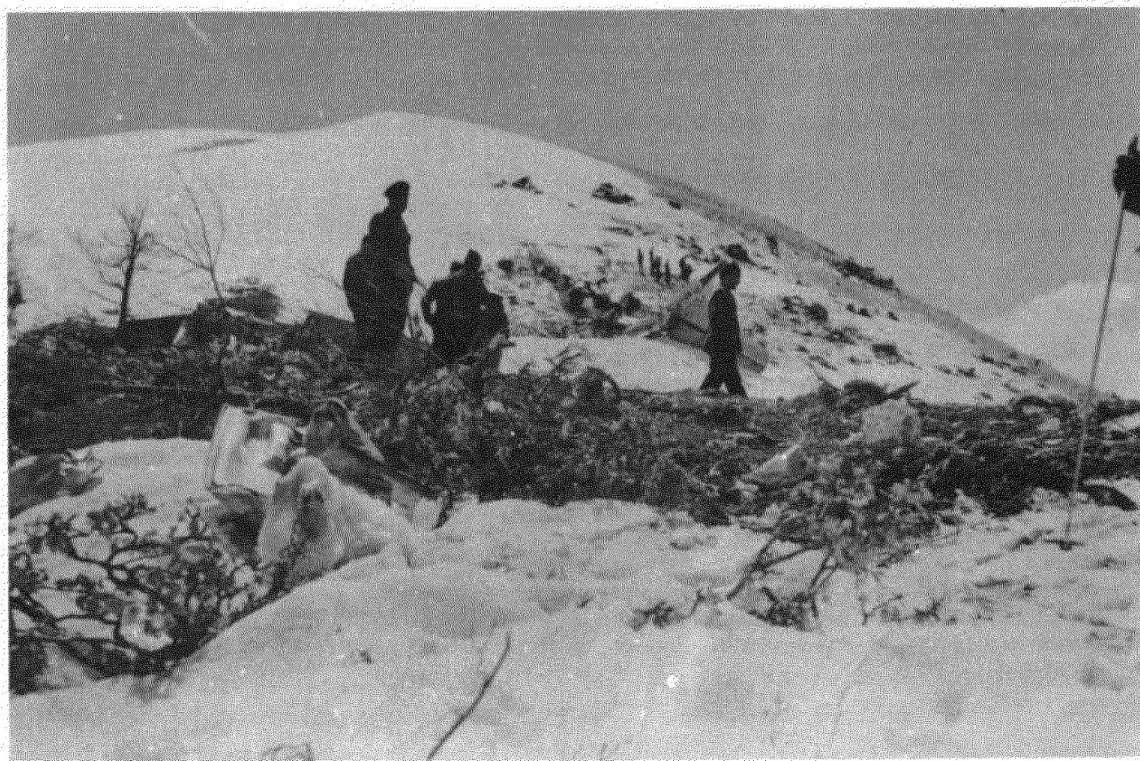
Figure 8

General view of crash area.
Costone dell'Acquasanta, Reatini Mountains.
