CIVIL AERONAUTICS BOARD

JUN 21 1 32 PM '57 AMENDED ACCIDENT INVESTIGATION REPORT

EASTERN AIR LINES, INC., LOCKHEED L-749A, CONSTELLATION  
N 112A, JACKSONVILLE, FLORIDA, DECEMBER 21, 1955

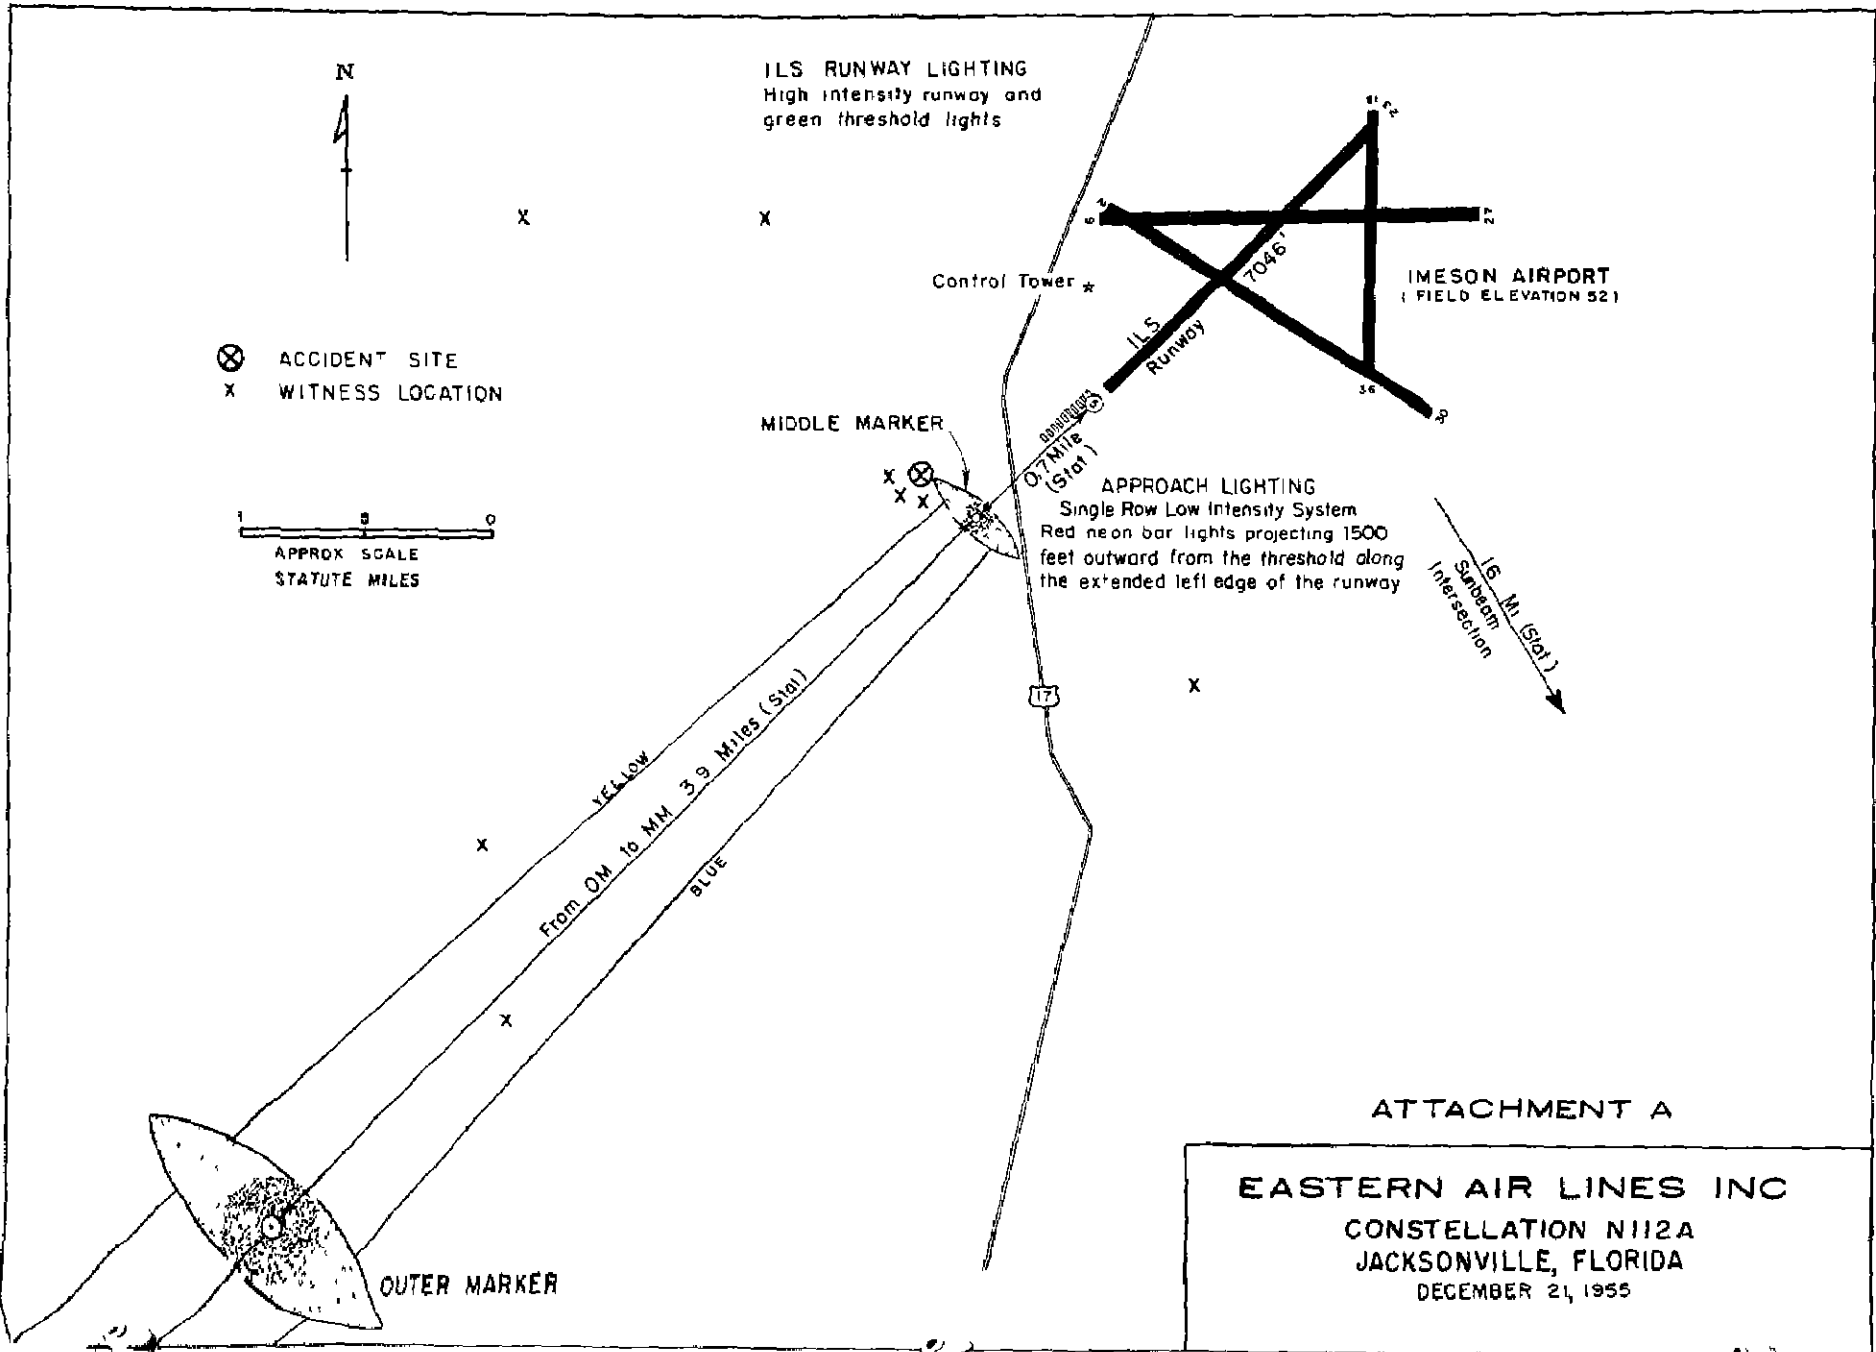
ATTACHMENT A

Several persons saw or heard the aircraft, with normal engine sound. A power surge was heard just before impact. One witness, who was near the middle marker, said he first saw the landing lights, lighted and pointing straight down, and that they partially extended before he lost sight of the aircraft. Other witnesses near the accident scene did not see the landing lights on. Subsequent investigation disclosed that the right landing light had been destroyed but the left light was found in the retracted position. There was no fire observed by any witness prior to impact. One witness saw the aircraft, at a very low altitude, make a slight turn to the right just before it contacted the trees and ground.<sup>3/</sup>
