No. 34

Linee Aeree Italiane, DC-6B aircraft, I-LEAD crashed after take-off at Paray-Vieille-Poste, France on 23 November 1956. Report by Commission of Inquiry set up by Order of the Secretary of State for Public Works, Transport and Tourism, France. Report released 24 April 1957.

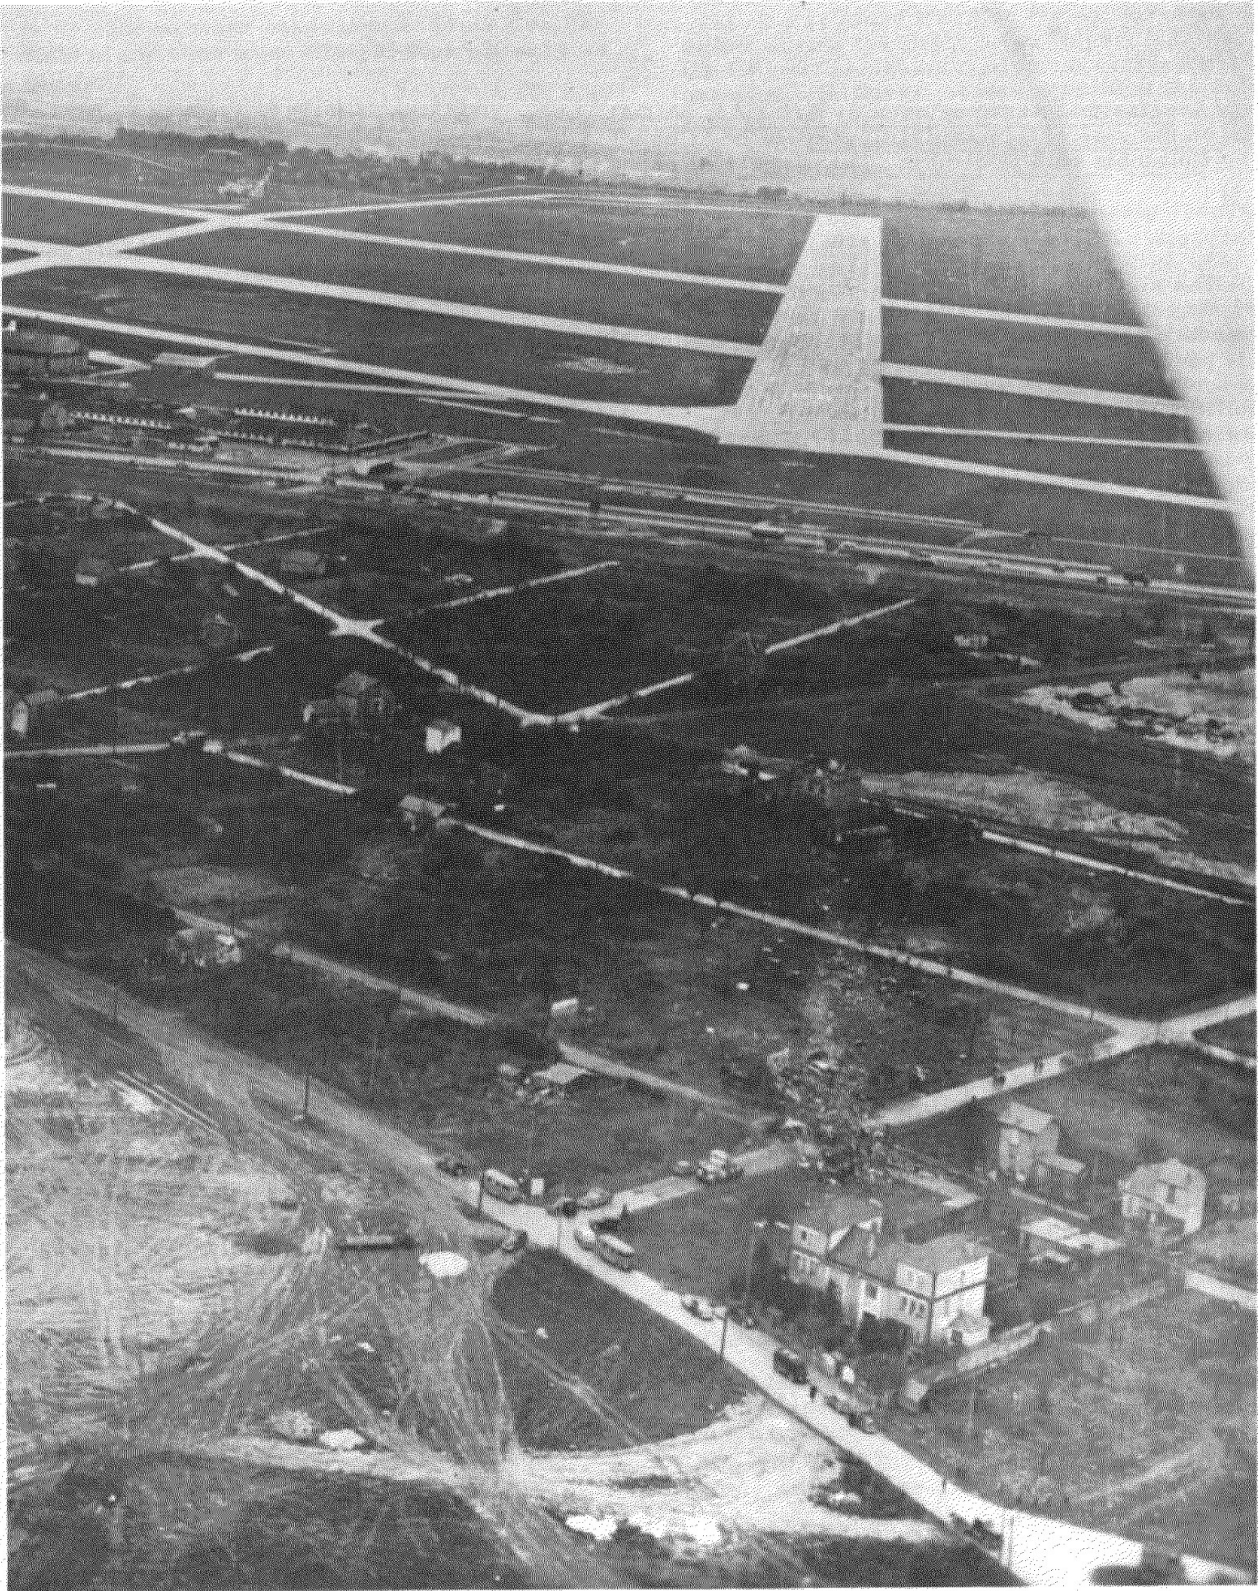
Figure 26

The wreckage was strewn over a distance of 200 metres. The main wreckage covered an area measuring approximately 30 by 15 metres only and had been greatly damaged by the fire which broke out following the crash.

Wreckage area of Linee Aeree Italiane DC-6B, I-LEAD, which crashed following take-off from Orly Airport, Paris, on 23 November 1956.
