No. 32

Pan American World Airways, Boeing 377, N 1023V, landing accident at  
Manila International Airport, The Philippines, on 2 June 1958.  
Report released by Civil Aeronautics Administration,  
Department of Public Works and Communications,  
Republic of The Philippines.

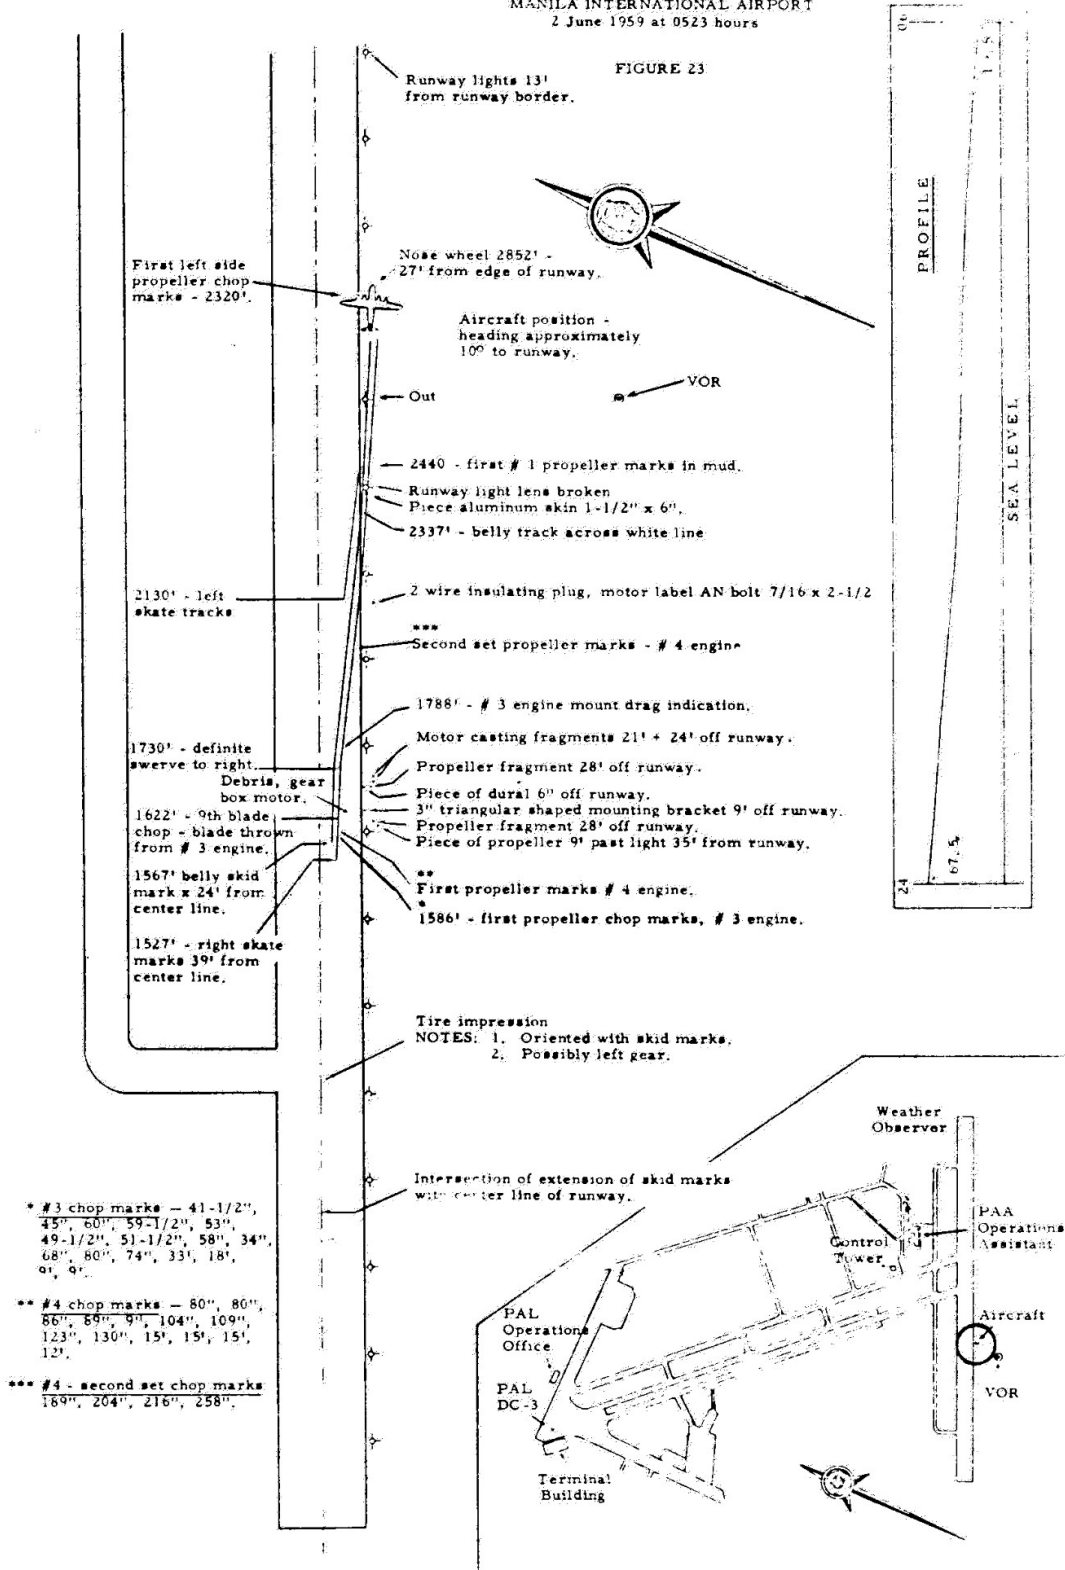
FIGURE 23

N 1023 V ACCIDENT  
 MANILA INTERNATIONAL AIRPORT  
 2 June 1959 at 0523 hours
