No. 9

East Anglian Flying Services Ltd. (Channel Airways), Dakota C-47,
G-AGZB, accident at St. Boniface Down near Ventnor, Isle
of Wight on 6 May 1962. C.A.P. 197, Civil Aircraft
Accident Report No. EW/C/05, released by
the Ministry of Aviation (U.K.)

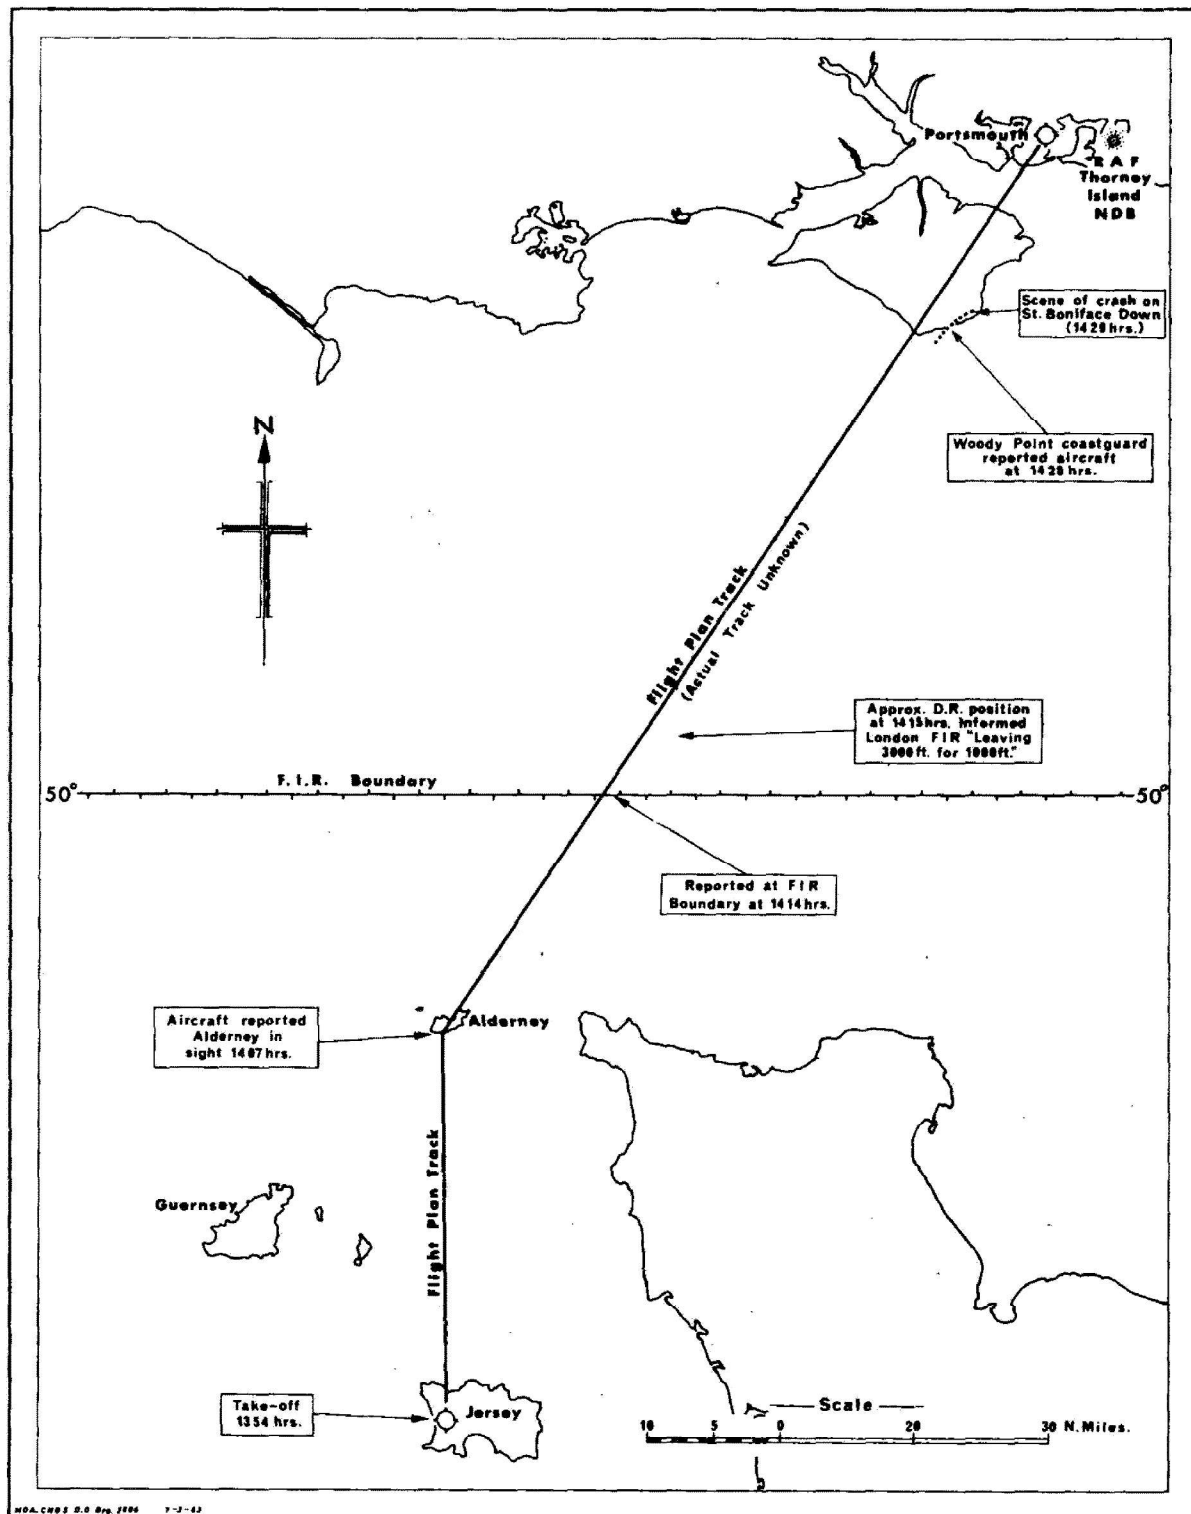
FIGURE 4

ACCIDENT TO C-47 OF CHANNEL AIRWAYS AT ST. BONIFACE DOWN,
Near VENTNOR, ISLE OF WIGHT, 6 MAY 1962
