No. 19Panair do Brasil S. A. , DC-8, PP-PDT, accident at Galeão Airport,
Guanabara State, Brazil on 20 August 1962. Report released by
the Brazilian Air Ministry (SIPAer).1. Historical1.1 Circumstances

ACCIDENT TO DC-8, PP-PDT OF PANAIR DO BRASIL S. A. AT GALEAO AIRPORT, BRASIL

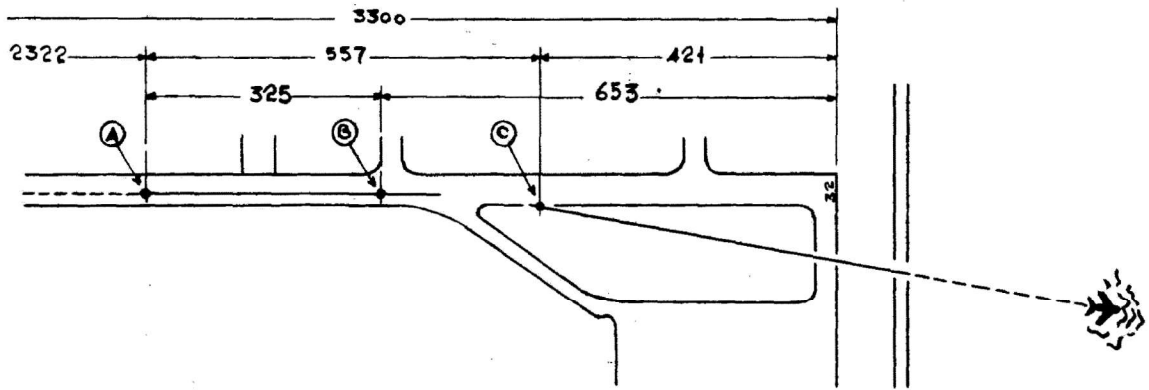
FIGURE 5

However, the pilot-in-command did not use correct emergency stop procedure. He first started to apply brakes and reduced power 5 seconds later when the aircraft was only 700 m from the end of the runway. He did not reverse thrust, which was done later on by the co-pilot, and the spoilers were not used. Furthermore, he did not inform the crew of his decision to abort the take-off, which resulted in considerable confusion in the activities of the crew.

CORRELATION WITH THE MARKS FOUND ON THE RUNWAY

- A - FIRST BRAKE MARKS
- B - BEGINNING OF VIOLENT BRAKING
- C - POINT WHERE THE AIRCRAFT LEFT THE RUNWAY
