Air Cameroun, Douglas C-54, TJ-ABC, accident at
Douala Airport, Cameroon, 13 June 1961.
Report released by the Director of Civil Aviation, Cameroon.

C-54, TJ-ABC, 13/6/61

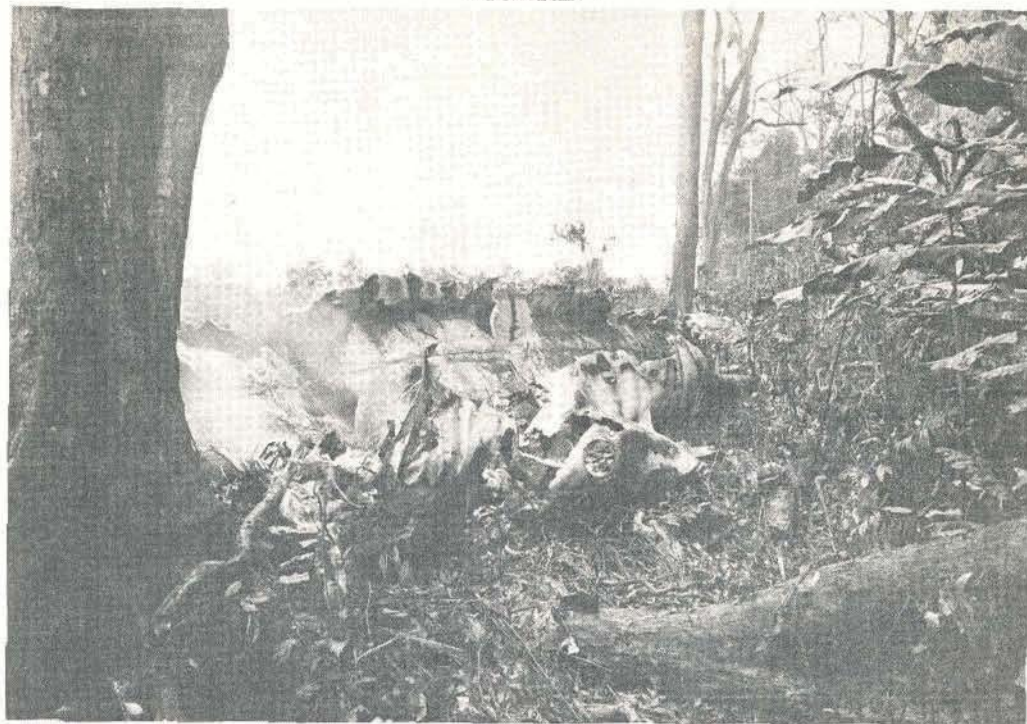
FIGURE 7

The fuselage, entirely destroyed by fire, was 240 m from the first point of impact. It had not crashed into the ground but slid and tilted to the left.

FLOOR OF PASSENGER COMPARTMENT WITH UPPER PART MISSING

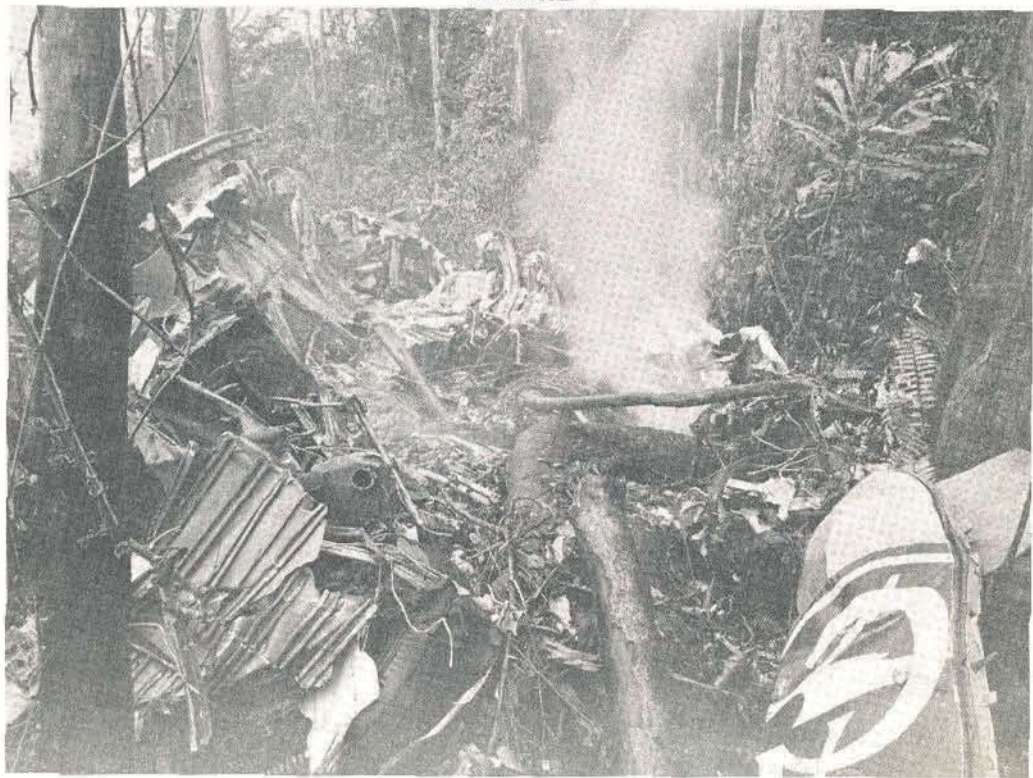
FIGURE 8

FORWARD FUSELAGE AND NOSE WHEEL
