HCL 49/01	Accident		
Aircraft Type:	Dassault Falcon 20	Aircraft Registration:	D-CBNA
Engine(s):	2 CF 700-2D2	Type of Flight:	Charter, IFR
Crew:	2- fatal injuries	Passengers:	1- fatal injuries
Place:	4.5 nm SW of Narsarsuaq	Date and Time:	05.08.2001 0443 UTC
	(BGBW)

FINAL REPORT

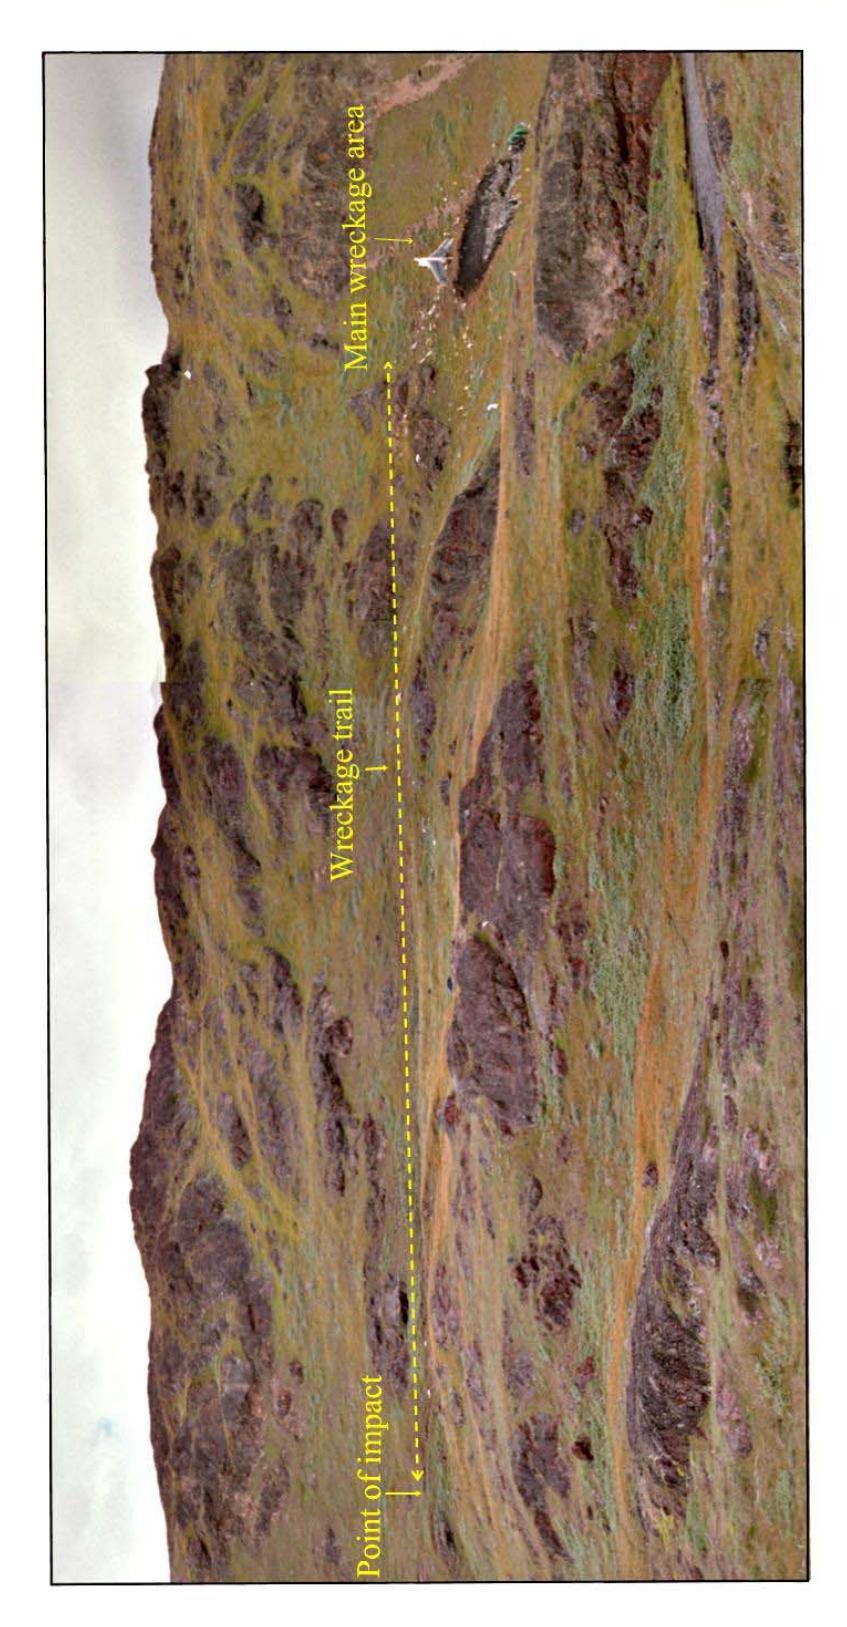
Enclosure 2

1.12.1.1 Examination of the ground scars and the debris pattern revealed that the aircraft impacted mountainous terrain at 61 07 194N 045 33 595W and at an elevation of about 700 msl in a wings-level attitude. The wreckage trail track had a direction of approximately 110 degrees magnetic. The wreckage pattern observed was consistent with a controlled shallow descent. The wreckage trail was approximately 165 metres long by 30 metres wide.

1.12.1.3 The aircraft started to break up from the beginning of the wreckage trail. During the break up, the cargo exited the aircraft and was spread over a relatively large area of the last part of the wreckage trail. No cargo tie-down rings or any other sign of use of cargo net were found within the accident area.

wreckage trail. When the aircraft came to a stop, the fuselage, the right wing and the cockpit caught fire. The fuselage, the right wing and the cockpit were burned out.

1.12.1.5 The two engines were found separated from their respective mounted positions on the aircraft. The starboard engine was located 40 metres SW of the main wreckage site. The port engine was located within the main wreckage area.

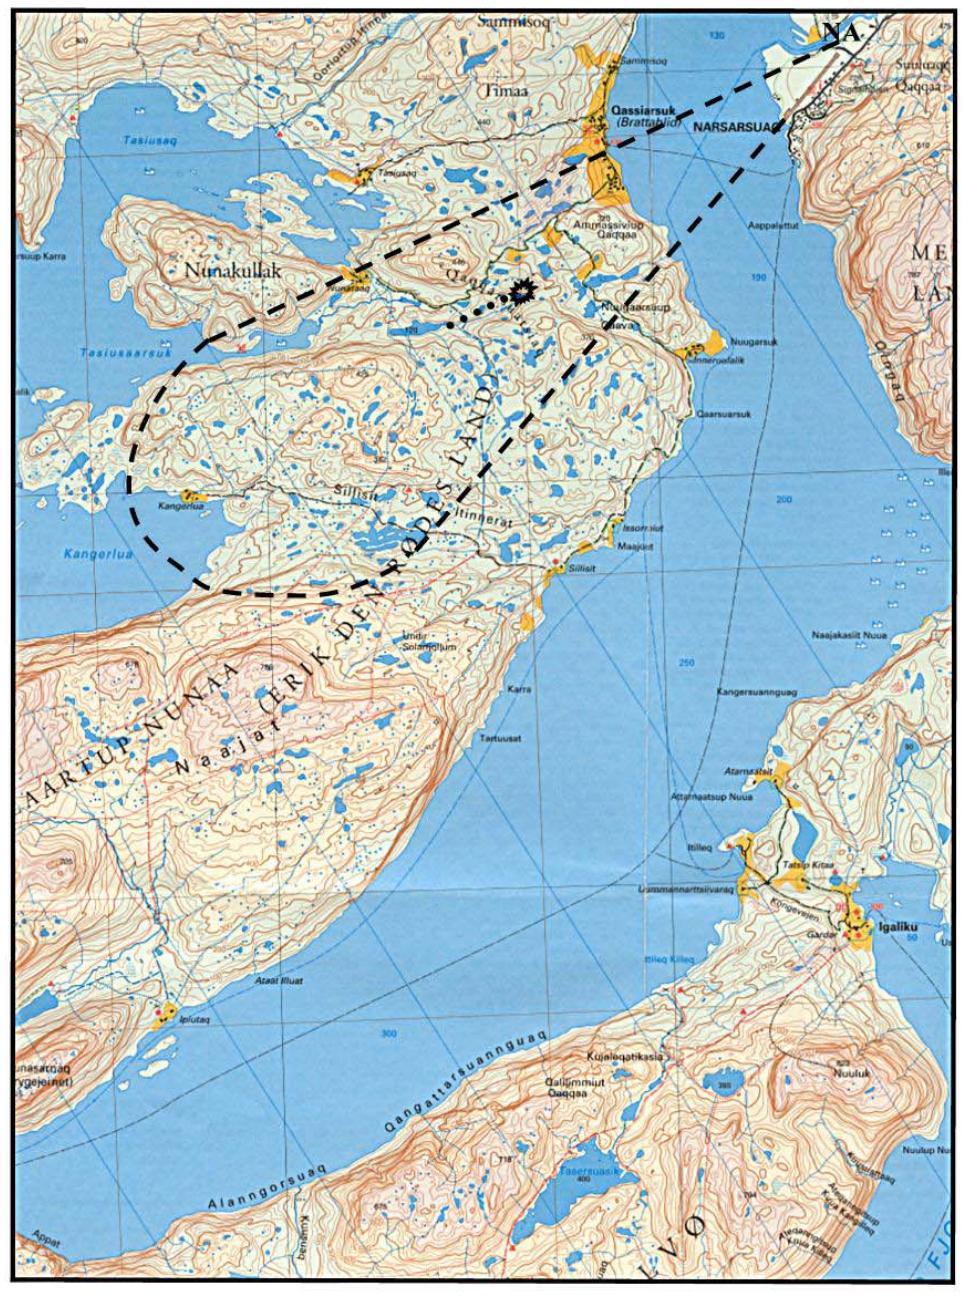
Enclosure 4

– – – – – NDB/DME approach procedure

•••••• The aircraft's assumed final approach track
