National Transportation Safety Board Aviation Accident Final Report

Location:	Jacksonville, Florida	Accident Number:	DCA19MA143
Date & Time:	May 3, 2019, 21:42 Local	Registration:	N732MA
Aircraft:	Boeing 737	Aircraft Damage:	Substantial
Defining Event:	Runway excursion	Injuries:	1 Minor, 142 None
Flight Conducted Under:	Part 121: Air carrier - Non-scheduled

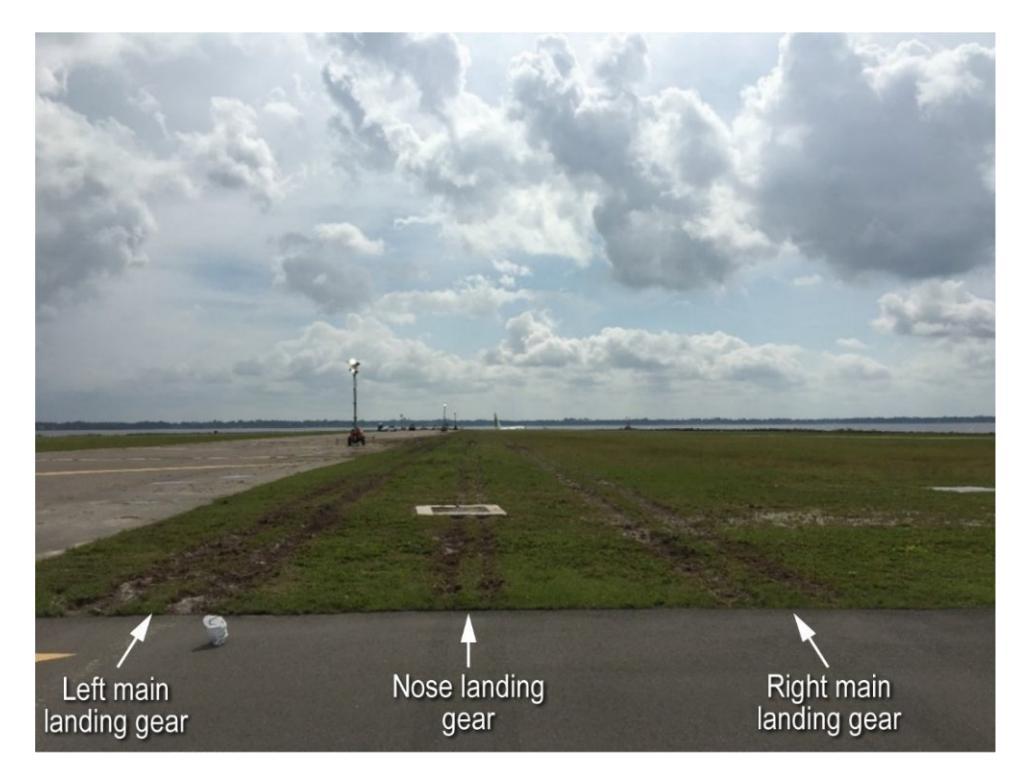
Light white landing gear track marks were visible on the pavement starting 1,592 ft from the displaced threshold (12 ft past the touchdown point of 1,580 ft computed by the onboard performance tool [OPT]) to the end of the pavement. The airplane's tracks showed variation in position relative to the right of centerline after touchdown and exited the paved surface about 55 ft to the right of centerline. The tracks continued in the grass area, deviating farther to the right of centerline and extending to the point at which the airplane struck the rock berm and entered the river, 90 ft right of centerline. Figure 1 shows the transition of track marks from the pavement to the grass and figure 2 shows the airplane at final rest in St Johns River.

Figure 1. Photograph of tire marks from the accident airplane's landing gear

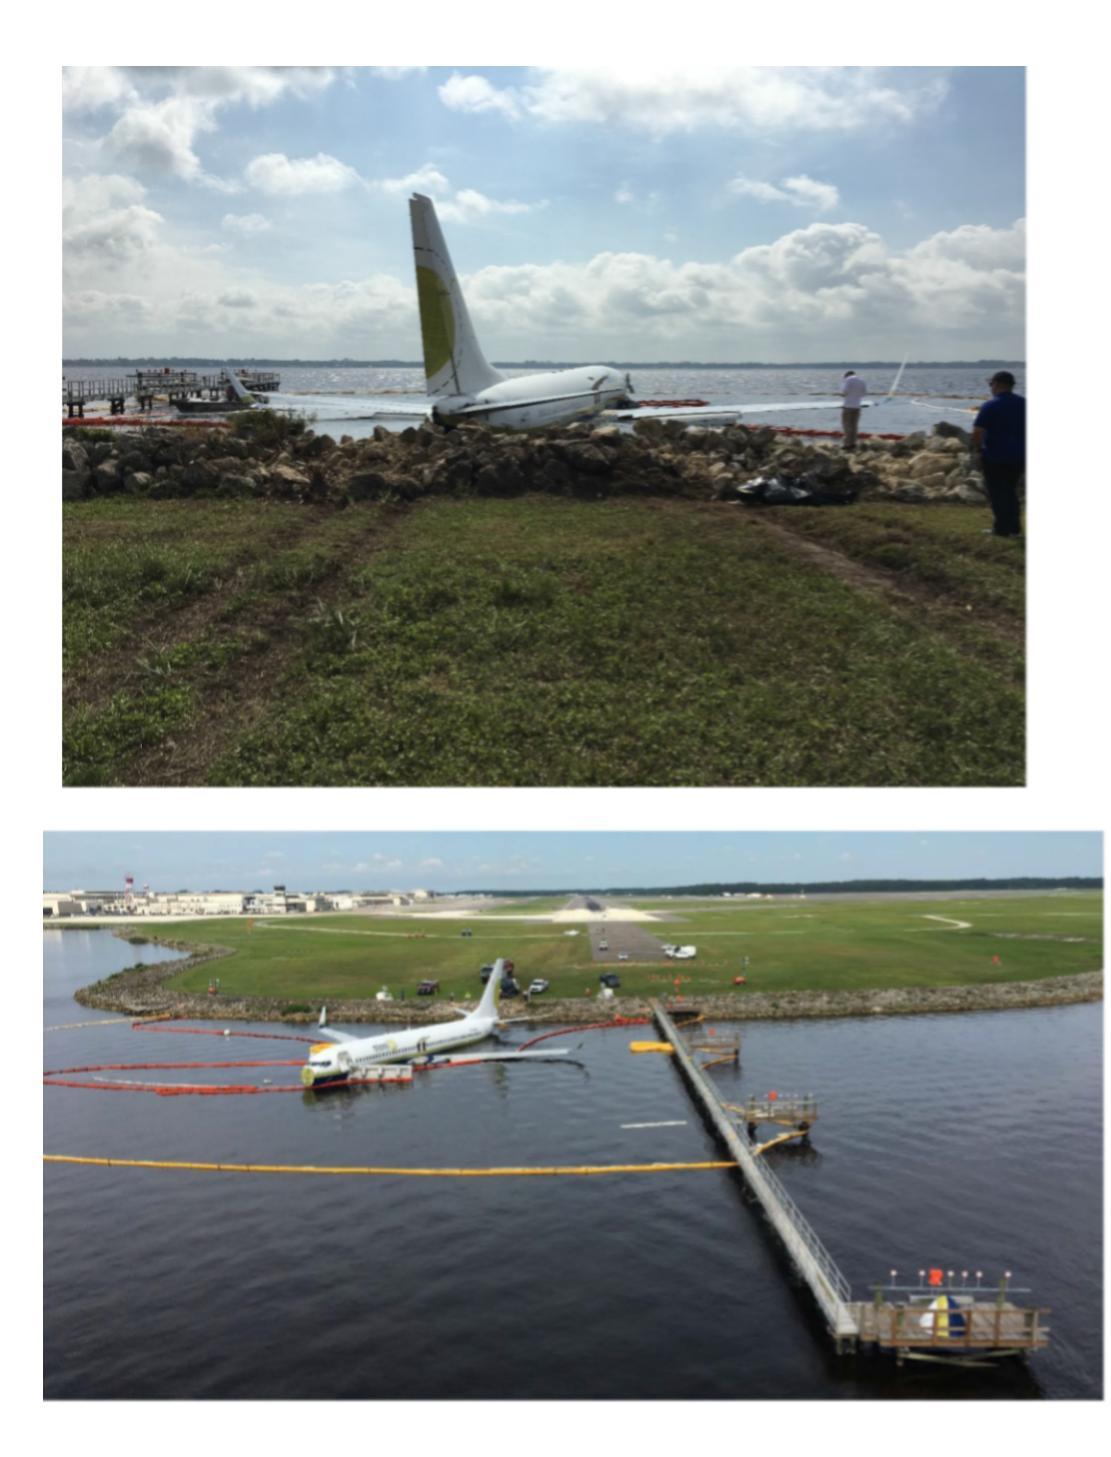
Figure 2. Photographs of accident airplane in St. Johns River

The airplane was mostly intact but sustained substantial damage. Portions of the engine cowlings, the radome, and both main landing gear separated during the accident sequence and were in the water adjacent to the airplane or on the rock embankment. Three life rafts were recovered in the water around the airplane. The L1 and R1 (forward) doors and the four overwing emergency exits were open. The L2 and R2 (aft) doors were closed. The L1 door
