# KC-135 Accident Investigation Board complete

Posted 12/20/2006 Updated 12/20/2006

12/20/2006 - **SCOTT AIR FORCE BASE, Ill.** -- Air Mobility Command today released the results of its investigation into the Sept. 26 KC-135R aircraft accident at Manas International Airport, Bishkek, Kyrgyz Republic.

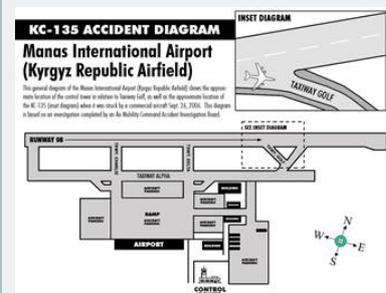
This general diagram of the Manas International Airport (Kyrgyz Republic Airfield) shows the approximate location of the control tower in relation to Taxiway Golf, as well as the approximate location of the KC-135 (inset diagram) when it was struck by a commercial aircraft Sept. 26, 2006. This diagram is based on an investigation completed by an Air Mobility Command Accident Investigation Board.
