FINAL REPORT

ACCIDENT OF M/S. AIRCRAFT SALES AND SERVICES BEEHCRAFT-1900D AIRCRAFT, REG. NO. AP-BII ON 18TH MARCH, 2016 AT JIAP, KARACHI

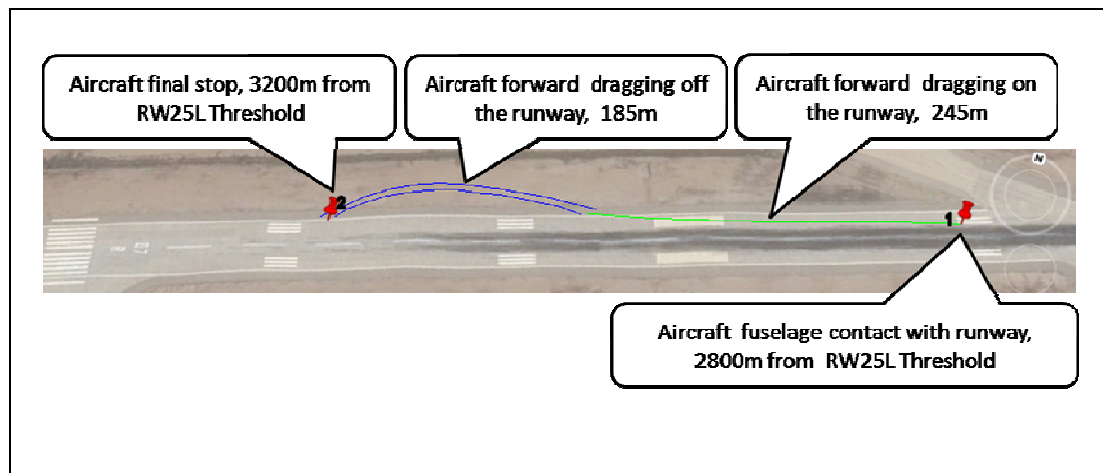
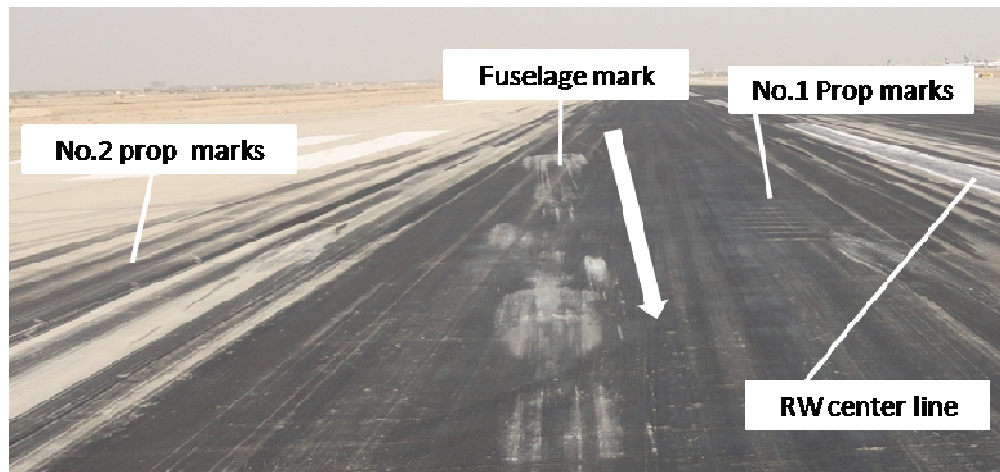
Initial runway marks

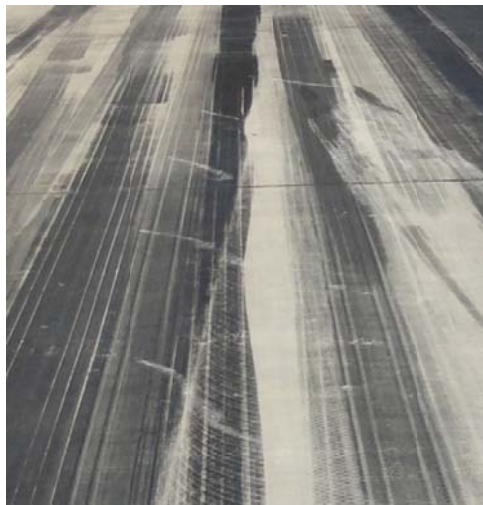
No. 2 Prop marks: Distance between marks 65 to 109 inches.

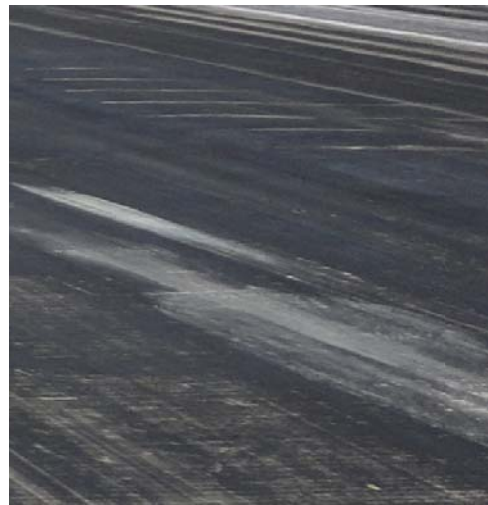
No. 1 Prop Marks : Distance between marks 19 to 22 inches

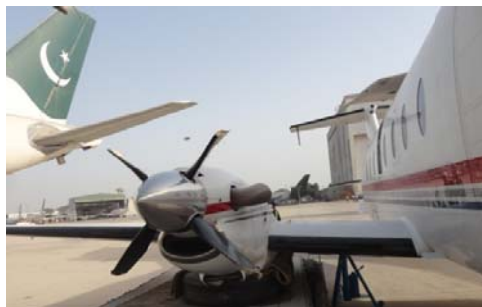
Aircraft right side- Prop in feather

- 2.2.2 Post incident visual inspection of No. 2 engine propeller blades indicated that blades were at feather position.
- 2.2.3 The fuel samples from aircraft and oil samples from both engines were drawn and submitted to Perac Research and Development Foundation (PRD) Karachi for analysis. The PRD reports did not reveal any abnormality with fuel and oil of the mishap aircraft.

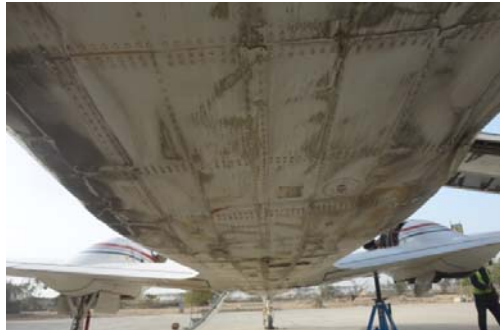
- 1.12 **Wreckage and Impact Information.** The aircraft remained intact after the incident. Both propellers, belly of the aircraft and lower part of the engine cowlings sustained damage due to gear up landing contact with the runway. The aircraft path on runway and other relevant pictures are shown below:

Aircraft Belly : Looking forward

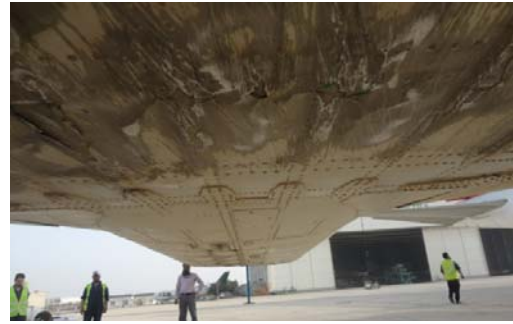
Aircraft Belly : Looking rearward
