Aviation Investigation Final Report

Location:	Monterey, California	Accident Number:	WPR21FA270
Date & Time:	July 13, 2021, 10:42 Local	Registration:	N678SW
Aircraft:	Cessna 421C	Aircraft Damage:	Destroyed
Defining Event:	Collision with terr/obj (non-CFIT)	Injuries:	2 Fatal
Flight Conducted Under:	Part 91: General aviation - Personal

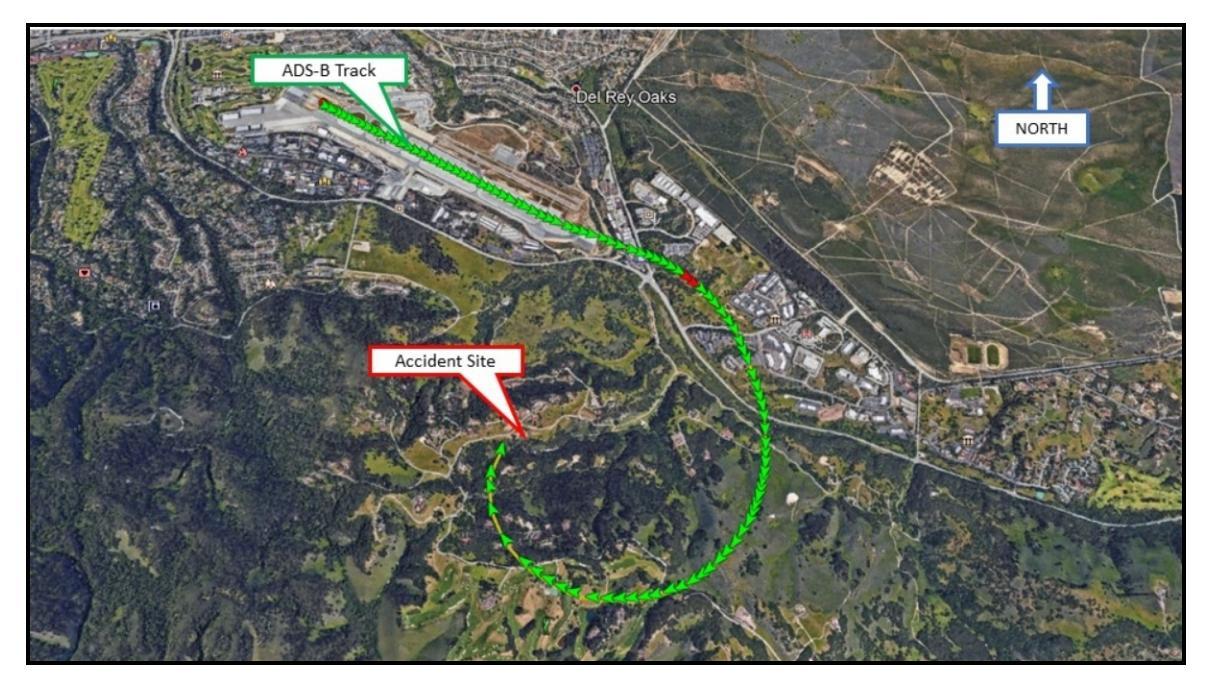
Recorded automatic dependent surveillance-broadcast (ADS-B) data provided by the Federal Aviation Administration (FAA) showed that the airplane departed from runway 10R at 1738:44 and ascended to 1,075 ft msl before a right turn was initiated. The data showed that at 1740:14, the airplane continued to ascend in a right turn and reached an altitude of 2,000 ft msl before a descent began. The airplane continued in a right descending turn until ADS-B contact was lost at 1740:38, at an altitude of 775 ft msl, about 520 ft southwest of the accident site as seen in figure 1.

Figure 1: View of airplane ADS-B track.

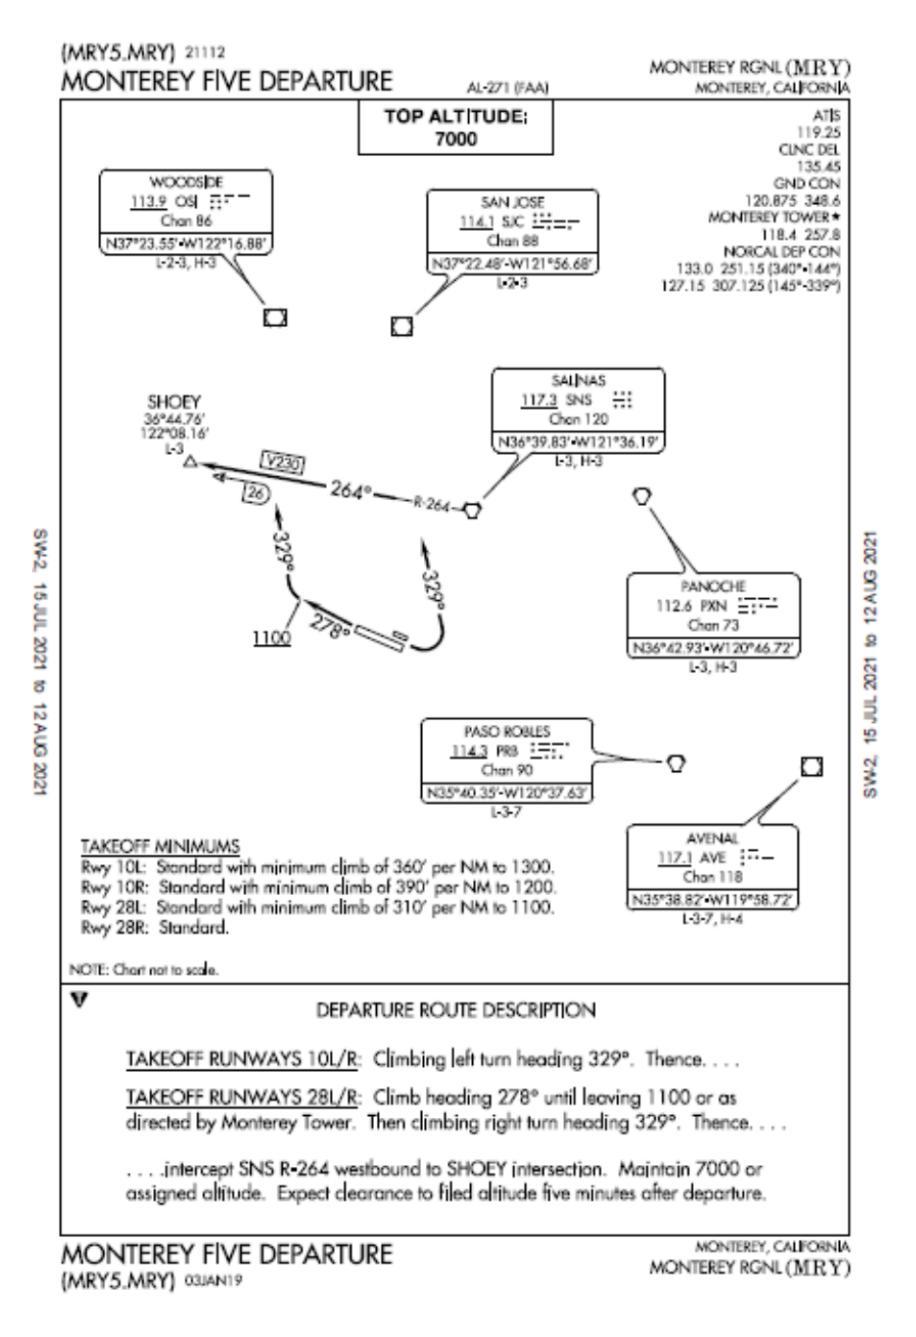
The Monterey Regional Airport is a public airport operating under class-Delta airspace. The airport features multiple runways. Runway 10R, is charted with two IFR departure procedures (both requiring a climbing left turn after takeoff), elevation is 158 ft and runway dimensions are 7,175 ft x 150 ft.

Figure 2: View of the Monterey Five Departure procedure.

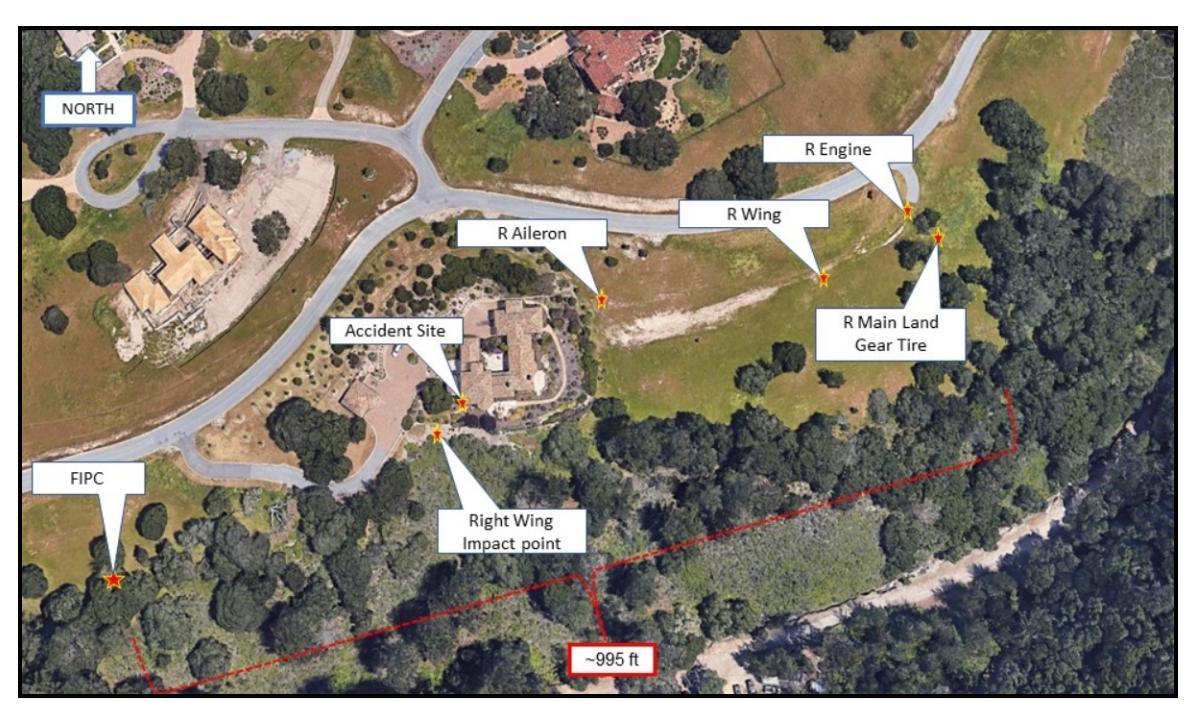
Examination of the accident site revealed that the airplane impacted trees about 1 mile south of the departure end of runway 10R. The first identifiable point of contact (FIPC) was a 50 to 75 ft tall tree that had damaged limbs near the top of the tree. The debris path was oriented on a heading of about 067° and was about 995 ft in length from the FIPC, as seen in figure 3. The main wreckage was located about 405 ft from the FIPC. Various portions of aluminum wing skin, right wing, flap, aileron, engine, propeller blades, and propeller hub were observed throughout the debris path. Additionally, several trees were damaged throughout the debris path. The fuselage came to rest upright against a residential structure at an elevation of 447 ft msl.

Figure 3: View of accident site diagram.
