AIRCRAFT ACCIDENT REPORT

**MOHAWK AIRLINES, INC.
FAIRCHILD HILLER FH-227B, N7811M
NEAR GLENS FALLS, NEW YORK
NOVEMBER 19, 1969**

Adopted: June 25, 1970

Report Number: NTSB-AAR-70-12

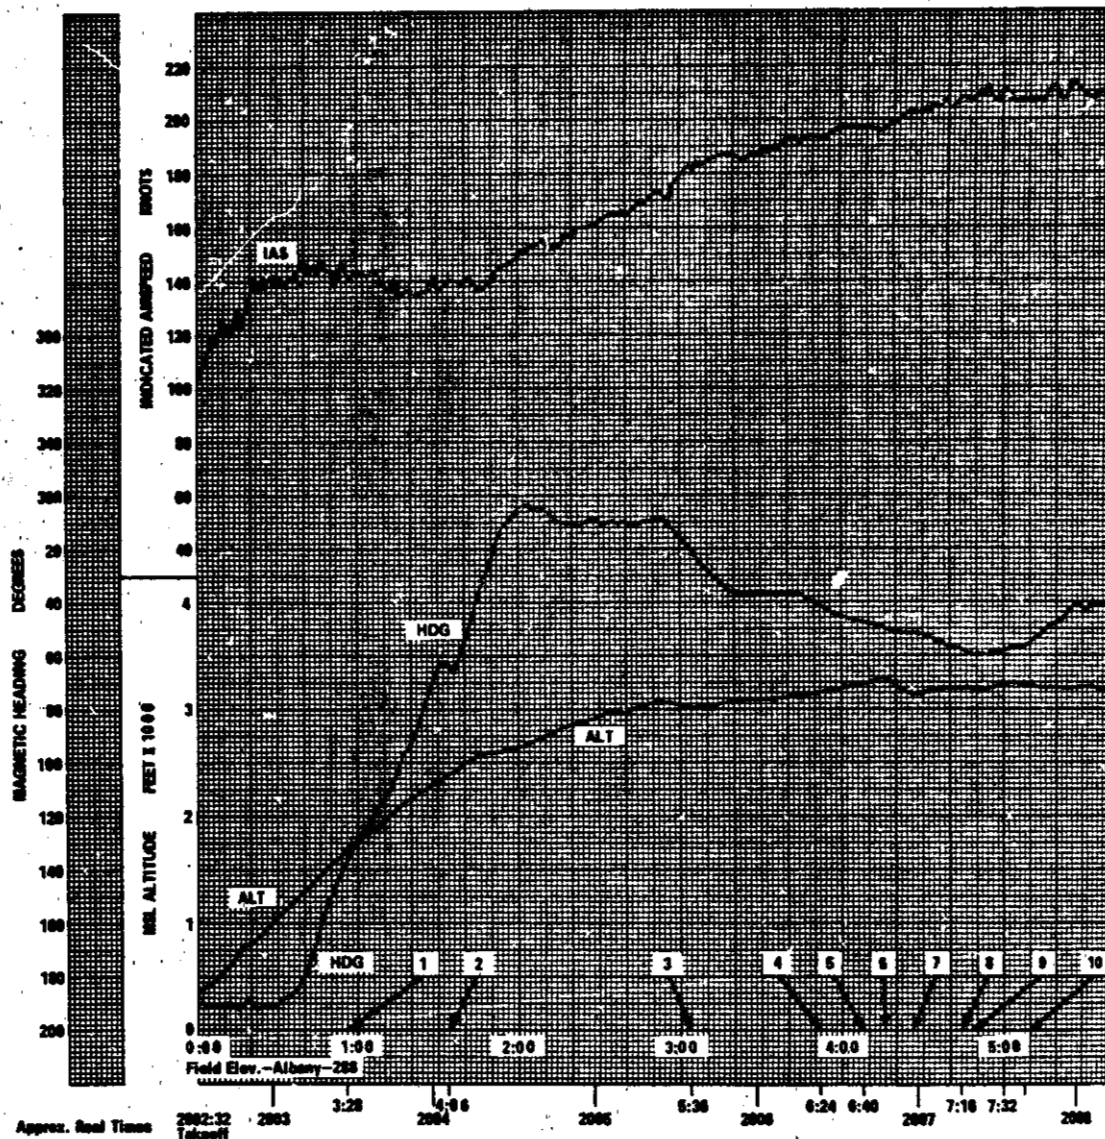
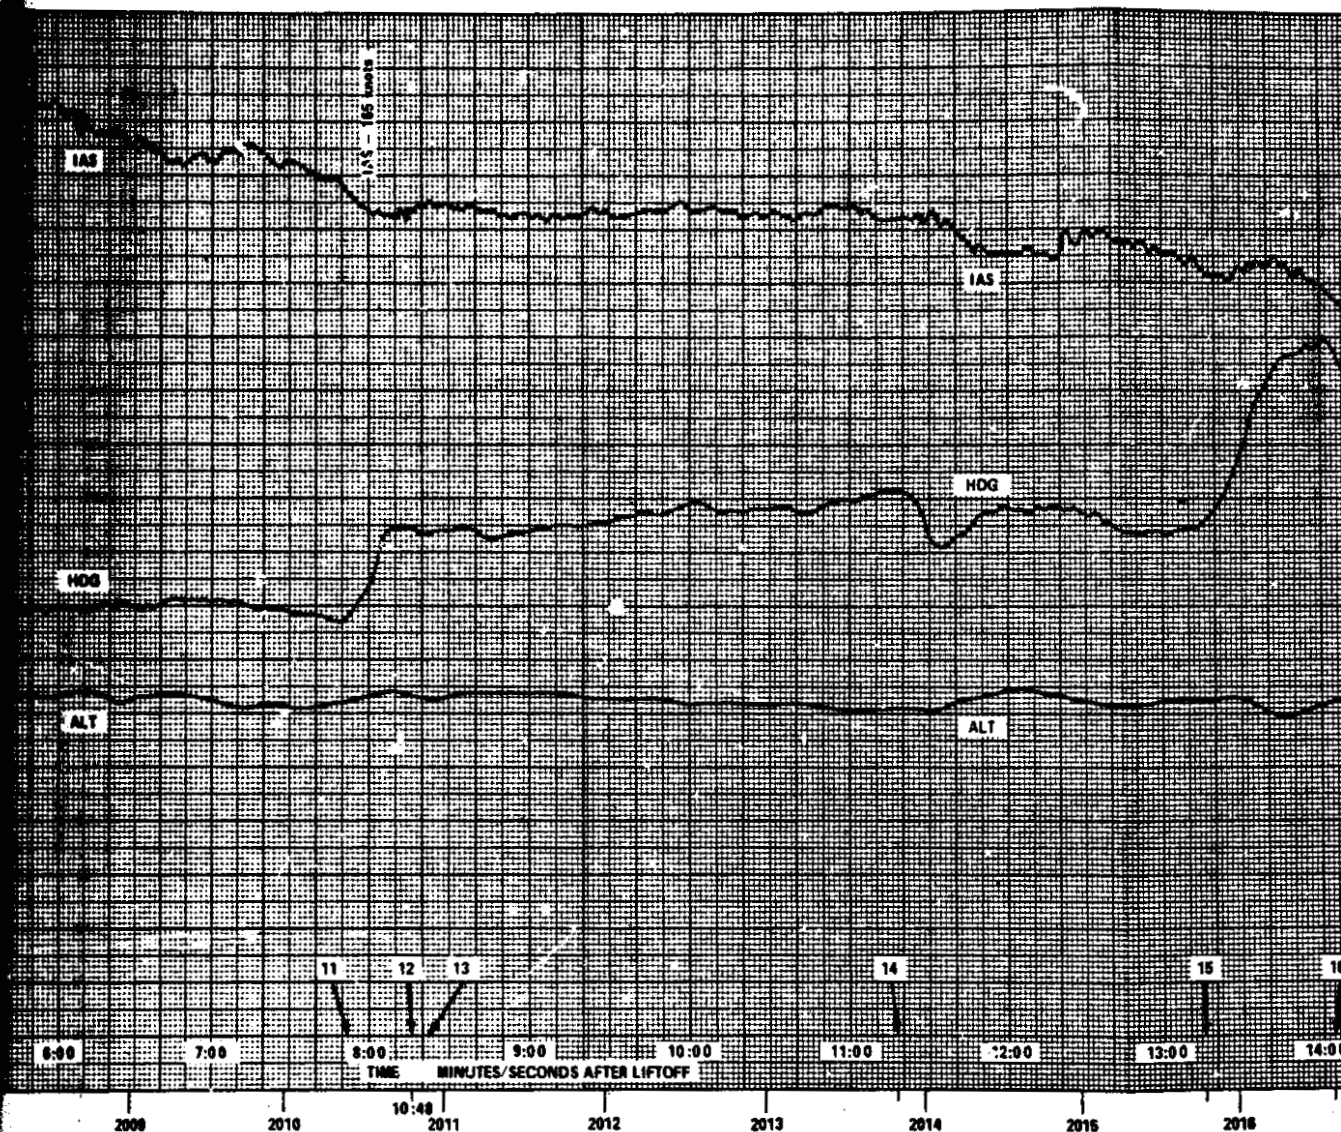
APPENDIX D, PAGE 2

1. DR - Mohawk 411 Contact Departure Control
2. DR - Ah Departure Mohawk 411 turning left zero one zero
3. DR - And Mohawk Four Eleven Ah intercept the zero three nine radial
4. DR - And Mohawk 411, the Glens Falls weather measured ceiling 2100 ft. overcast, visibility 7, light rain, wind 180 at 12, peak gusts 22, and altimeter 29.80. Ry 18 in use
5. 411 - Four Eleven, Thanks
6. 411 - Albany Ah Four Eleven, do you have the temperature up there?
7. DR - Ah, stand by one
8. DR - And Glens Falls temperature five four
9. 411 - Thank you

10. DR - And Mohawk Four Eleven, you're close approach at the Warren County Airport. Thank you Four Eleven
11. Turn to 010° initiated Miller Intersection
12. 411 - Albany Ah Mohawk Four Eleven's at Miller Radio
13. DR - Roger 1, MO-411, advise Glens Falls for your cancellation and radar service. Thank you.
14. Right, left turn commences in vicinity of Clear
15. Reverse A1 turn initiated to the left

20. Momentary level-off about same time greater turbulence commences
