AIRCRAFT ACCIDENT REPORT

**COIN ACCEPTORS, INC.
CESSNA MODEL 551, CITATION II, N2CA
MOUNTAIN VIEW, MISSOURI
NOVEMBER 18, 1982**

NTSB/AAR-83/04

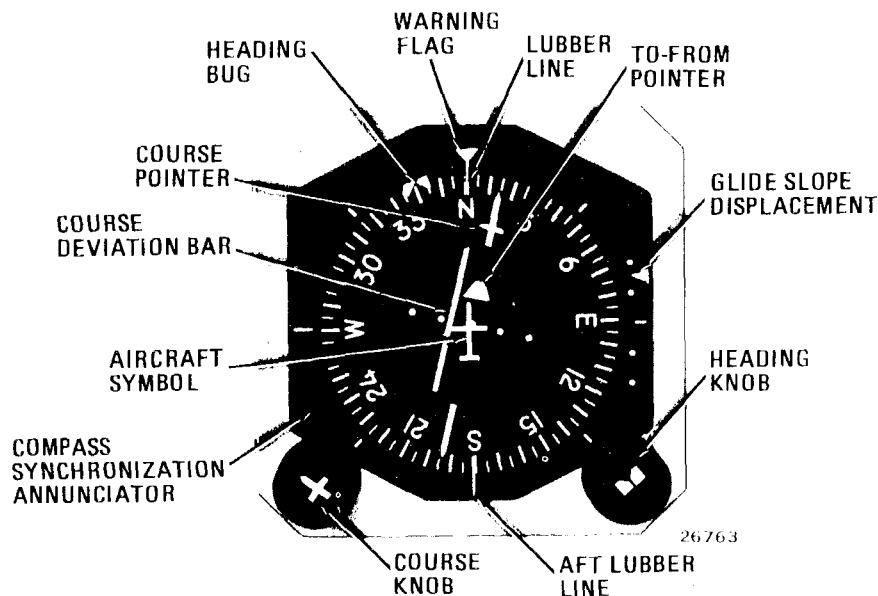
Figure 4.--Copilot's RD-44 Horizontal Situation Indicator.

The copilot's HSI was a RD-44, 4-inch display. (See figure 4.) The system has a compass synchronization annunciator. The display will oscillate between the two indicators when the system is in the slaved mode, indicating that the gyro stabilized rotating heading dial is synchronized with the airplane's magnetic heading.

Both HSI's have warning flags which appear if the heading information is not reliable, or if the gyro is not providing adequate power to the HSI.
