# **NATIONAL TRANSPORTATION SAFETY BOARD**

## **AIRCRAFT ACCIDENT REPORT**

**BRITTEN-NORMAN BN-2A-6 ISLANDER, N589SA**

**NTSB/AAR-85/08**

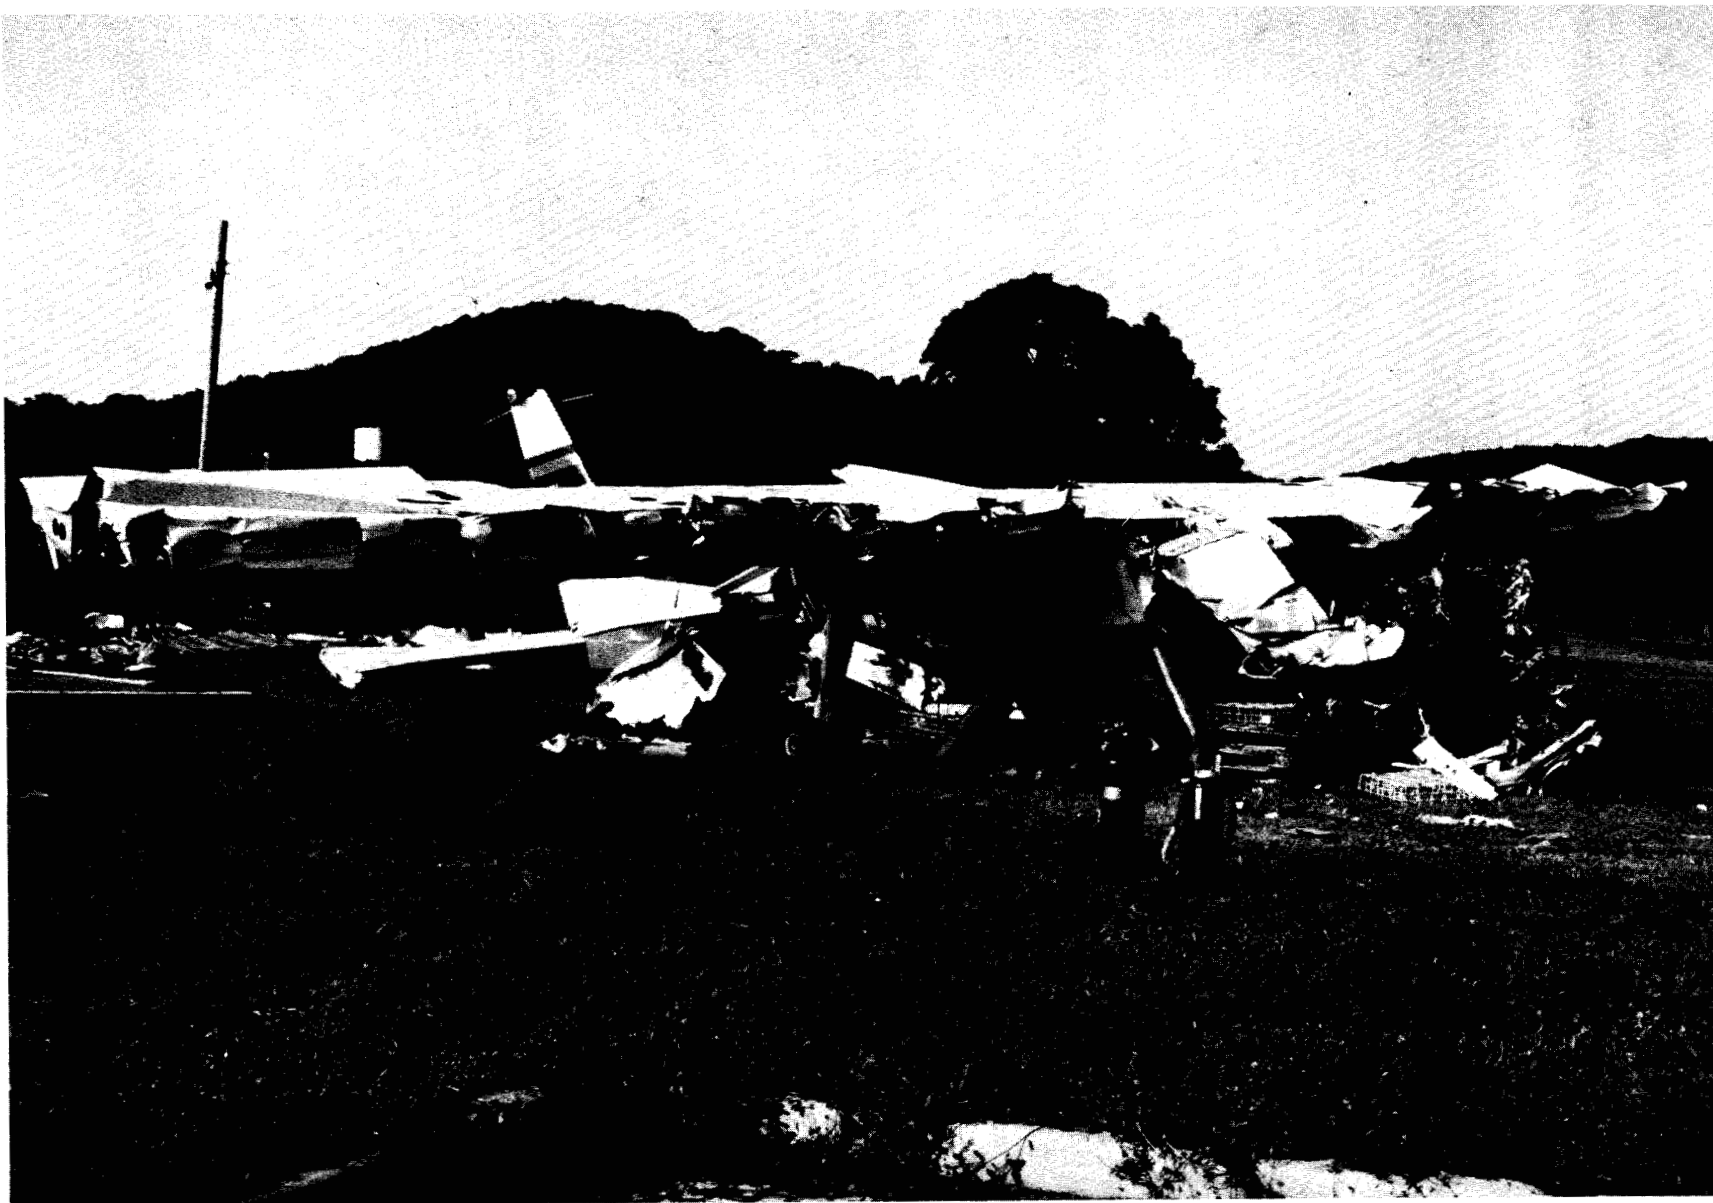
**Figure 2.--Britten-Norman BN-2A-6 Islander N589A.**

The forward fuselage was crushed rearward to just forward of seat row 3. (See figure 2.) This area included the flight compartment and the first two rows of passenger seats. Both sides of the fuselage were buckled outward about 9 inches beneath the wings in the vicinity of seat rows 3 and 4. The empennage and tail section separated from the fuselage at the rear baggage compartment.
